FACILITY CONDITON ASSESSMENT SERVICES REPORT

Compass Point Phases 1 and 2

ARMSTRONG ATLANTIC STATE UNIVERSITY

October 1, 2013

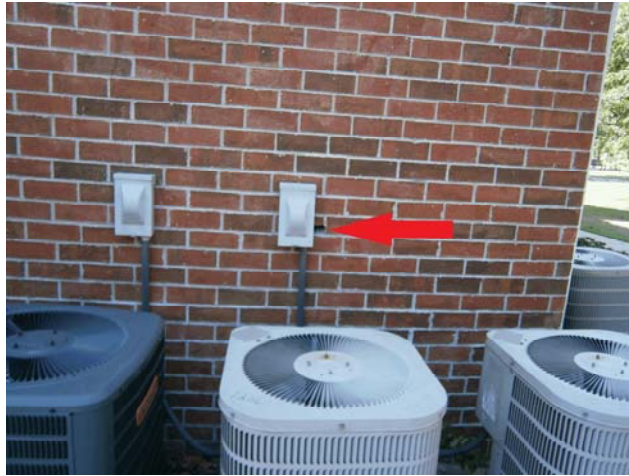
Fig. 2.6.3-1

Hole in brick veneer near HVAC disconnect

2. At Building 1000, a hole in the brick veneer exists near an HVAC compressors disconnect on the north side of the building.

Section	Description	Estimated Cost
3.6.3.1.1.	Exterior Walls	
	Trim ground level weep tubes	
	Patch holes in masonry near HVAC compressors	
	Correct stucco at recessed areas near downspouts	
	Correct horizontal stucco termination at brick	
	Re-caulk vertical joints between brick and stucco at recesses	
	Repair Exterior Finishes	\$8,750.00
3.6.3.1.2.	Sprinkler Riser Room Exterior Walls	
	Caulk/seal at penetrations – of sprinkler riser room	
	Correct riser room flashing	
	Repair Exterior Finishes	\$500.00
3.6.3.1.3.	Doors	
	Replace wood frames with hollow metal frames in Sprinkler Riser Room	\$700.00
3.6.3.1.6.	Roofs & Drainage Systems	
	Clean gutters and install gutter protection	\$1,600.00

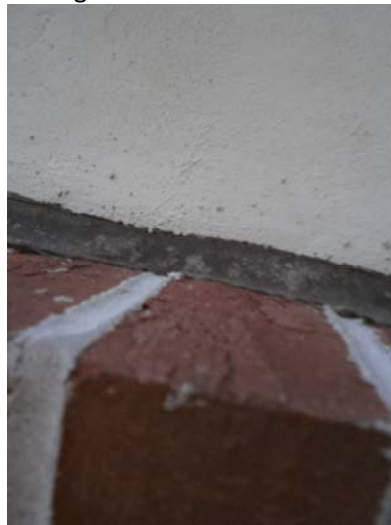
Fig. 2.6.3-2

Typical conditions of caulk joint at brick and stucco termination

3. At Building 1000 the stucco terminates into the rowlock course at the top of the brick with a caulk joint. This detail does not allow water that penetrates the stucco finish to weep out.
4. At Buildings 1000, a correction of this condition has been attempted - at recessed areas an approximately 1x4 nominal strip of wood or synthetic lumber is attached to the bottom of the stucco. Below, and presumably behind this, metal flashing partially covers the top of the rowlock course.

1. At Building 2000 the stucco terminates into the rowlock course at the top of the brick with a caulk joint. This detail does not allow water that penetrates the stucco finish to weep out. (See Fig. 2.6.3-2)
2. At Building 2000, it appears the exposed caulking joint at this vertical intersection of the brick and stucco is currently failing. (See Fig. 2.6.3-4)

1. At Building 4000 the stucco terminates into the rowlock course at the top of the brick with a caulk joint. This detail does not allow water that penetrates the stucco finish to weep out. (see Fig. 2.6.3-2)

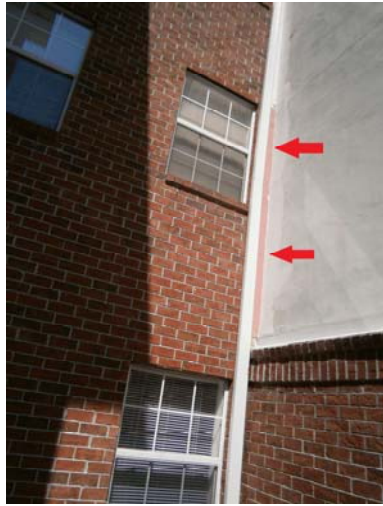
Fig. 2.6.3-3
Relocated downspout in recessed area

5. At Building 1000, it appears the downspouts have been relocated in the recessed areas. Unfinished stucco backup is visible at the intersection of the stucco side walls and the brick rear walls of the recesses. It appears this work is an unfinished repair. The exposed caulking joint at this intersection of the brick and stucco is currently failing.

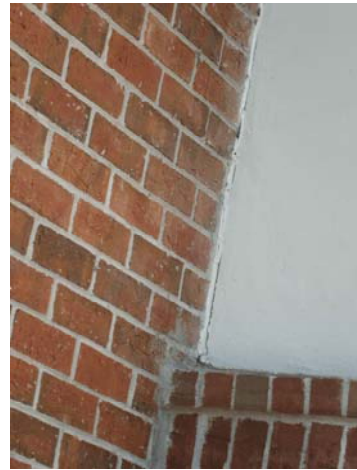
Fig. 2.6.3-4
Typical vertical failing caulking joint

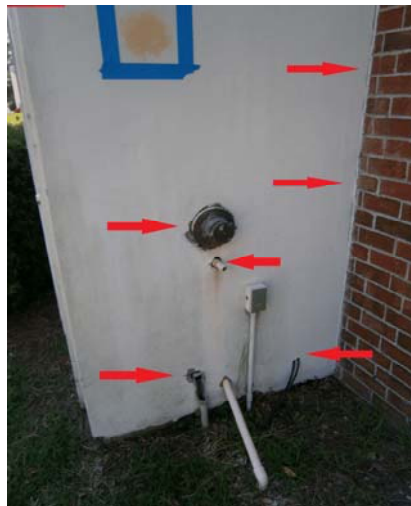
Fig. 2.6.3-5
Typical conditions at Riser Room, lack of penetration seals

6. Each building has a fire sprinkler riser room attached to the structure. Typically these are not as well constructed as the main parts of the buildings.
7. Penetrations in exterior walls are typically not caulked as noted above in Fig. 2.6.3-5.

1. Each building has a fire sprinkler riser room attached to the structure. Typically these are not as well constructed as the main parts of the buildings.
2. Penetrations in exterior walls are typically not caulked. (see Fig. 2.6.3-5)

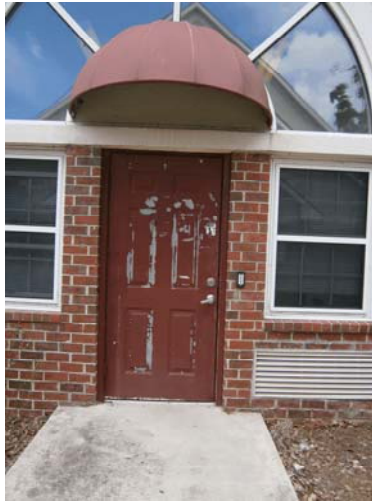
Fig. 2.6.3-6

Typical condition of door in need of maintenance

1. Doors appear to be in good to fair condition. Some doors appear to require painting and or regular maintenance. (see Fig. 2.6.3-6)
2. Sprinkler room door frame is of wooden construction. This frame is experiencing some deterioration, some areas more than others.

1. Doors appear to be in good to fair condition. Some doors appear to require painting and or regular maintenance. (see Fig. 2.6.3-6)

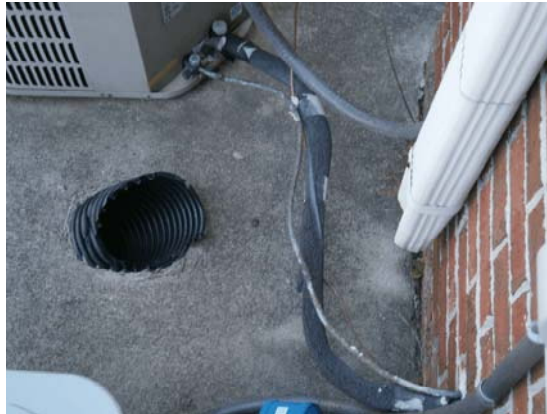
Fig. 2.6.3-7
Typical condition of downspouts
being disconnected from underground piping system

4. Several downspouts were not connected to the existing underground piping system. (see Fig. 2.6.3-7)
5. Shingle problems observed at Compass Point tend to point to installation issues. Isolated failures will continue to occur.

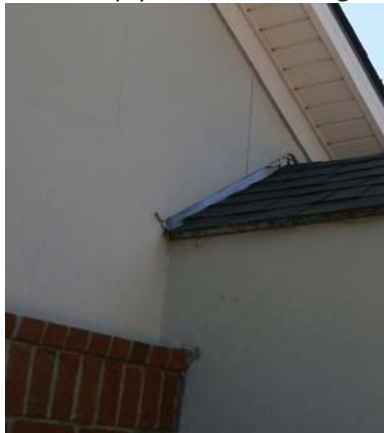
Fig. 2.6.3-8

Typical conditions of Flashing installed
directly under finished coat of stucco

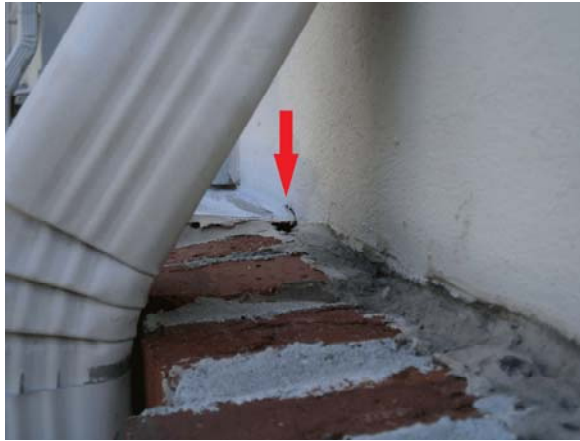
Fig. 2.6.3-9
Typical condition of caulking joint correction

2. At Building 4000, it appears a correction of this condition was attempted on the perimeter of the building. An approximately 1x4 nominal strip of wood or synthetic lumber is attached to the bottom of the stucco. Below, and presumably behind this, metal flashing covers the top of the rowlock course. However, some of the flashing is poorly installed and directs water into the wall cavity. (see Fig. 2.6.3-9)
3. At Building 4000, it appears the exposed caulking joint at this vertical intersection of the brick and stucco is currently failing. (See Fig.2.6.3-4)

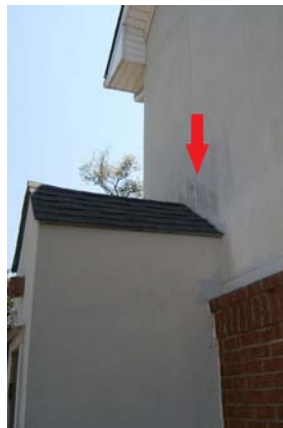
Fig. 2.6.3-10
Dark discoloration above caulked joint at roof and wall joint

3. Some riser room areas have no flashing at the junction of the main building wall and the riser room roof, this joint is simply caulked, inviting water penetration. This is visible at building 4000 riser room as the dark stucco above the calked joint is a sign of moisture penetration. (See Fig. 2.6.3-10)
4. Building has poorly installed flashing between the main building and riser room. This flashing also lacks kick-out flashing at the roof edge.

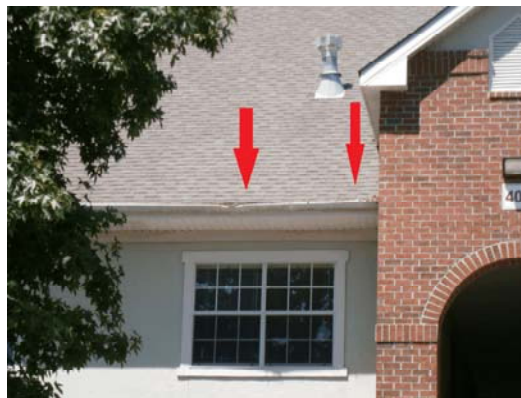
Fig. 2.6.3-11
Typical condition of gutters containing debris

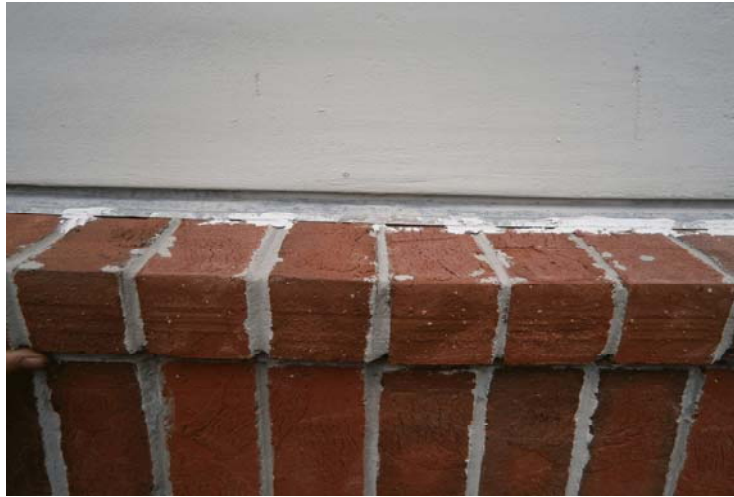
Fig. 2.6.3-12

Typical conditions of stucco screen being used as a weep screen

1. At Building 5000, a stucco screed (not a weep screed) was used at the bottom of the stucco. While not the optimum solution, it is much better than the first four buildings. (See Fig. 2.6.3-12)
2. The stucco to brick flashing at this building does not extend to the outboard edge of the rowlock course. Due to the texture of the brick, it is impossible to get a good seal to at this joint. Attempts have been made in several locations to caulk this joint. This flashing is galvanized metal, and is rusting in many places.

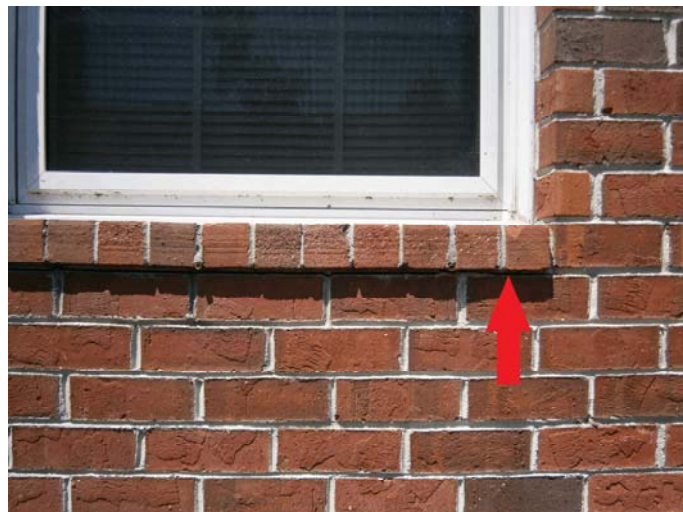
Fig. 2.6.3-13

Typical condition at window sill

3. At the center two pods of Building 5000, on the first floor east side, there are no weeps below the brick window sill at the outer two pods. Weeps exist directly under the brick window sills at the center two pods. At these window openings (center two pods east side) the brick has lifted at the outer edge, and now tilts back directing water towards the window sill. A crack exists in the mortar where the brick has lifted. While the root cause of this condition is unknown, it may be due to corroding reinforcing. (See Fig. 2.6.3-13)

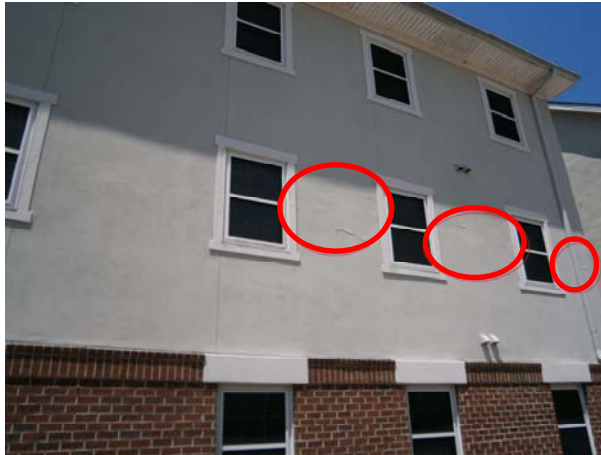
Fig. 2.6.3-14

Typical condition of cracking/delamination of stucco surface

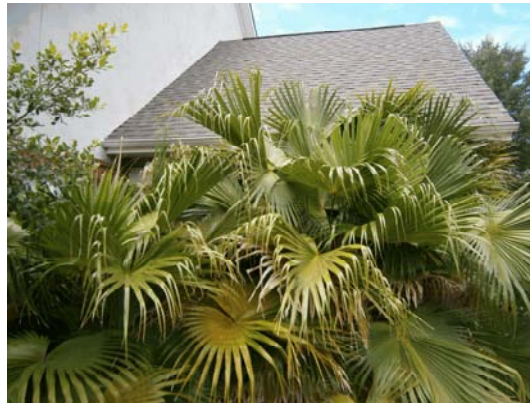
Fig. 2.6.3-15

Typical condition of vegetation too close to building

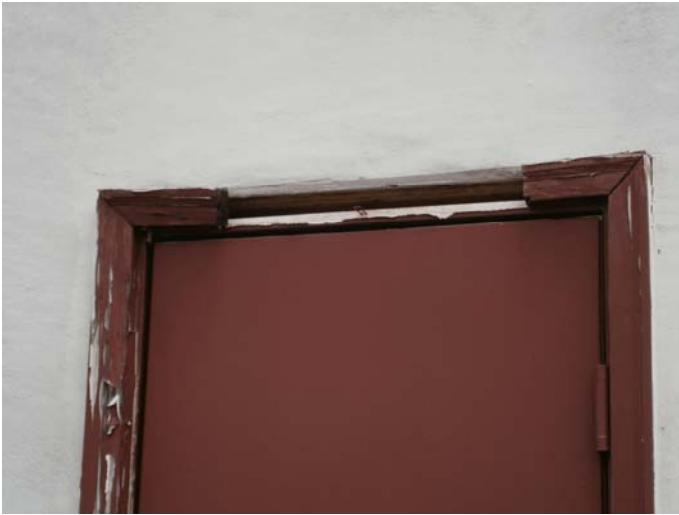
Fig. 2.6.3-16
Condition of building 6000
riser room door

3. The frame at Building 6000 is missing a piece of the head trim as shown in Fig. 2.6.3-16.

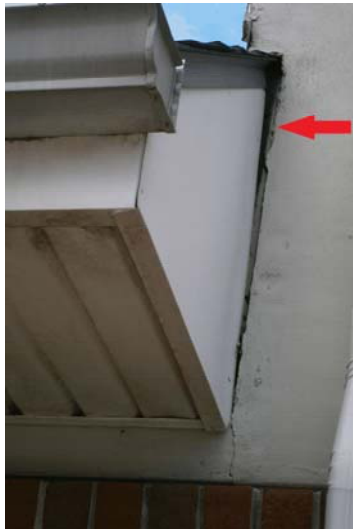
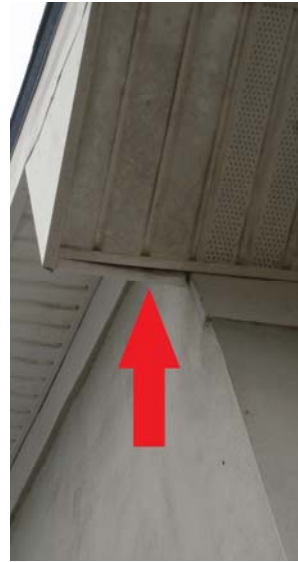
Condition where fascia is pulling
away from stucco

Condition where
fascia is pulling apart

2. At Building 6000, west end of south elevation, at the one story roof the “bird box” fascia is pulling away from the stucco. (see Fig. 2.6.3-17 & Fig.2.6.3-18)

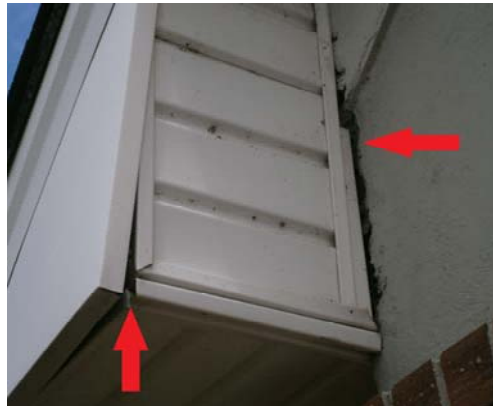
Fig. 2.6.3-19

Condition where “bird Box” is pulling away

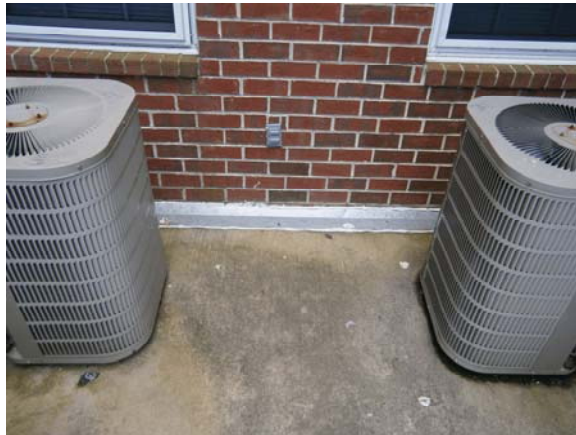
Fig. 2.6.3-20
Condition of improperly
sloped concrete slab

6. Poor drainage at compressor slab at Building 6000. Metal flashing and caulk have been used in an attempt to keep water out of the building. It appears the through wall flashing is two brick courses above the finish floor. (See Fig. 2.6.3-20)

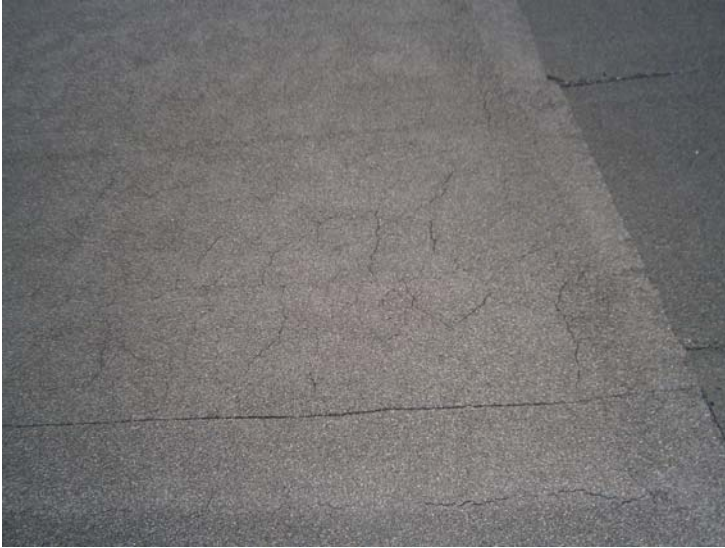
Fig. 2.6.3-21
Condition at commons building
roof membrane (new on left;
old on right)
