# FACILITY CONDITON ASSESSMENT SERVICES REPORT

## University Crossings

ARMSTRONG ATLANTIC STATE UNIVERSITY

October 15, 2013

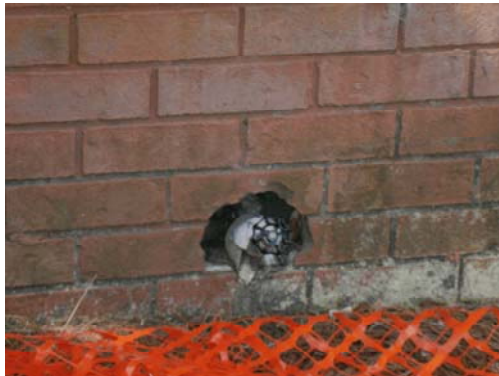
Figure 2: Typical condition of opening in wall at Hose bibb

2. In several locations, openings exist in the brickwork allowing insects and vermin access to the cavity. (See Fig. 1 - 2)
3. Typically these openings exist at HVAC refrigerant line penetrations, electrical penetrations, and hose bibb locations. (See Fig. 1 - 2)

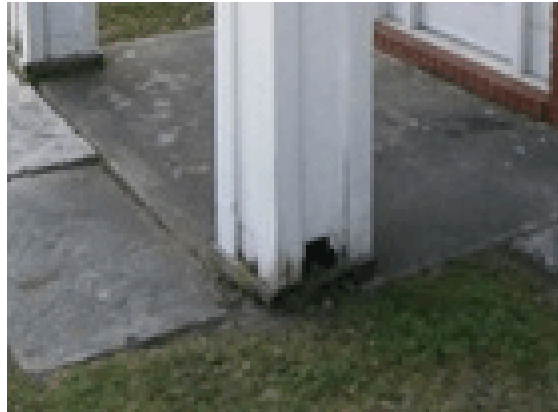
Figure 3: Typical condition of column trim

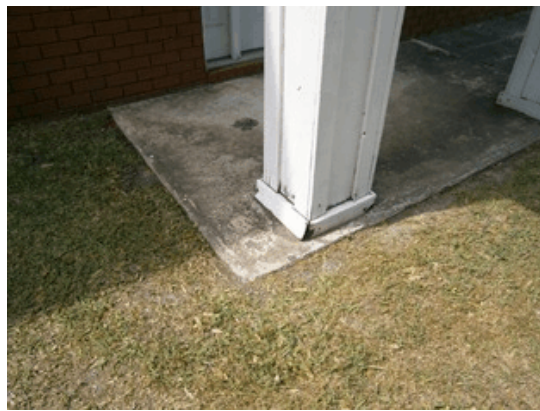
Figure 4: Typical condition of column base trim

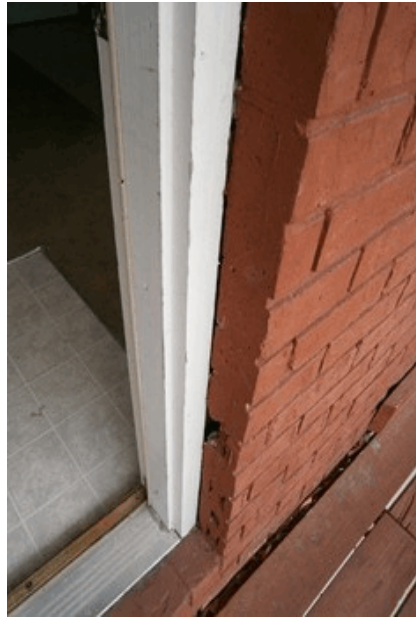
Figure 5: Typical condition of lack of door frame trim allowing brick cavity to be exposed

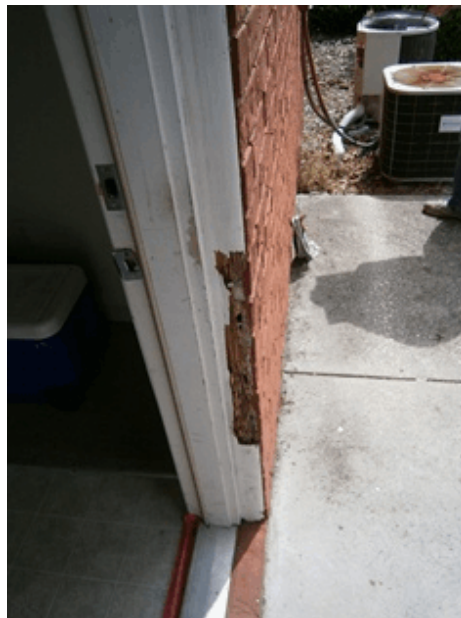
Figure 6: Typical condition of damaged additional trim

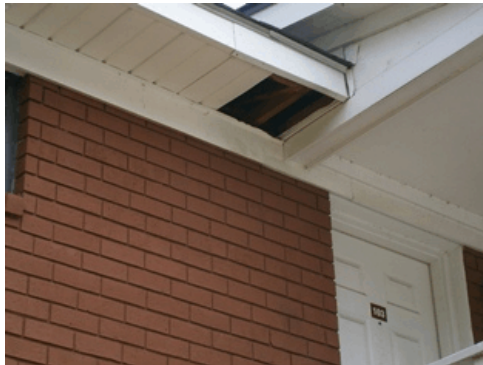
Figure 7: Typical condition of missing soffit

1. At building 900 isolated failures of vinyl soffit material are present. It appears this material was installed over plywood soffits, however, where the plywood has been removed for later construction of porches or other construction, failure of the vinyl soffit provides access to the attic space for animals such as squirrels and bats. (See Fig. 7 - 9)

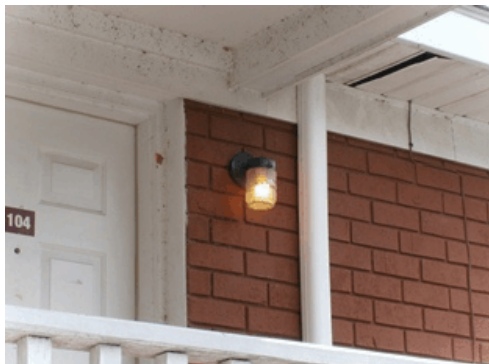
Figure 8: Typical condition of unsecure soffit in need of repair

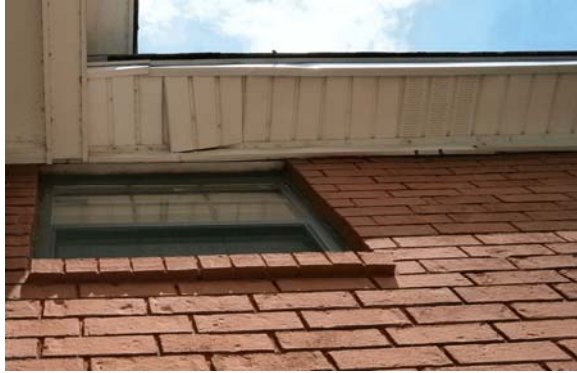
Figure 9: Typical condition of damaged soffit in need of repair and or replacement

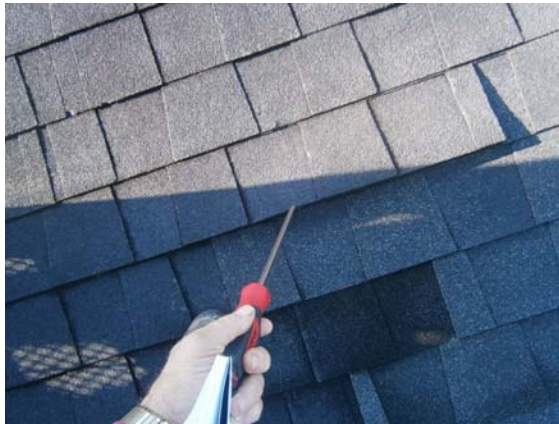
Figure 10: Typical condition of failing self-sealing adhesive strips on shingles

1. On most of the buildings, the self-sealing adhesive strips are failing in multiple locations, typically on the south facing side of the roofs. Strips of shingles may be easily lifted apart. This typically occurs with age and repeated thermal movement. This leaves the shingles vulnerable to wind damage. (See Fig. 10)
2. The granules are beginning to release from the shingles. This is a sign the shingles have exceeded their useful life.

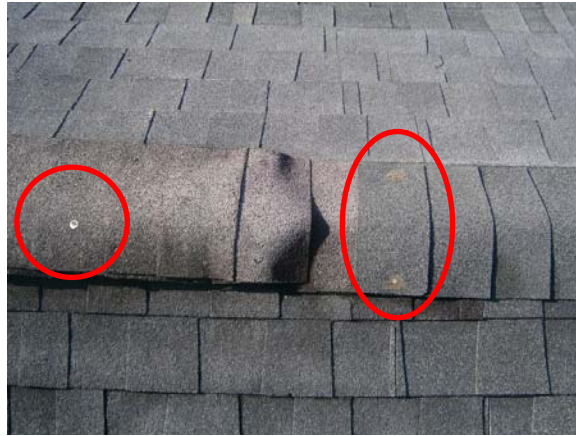
Figure 11: Typical condition of improper nailing of ridge vents with caulk patches

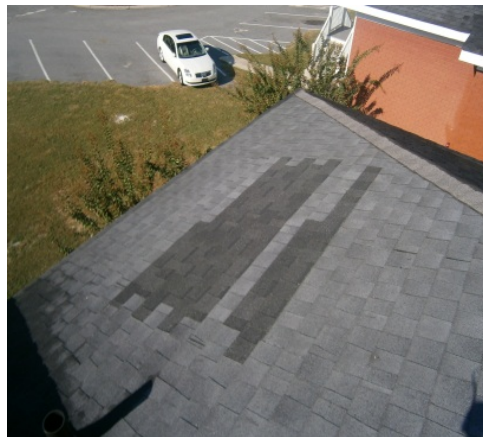
Figure 13: Typical condition of large scale roof patch

4. Numerous patched areas and faulty repairs are evident on the roofs. (See Fig. 12 – 14)

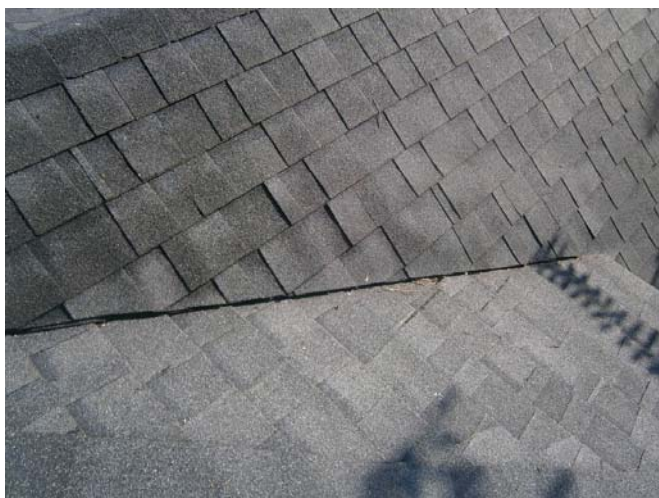
Figure 15: Typical condition of porch roof additions with cut valleys

5. During installation of the porch roofs, cut valleys were used. While acceptable, they are inferior to a woven valley. (See Fig. 15)
6. Woven valleys were used when the sprinkler riser rooms were added.

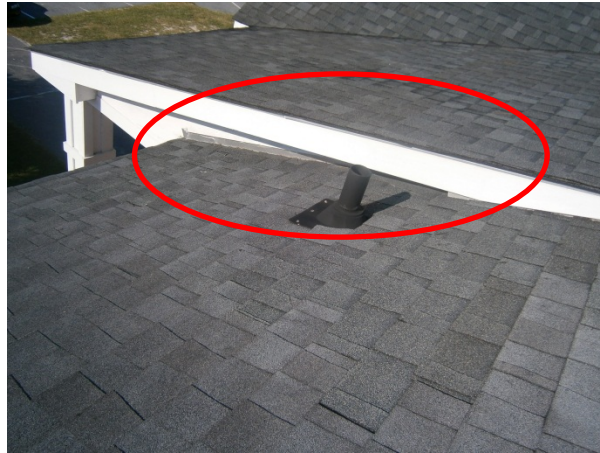
Figure 16: Typical condition where one long single piece of flashing is used, and is a defective installation

7. At front dormers, the flashing at the upper part of the dormer is installed as one long single piece. This is a defective installation. Flashing at sidewall conditions should be woven into the shingles, i.e., step flashed. Where the dormer has some amount of overhang, similar flashing is used. The metal used was galvanized, the installers attempted to conceal it from view using painted trim material, which is now too close to the roof surface. (See Fig. 16 – 17)

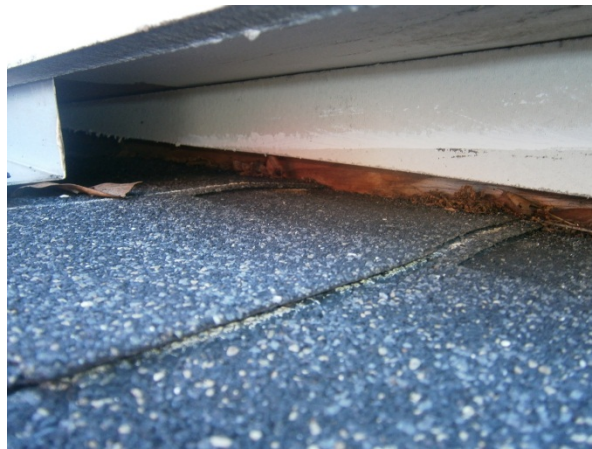
Figure 17: Typical condition of improper trim being used to hide flashing and trim is too close to roof surface

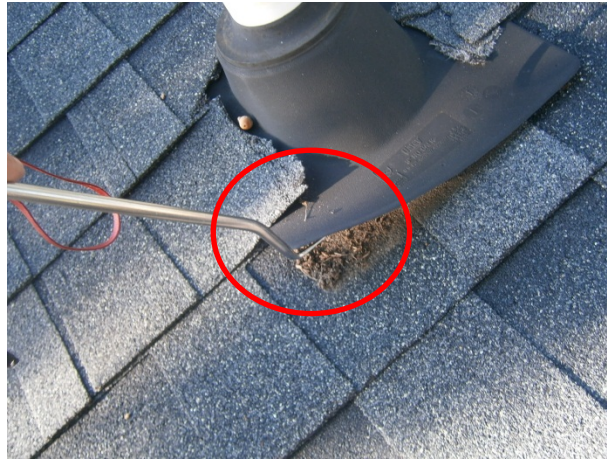
Figure 18: Typical condition where rubber boots are failing

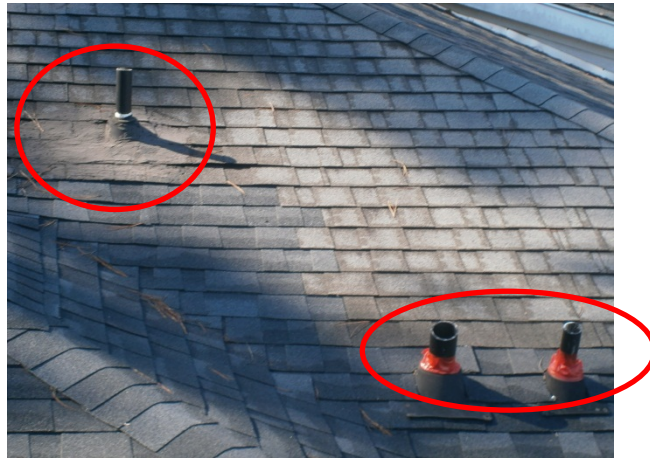
Figure 19: Typical condition where tape has been used improperly to seal rubber boot

8. At pipe and vent penetrations, Galvanized metal or vinyl flashings with rubber boots have been installed. On many of these installations the rubber is cracking or broken. Attempts have been made to remedy the situation with sealants and even tape. This repair should have been corrected with manufactured repair boots. (See Fig. 18 – 19)
9. Flashing cement around upper boot in Fig. 19.
10. At many locations, the flanges of these boots are not nailed and sealed at the downslope side, creating an opportunity for water penetration from windblown rain. (See Fig. 18)
11. At several pipe penetrations, the pipe does not extend the recommended 6" above the roof surface. (See Fig. 19)

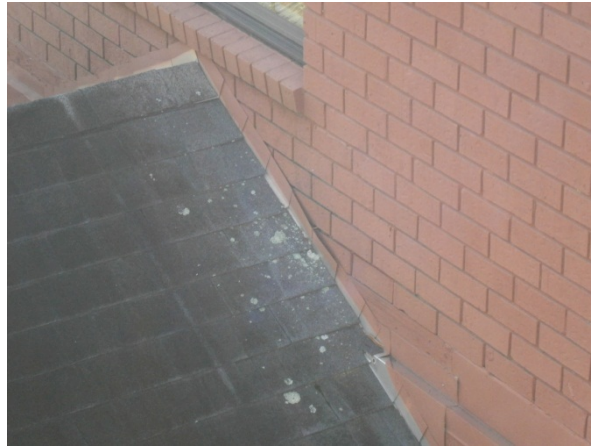
Figure 20: Typical condition at rear porch structure; showing improper flashing and algae growth

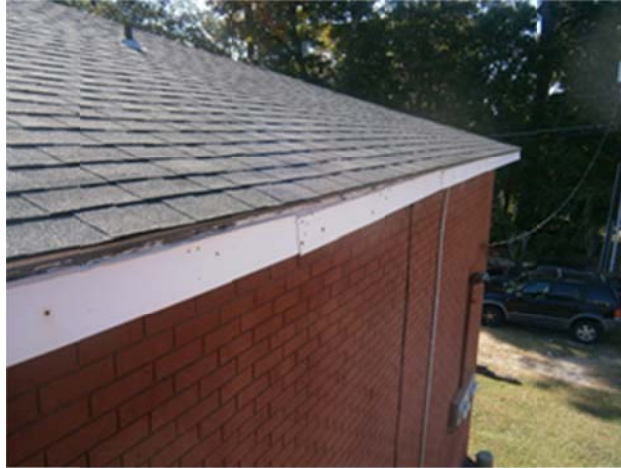
Figure 21: Faulty fascia trim installation on building 900

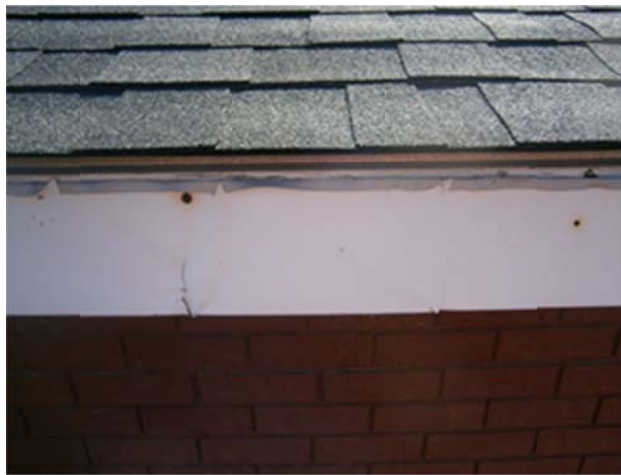
Figure 22: Close-up of Faulty fascia trim installation on building 900

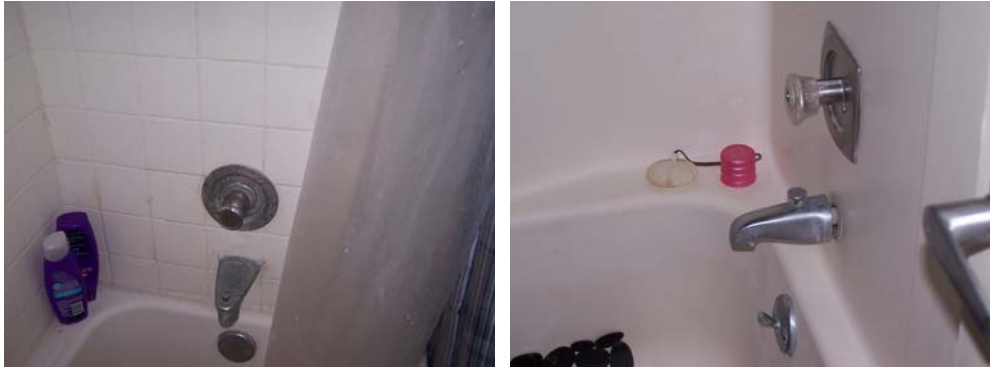
1. Many of the plumbing fixtures in these buildings, especially in Buildings 1-5 and 9 are in very poor condition. These should be replaced as soon as practicable.

**Figure 23: Typical condition of Existing Plumbing Fixtures, Typical of Building 1 – 5 and 9**

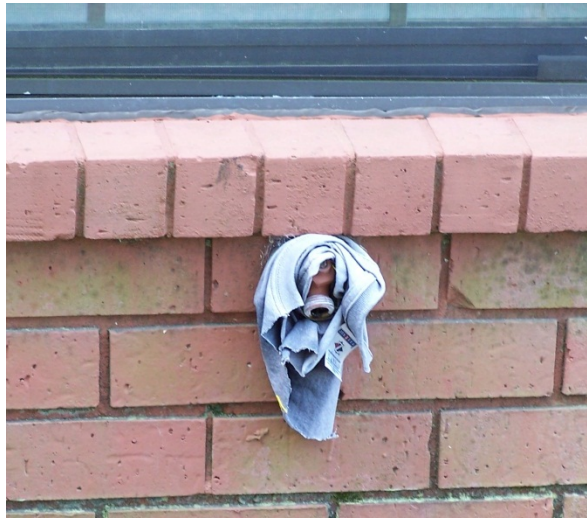
2. Some of the original plumbing fixtures and water heaters do not comply with current codes.
3. There are kitchen disposals installed in each unit throughout the University Crossings Housing complex. Most of these units either do not work at all or make extremely loud noises while in operation.
4. The exterior hose bibs installed on these buildings do not have proper freeze protection.

**Figure 24: Non-Freeze Protected Hose Bib (Typical on all Buildings)**

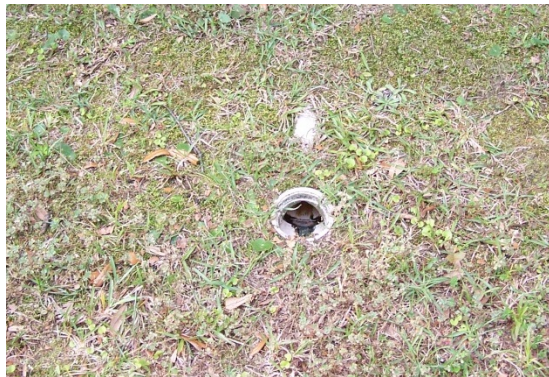
3. There is a cleanout located at the rear of this building that the cover has been cracked and is now open.

Figure 27: Cleanout with Broke Cover

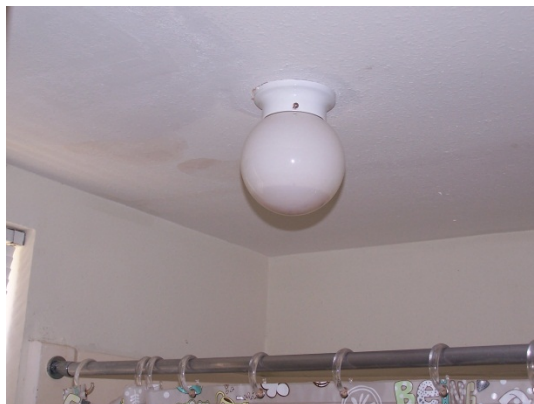
1. There appears to be some form of leak either from the toilet or tub/shower unit.

Figure 29: Bathroom Ceiling and Light Fixture Indicating Leak Above

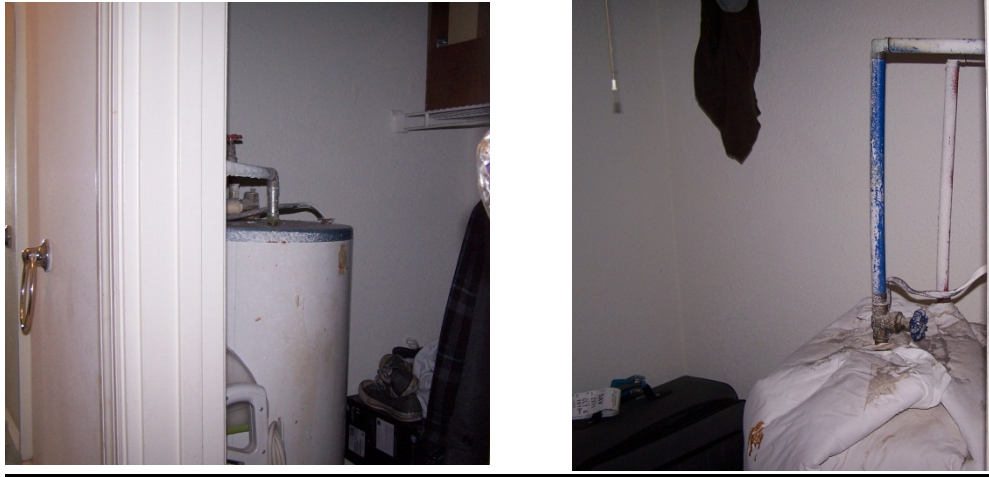
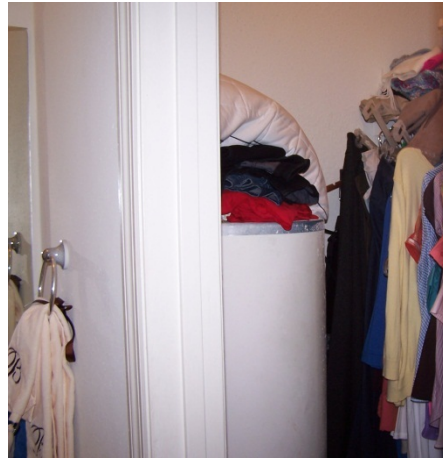
1. The water heaters for this building have been installed in the clothes closets. Students are using these water heaters in many cases as places of storage, which can lead maintenance problems due to the exposed piping.

Figure 30: Water Heaters in Clothes Closets

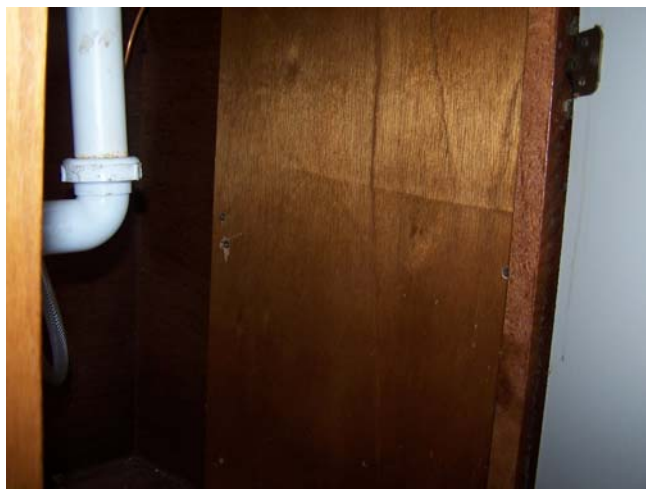
1. The water heaters for this building have been installed below the corner of the kitchen cabinets. This installation renders these water heaters very difficult to access.

Figure 31: Water Heater Located Below Cabinet with Minimal Access

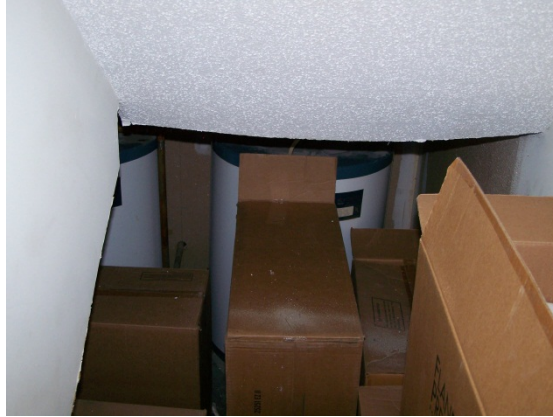
1. The water heaters for this building are located in closet space under the stairs. The closet is also being used as storage for the air handler air filters for the complex. This can cause maintenance issues in the future.

Figure 32: Water Heater Access Issue

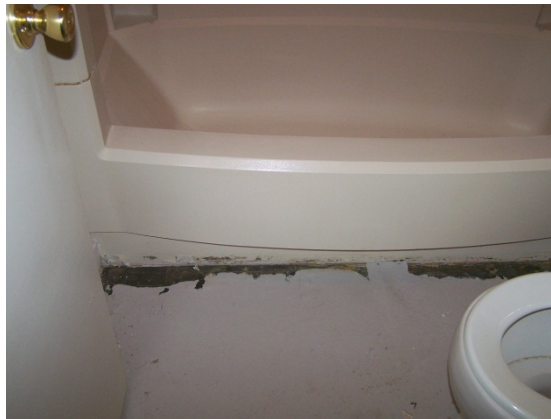
1. The floor appears to stay wet. This may have been caused by a leaky toilet or bathtub.

Figure 33: Leaking Plumbing Fixture Issue

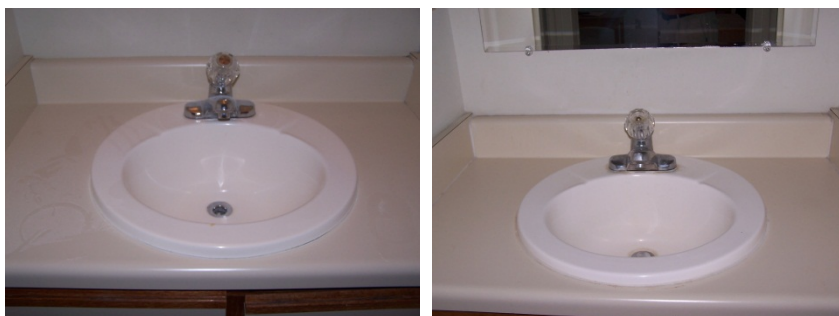
1. The water heaters for this building have been installed below the corner of the kitchen cabinets. This installation renders these water heaters very difficult to access.
2. There are missing faucet tags and drain stoppers in various units.

Figure 34: Missing Sink Stopper and Sink Tags

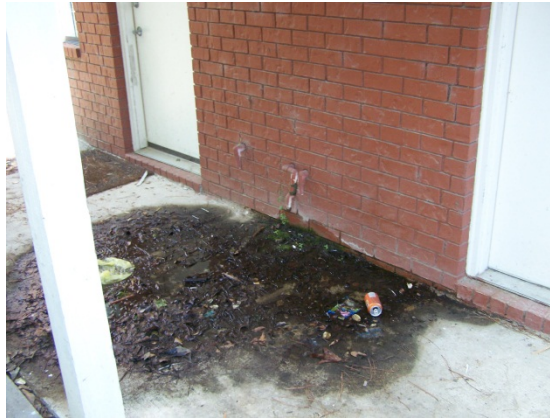
4. The outdoor condensing units are located along the rear of the building. Large amounts of trash and debris were located around the condensing units. This can cause refrigerant lines and the condensing units themselves to deteriorate and malfunction.
5. The condensate from the four indoor air handlers is discharged on the rear porch of the lower apartments. This causes water to collect and puddle along the building.

Figure 35: Condensate Discharge Issue

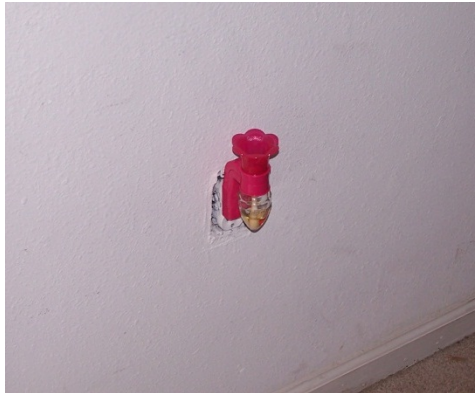
Figure 40: Unit 401 Missing Device Plate (Typical Condition in Most Units)

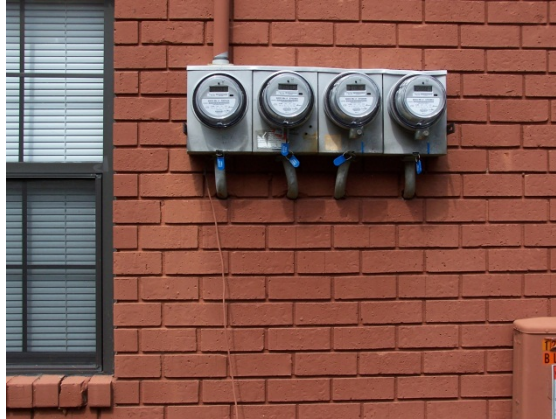
1. The existing electrical service for this building consists of a 4 gang meter center located on the exterior of the building. Each meter serves 1 of the 4 living units in the building. The existing service entrance cables are routed exposed below each of the meters on the exterior of the building. This installation does meet current codes. However, the existing service is lacking the current code required main disconnecting means for each unit. Based on the date when these units were built, these disconnects may not have been required. Further, the exposed service entrance cables are not a best installation practice. Should these cables become damaged in any way there is no overcurrent protection. This service is in fair physical shape and should not give any problems during the next five years.

Figure 41: Building 1 Service Meters and Exposed Service Entrance Cables

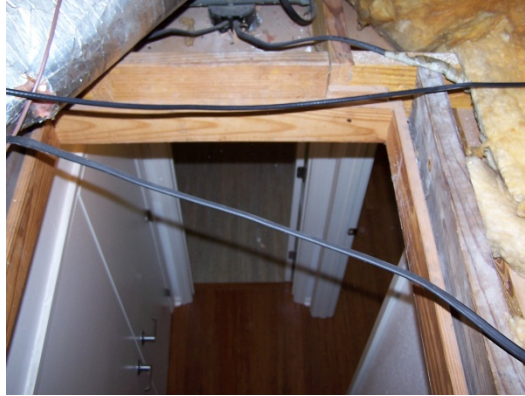
5. The building attic access in Unit 103 has NM cables and low voltage cable running across the access opening. This is a code violation. The cables must be routed around the opening and they are within 6 feet of the opening it must have physical protection. In the upper left hand corner of the picture below there is an open splice made in the NM cable.

Figure 42: Building 1 – Attic Access Exposed and Unprotected Cables

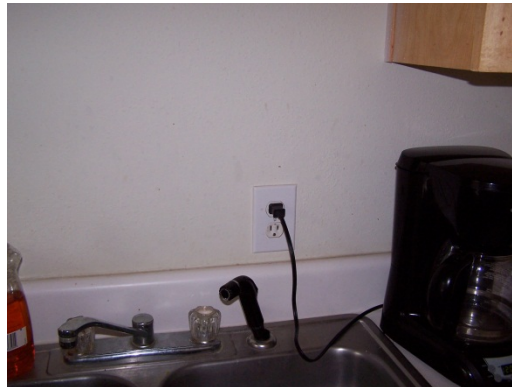
6. There was no GFCI protection found for the kitchen counter top receptacles or the bathroom receptacles. This is a violation of current code and presents a safety issue.

Figure 43: Building 1 – Unit 101 No GFCI Protection

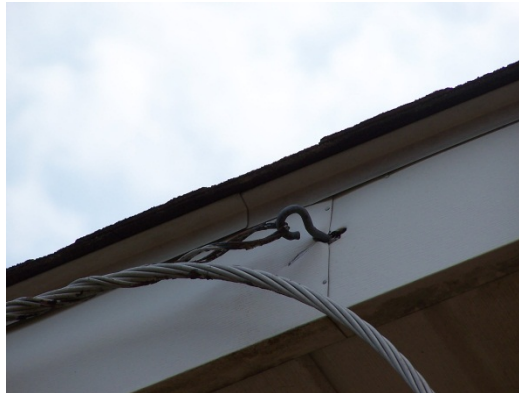
2. This overhead service on this building has and open eye bolt on the messenger cable which is open in the direction of tension.
3. There was no GFCI protection found for the kitchen counter top receptacles or the bathroom receptacles. This is a violation of current code and presents a safety issue.

Building 2 Open Eye Bolt on Service Messenger Cable

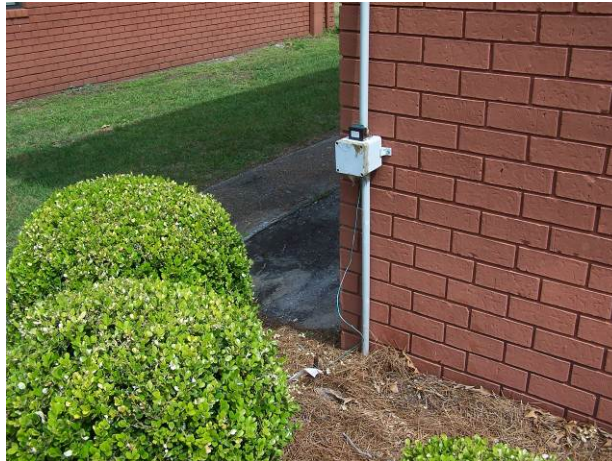
5. The stairs serving this building do not have any form of emergency lighting. Each of the existing apartment units have an associated exterior door light, however, none of these lights have emergency capabilities. All egress stairs should have emergency lighting meeting minimum standards for egress during an emergency.
6. The grounding conductor installed during the fire alarm modifications is not protected from physical damage nor supported properly.

Figure 46: Building 2 Unprotected Grounding Conductor

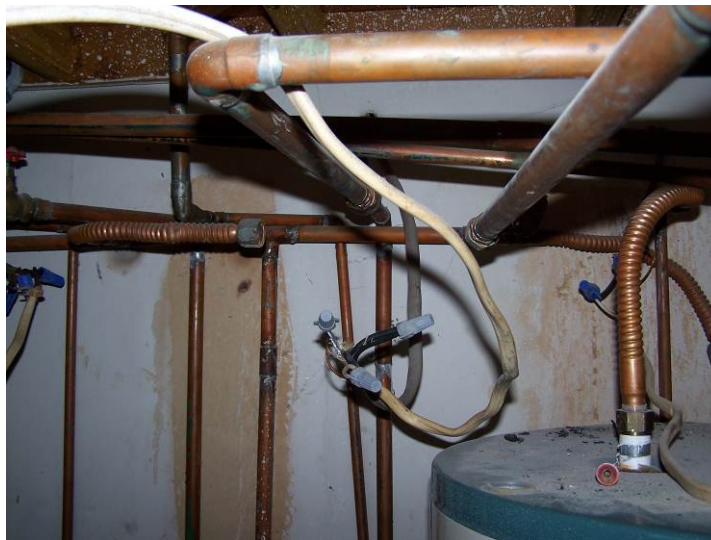
7. The water heaters for all 4 units are located in the storage room below the interior stair case. The wiring serving these units has numerous open splices and improperly terminated cables.

Figure 47: Building 2 Storage Closet with Open Splices and Incorrect Terminations

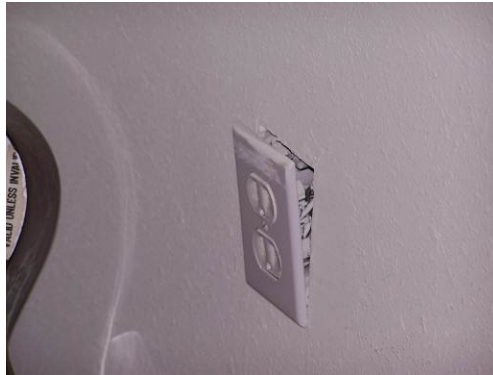
1. There is a receptacle in the living area that is not properly secured to the wall.

Figure 49: Unit 304 – Improperly Secured Device

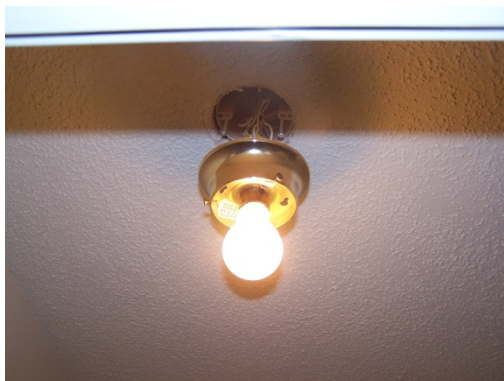
1. One of the closet light fixtures is not secured to the ceiling.

Figure 50: Unit 602 – Light Fixture not Secured and Missing Lens

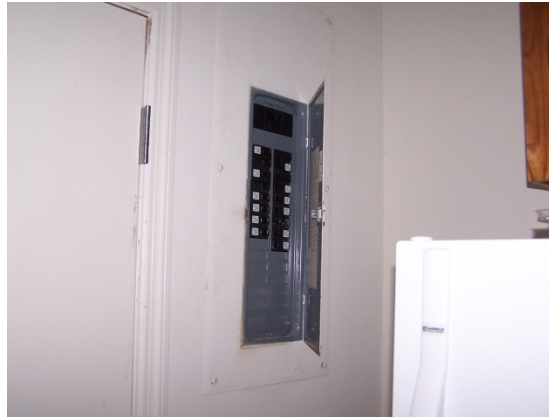
1. The existing electrical service for this building consists of two four gang meter centers on the exterior of the building. Each meter serves 1 of the 8 living units in the building. The existing service has exterior main disconnecting means for each unit. This service is in good physical shape and should not give any problems during the next five years.
2. The stairs serving this building do not have any form of emergency lighting. Each of the existing apartment units have an associated exterior door light, however, none of these lights have emergency capabilities. All egress stairs should have emergency lighting meeting minimum standards for egress during an emergency.
3. The code required clearance is not maintained in front of the electrical panel serving each unit in this building. Currently the refrigerator of each unit is blocking the needed clearance.

Figure 51: Unit 701 Panel Clearance Issue

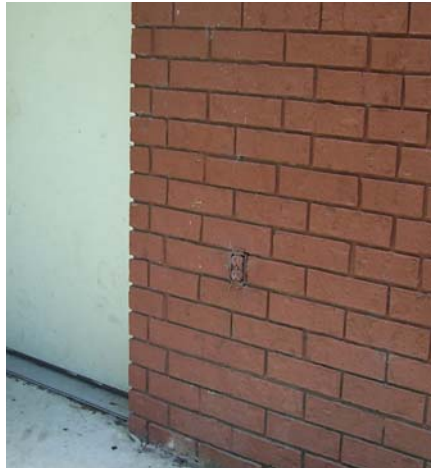
1. One of the 120V smoke detectors is missing. This leaves an open junction box on the ceiling.
2. The weather proof receptacle on the back porch is missing a cover.

Figure 52: Unit 901 - Missing Weather Proof Cover
