FACILITY CONDITON ASSESSMENT SERVICES REPORT

Windward Commons

ARMSTRONG ATLANTIC STATE UNIVERSITY

November 18, 2013

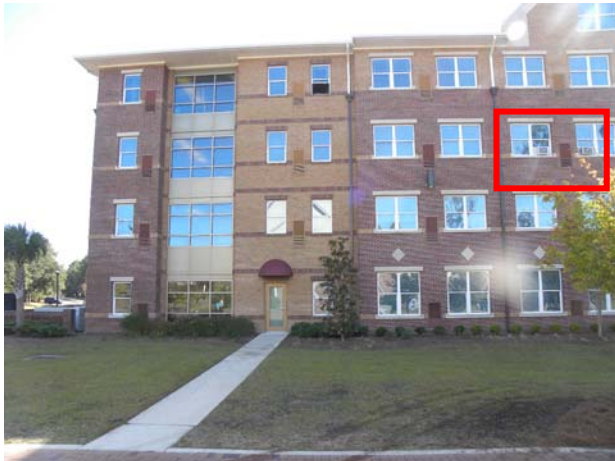
Figure 2 East Tower – East Side of North Elevation w/ window units

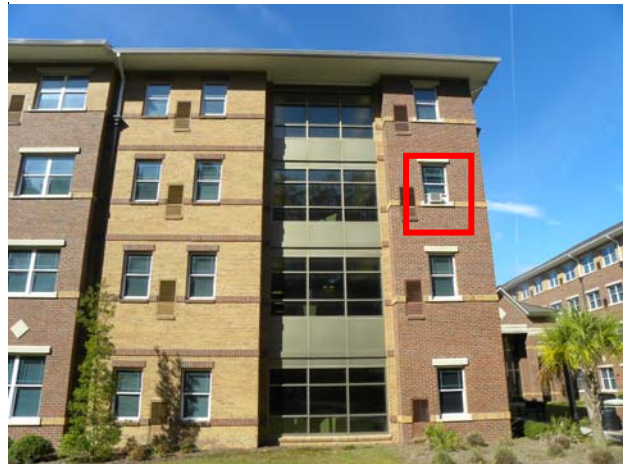
Figure 16 West Tower – South Elevation w/ window unit

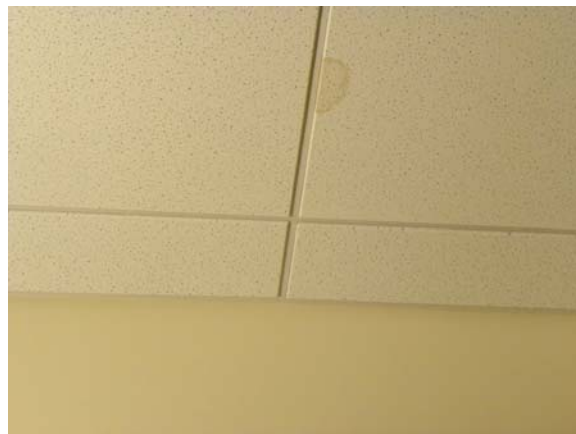
Figure 27 Stained Ceiling Panel

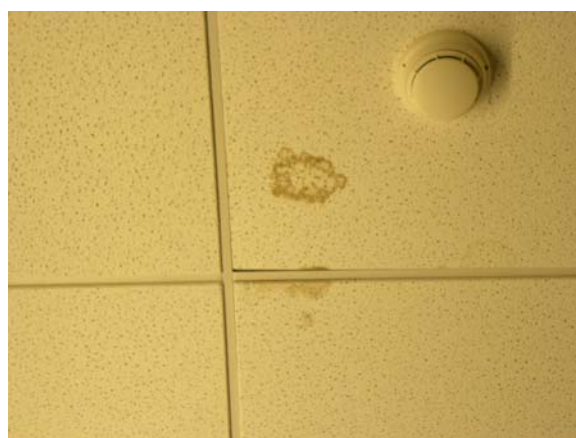
Figure 28 Stained Ceiling Panel

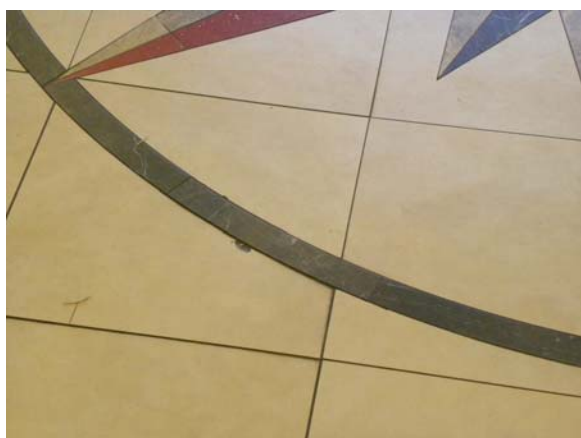
Figure 26 Chipped Tile at Entry

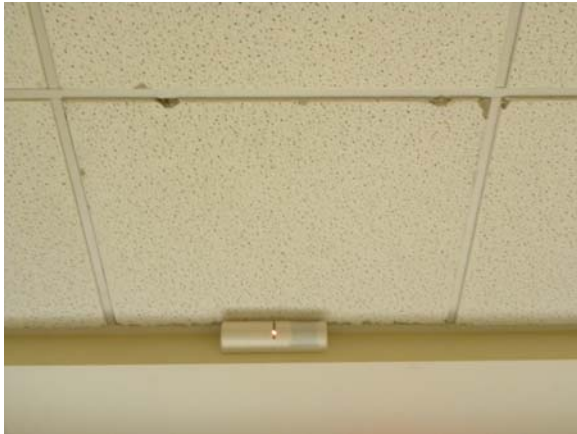
Figure 30 Damaged Ceiling Panel

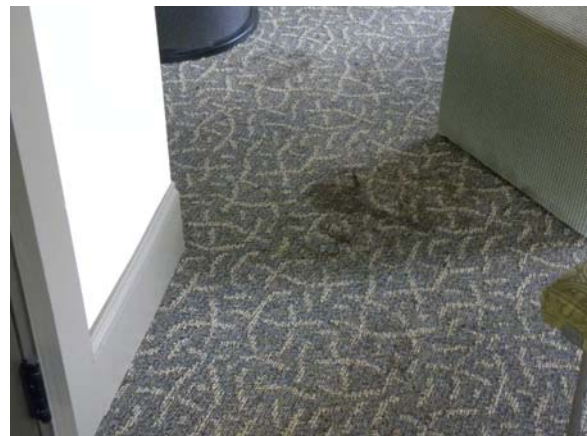
Figure 35 Carpet Stains

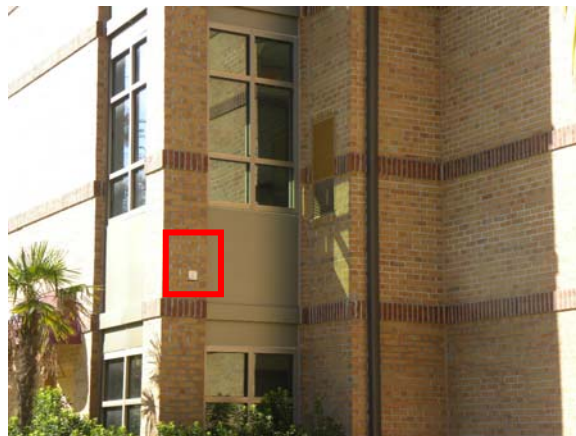
Figure 40 Exposed Electrical Box

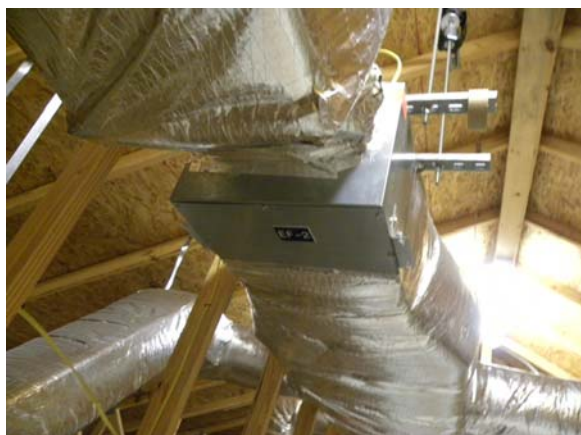
Figure 38 – Attic Ductwork

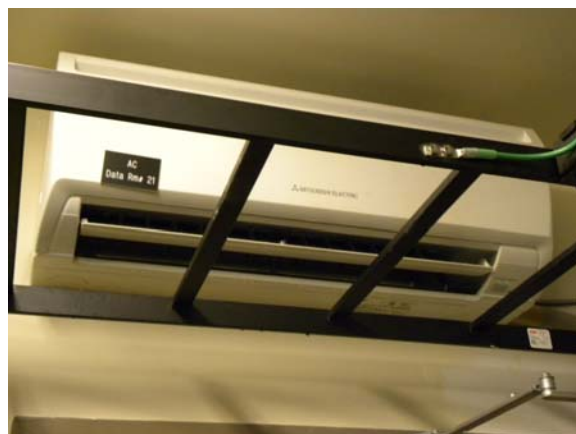
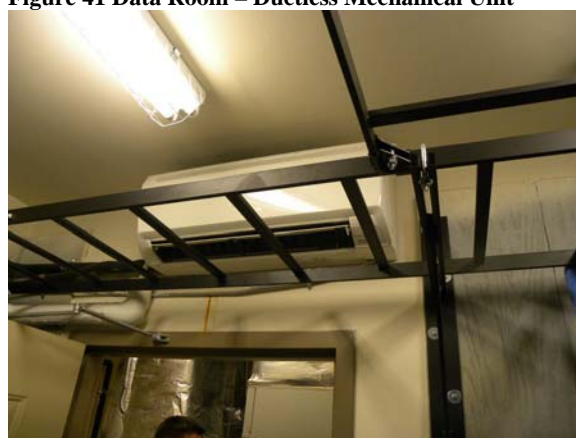
It was also noted that several data rooms units had issues. However, there were no safety alarms in the data room to alarm if the units were having issues. The units having issues will need to be repaired or replaced.

Figure 41 Data Room – Ductless Mechanical Unit

Figure 42 Data Room – Ductless Mechanical Unit

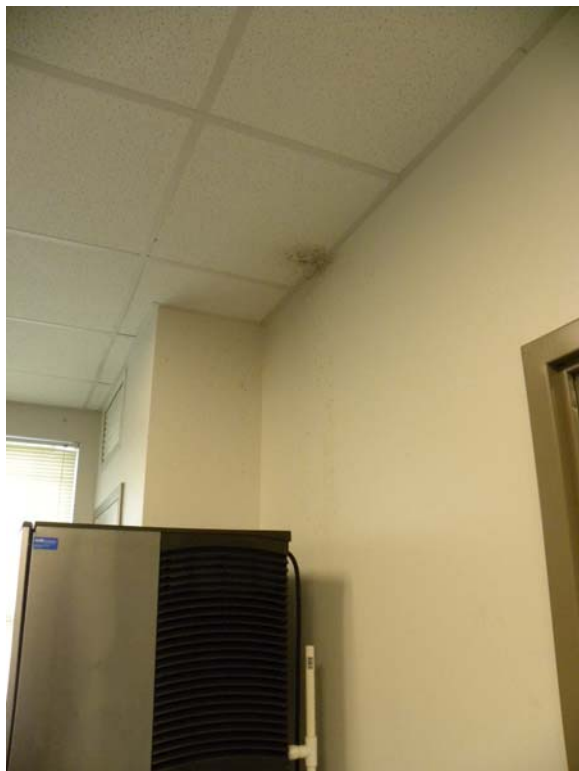
Figure 43 Dirt/Mildew above Ice Machine

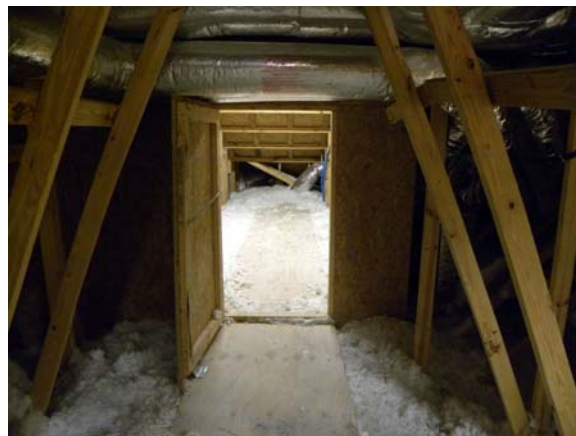
Figure 51 Attic Smoke Door Propped Open

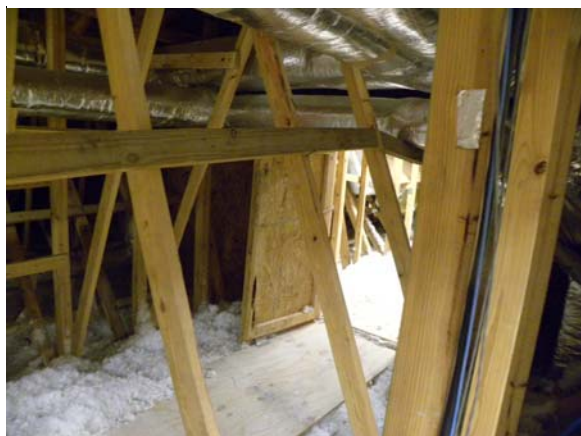
Figure 49 Attic Smoke Door Left Open

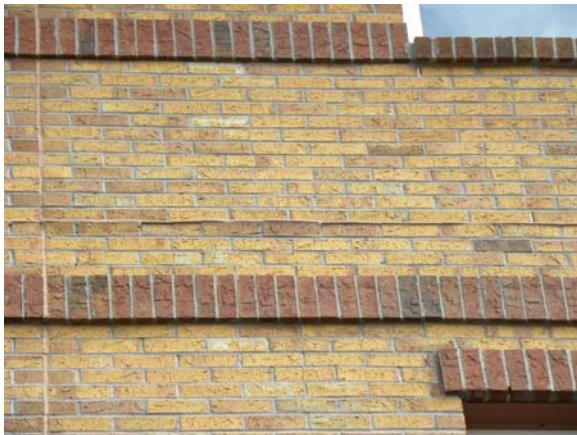
1. During the exterior inspection window air conditioning units were observed.
2. Weep holes are present and appear to be functioning properly.
3. It was noted that all inside corners of the building are sealed with caulk and are considerably large in regions.
4. All joints where storefront systems meet exterior walls, a rather large caulk joint is present.
5. It was observed that the canopies over doors also have large caulking joints that seal them to the brick veneer.
6. Horizontal expansion joint is in need of re-working.

Figure 55 Horizontal Expansion Joint

Section	Description	Estimated Cost
3.6.3.2.1.	Exterior Walls – East Tower	
	Rake-out caulk & reinstall horizontal expansion joint	
	Repair Exterior Finishes	\$1,143.56

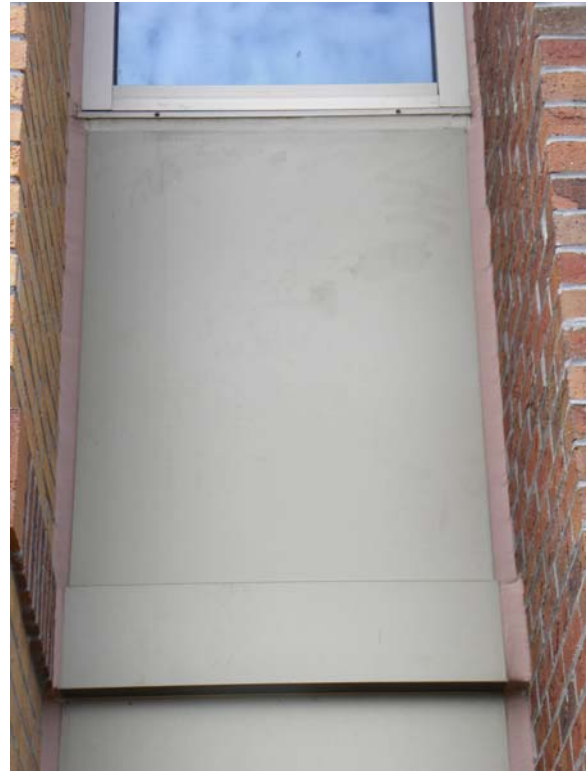
1. At building knuckle weep holes are present and appear to be functioning properly.
2. It was noted that all inside corners of the building are sealed with caulk and are considerably large in regions.
3. All joints where storefront systems meet exterior walls a rather large caulk joints is present.

Figure 56 Vertical Storefront Expansion Joints

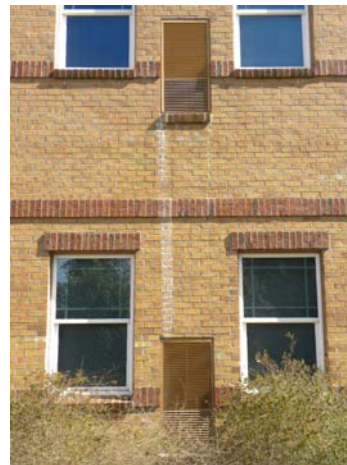
Figure 57 Possible HVAC Leak

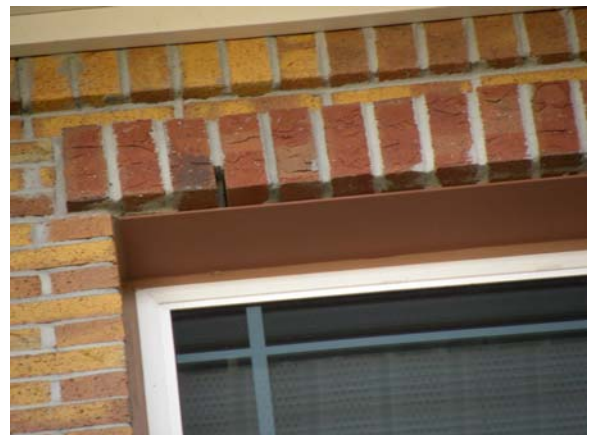
1. During the exterior inspection window air conditioning units were observed.
2. Weep holes are present and appear to be functioning properly.
3. It was noted that all inside corners of the building are sealed with caulk and are considerably large in regions.
4. All joints where storefront systems meet exterior walls, a rather large caulk joint is present.
5. It was observed that the canopies over doors also have large caulking joints that seal them to the brick veneer.
6. The northern exterior wall has an open head joint on both the third and fourth level.
7. The northern exterior wall has a PTAC unit grill which appears to not be flush with exterior wall.

Figure 61 Open Head Joint

Section	Description	Estimated Cost
3.6.3.3.1.	Exterior Walls – West Tower	
	Repair open head joints	
	Repair Exterior Finishes	\$45.00

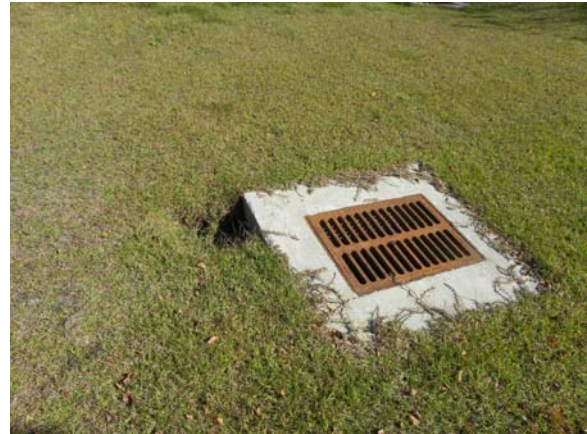
Overall, Property drainage appeared to be good and the drainage infrastructure components appeared to be in good condition. However, during the exterior inspection of the west tower a small area of erosion was observed near the inlet to a storm drain.

Figure 64 Stormwater Erosion

It is recommended that the above-mentioned storm drain inlet be excavated and inspected for proper function. Then the eroded area should be properly back filled with soil and compacted. The area affected during this inspection and repair should then be seeded and covered with a protective layer of straw. Based on the observed condition of the remaining storm water drainage systems, only routine maintenance will be required during the evaluation period.

Section	Description	Estimated Cost
3.3.2.	Storm Water Drainage	
	Storm drain inlet inspection & Repair	
	Repair of Storm Water Drainage	\$1500.00
