PHASE I ENVIRONMENTAL SITE ASSESSMENT AND
LIMITED SUBSURFACE INVESTIGATION

HOOVER CREEK VILLAS, 12202 APACHE AVE.,
& HUGGINS PROPERTY, 12206 APACHE AVE.
SAVANNAH, GEORGIA

NOVEMBER 2003

EMC PROJECT NO. 03-0527.30

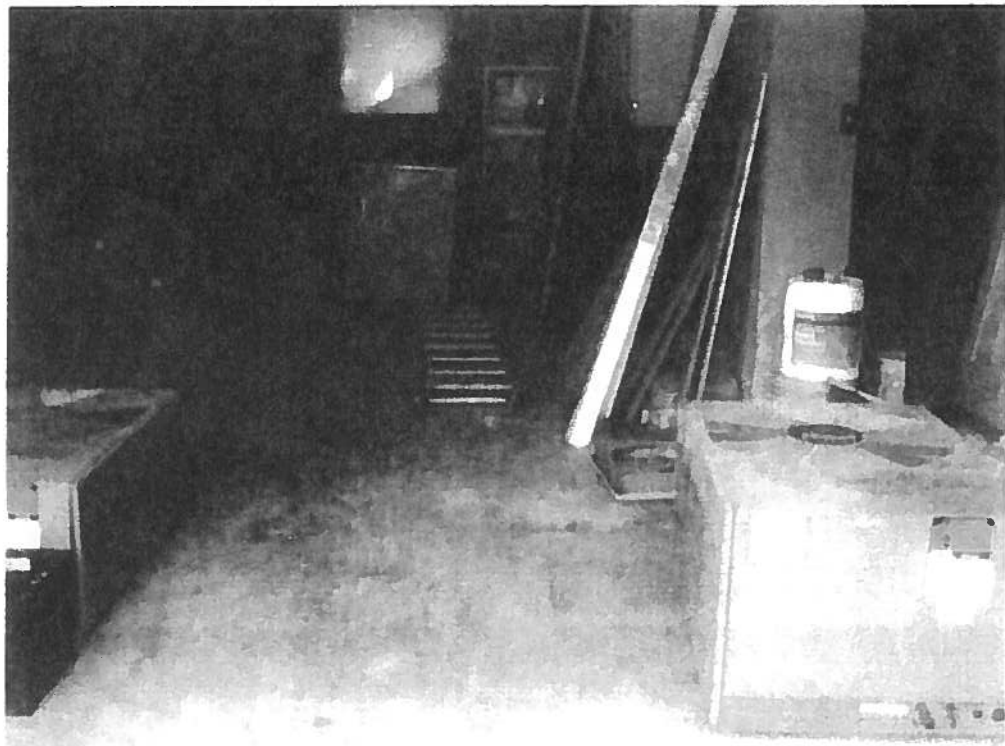
No evidence of petroleum products or hazardous chemicals were observed on the premises except for the single 5-gallon can of paint thinner previously identified in the garage. There is no evidence of buried debris, underground storage tanks, or other recognized environmental conditions.

EMC PROJECT NO. 03-052730	DESCRIPTION	Inside of the storage shed, paint thinner in the 5-gallon can on the right	10
	SITE NAME	Hoover Creek Villas, 12202 Apache Avenue, Savannah, GA	DATE 10/23/03
	CLIENT	HUNTER MACLEAN EXLEY & DUNN, PC

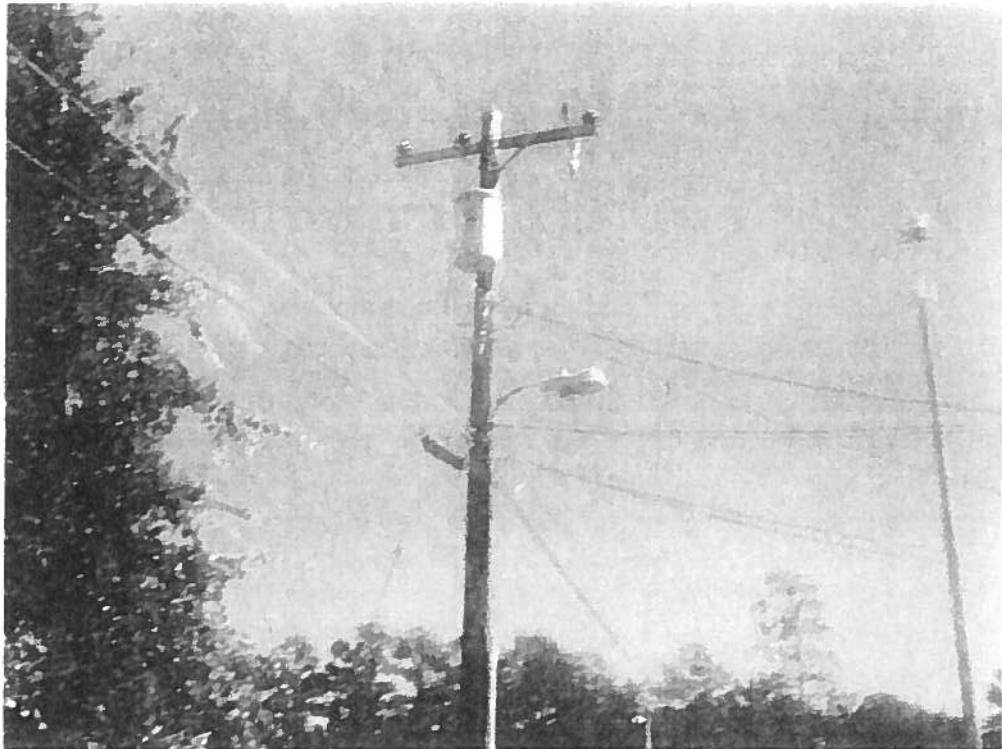
The subject property has a number of sanitary sewer manhole covers. The sanitary sewer line is laid out on the subject property like the letter "F" with the main line running along Apache Avenue and the feeder lines running across the north and center of the property. A water supply vault was observed just inside the entrance off of Apache Avenue. Electric utility poles were observed along the north side of the subject property. Electric transformers were observed on the utility poles. According to Savannah Electric personnel, none of these transformers contain PCBs. No stained soils were observed around the utility pole and beneath the transformers.

EMC PROJECT NO. 03-0527.30	DESCRIPTION	Transforms on light poles on the north side of the Hoover Creek Villas	13
	SITE NAME	Hoover Creek Villas, 12202 Apache Avenue, Savannah, GA	DATE 10/23/03
	CLIENT	HUNTER MACLEAN EXLEY & DUNN, PC

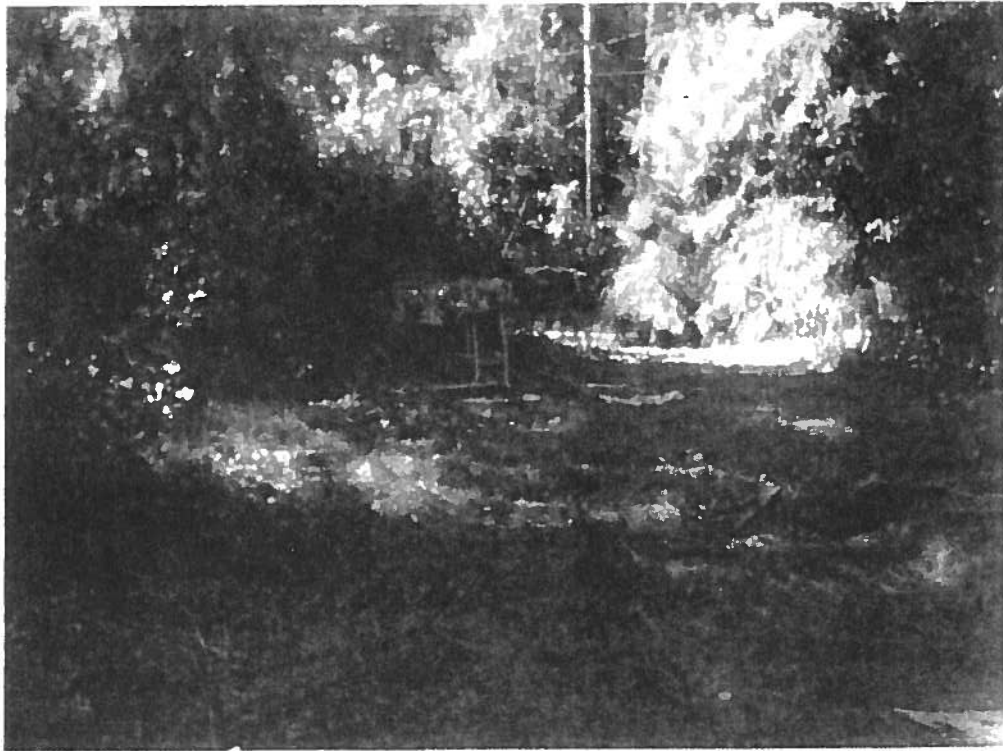
EMC PROJECT NO. 03-0527.30	DESCRIPTION	Trash on the site.	4
	SITE NAME	Huggins Property, 12206 Apache Avenue. Savannah, GA	DATE 10/21/03
	CLIENT	HUNTER MACLEAN EXLEY & DUNN, PC

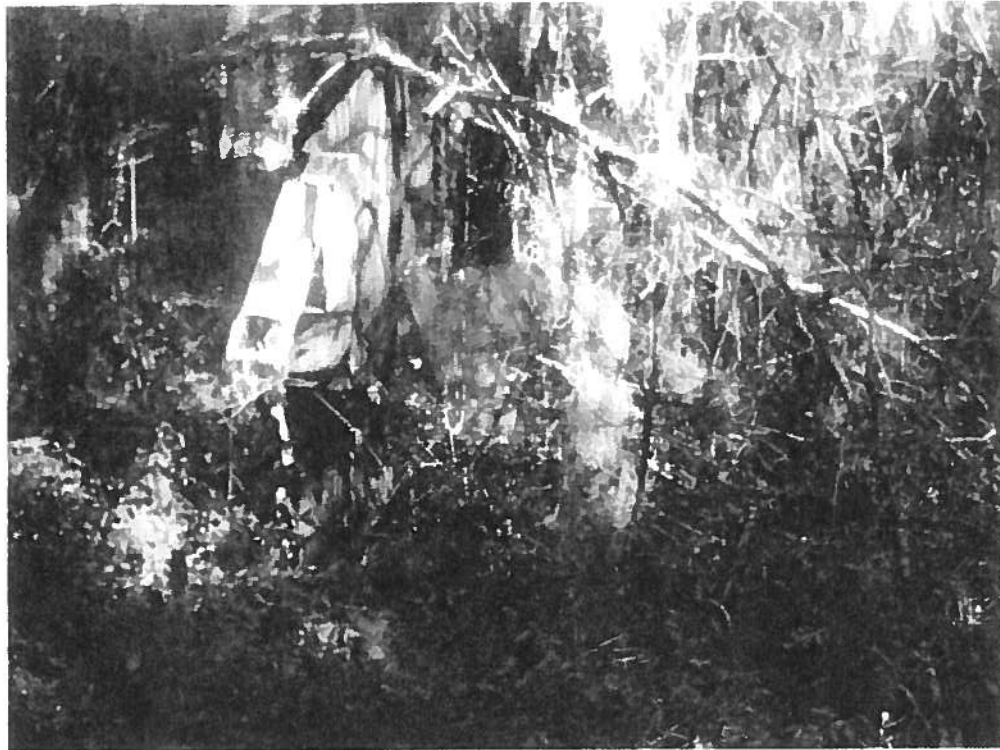
EMC PROJECT NO. 03-0527.30	DESCRIPTION	Trash on the site	5
	SITE NAME	Huggins Property, 12206 Apache Avenue, Savannah, GA	DATE 10/21/03
	CLIENT	HUNTER MACLEAN EXLEY & DUNN, PC

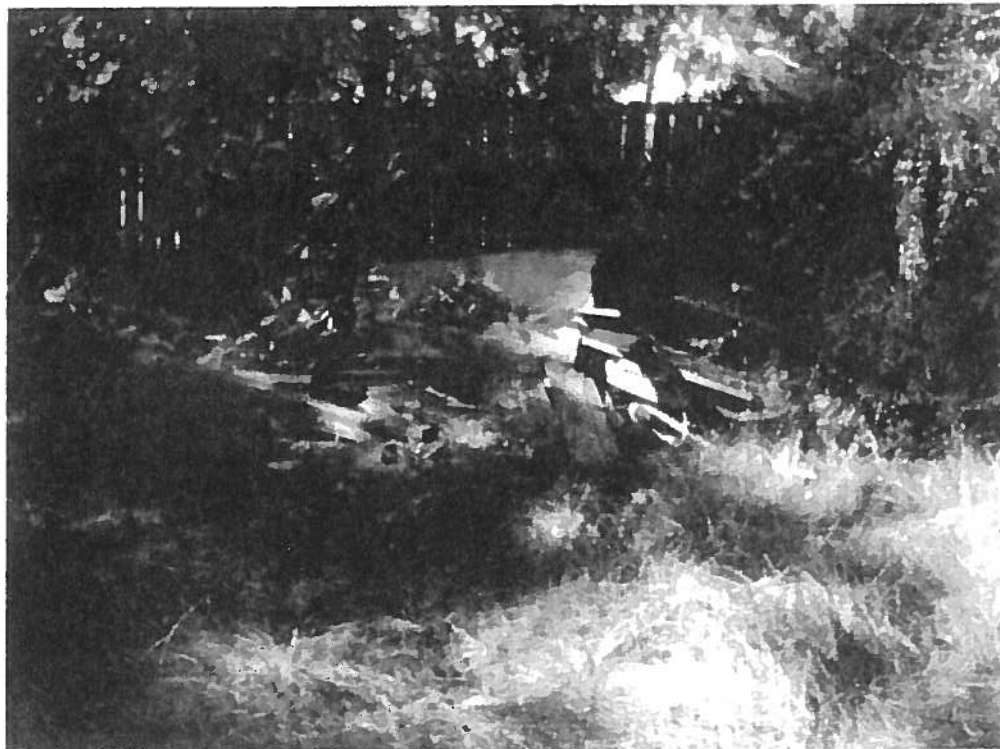
EMC PROJECT NO. 03-0527.30	DESCRIPTION	Trash on the site	6
	SITE NAME	Huggins Property, 12206 Apache Avenue, Savannah, GA	DATE 10/21/03
	CLIENT	HUNTER MACLEAN EXLEY & DUNN, PC

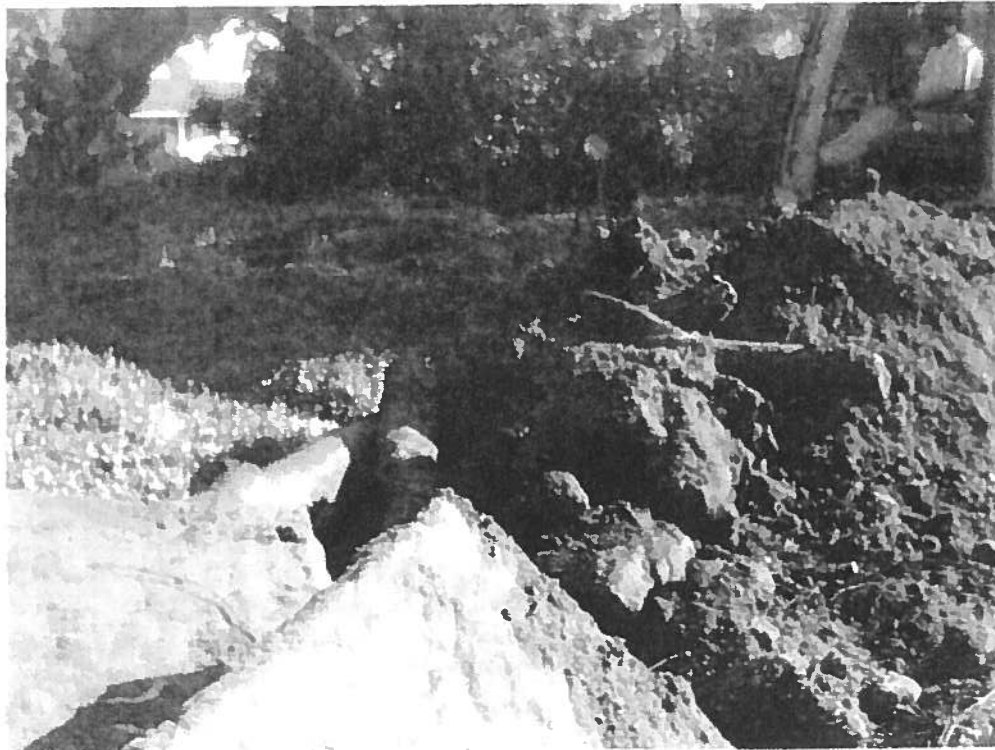
This assessment has revealed evidence of no recognized historical environmental conditions, as defined by ASTM, in connection with the developed property located at 12202 Apache Avenue. The subsurface investigation has revealed evidence of buried solid waste at the undeveloped property located at 12206 Apache Avenue.

EMC PROJECT NO. 03-0527.03	DESCRIPTION	Track hoe digging up buried concrete and logs on site	10
	SITE NAME	Huggins Property, 12206 Apache Avenue, Savannah, GA	DATE 9/26/03
	CLIENT	HUNTER MACLEAN EXLEY & DUNN, PC

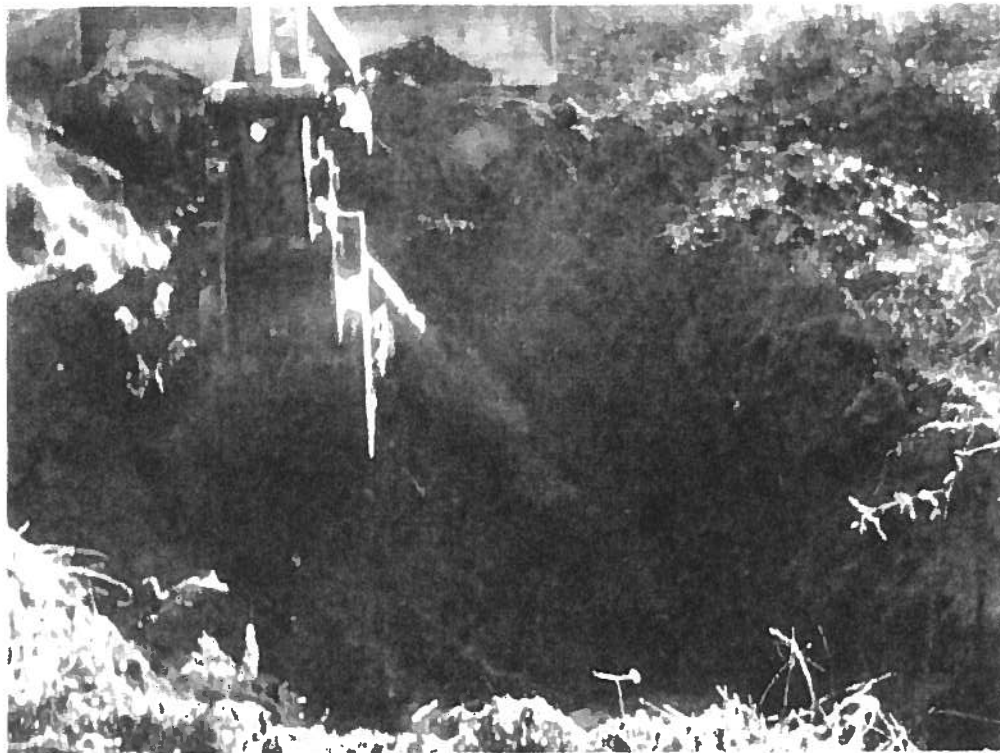
EMC PROJECT NO. 03-0527.30	DESCRIPTION	Track hoe digging up buried logs on site	11
	SITE NAME	Huggins Property, 12206 Apache Avenue, Savannah, GA	DATE 10/21/03
	CLIENT	HUNTER MACLEAN EXLEY & DUNN, PC

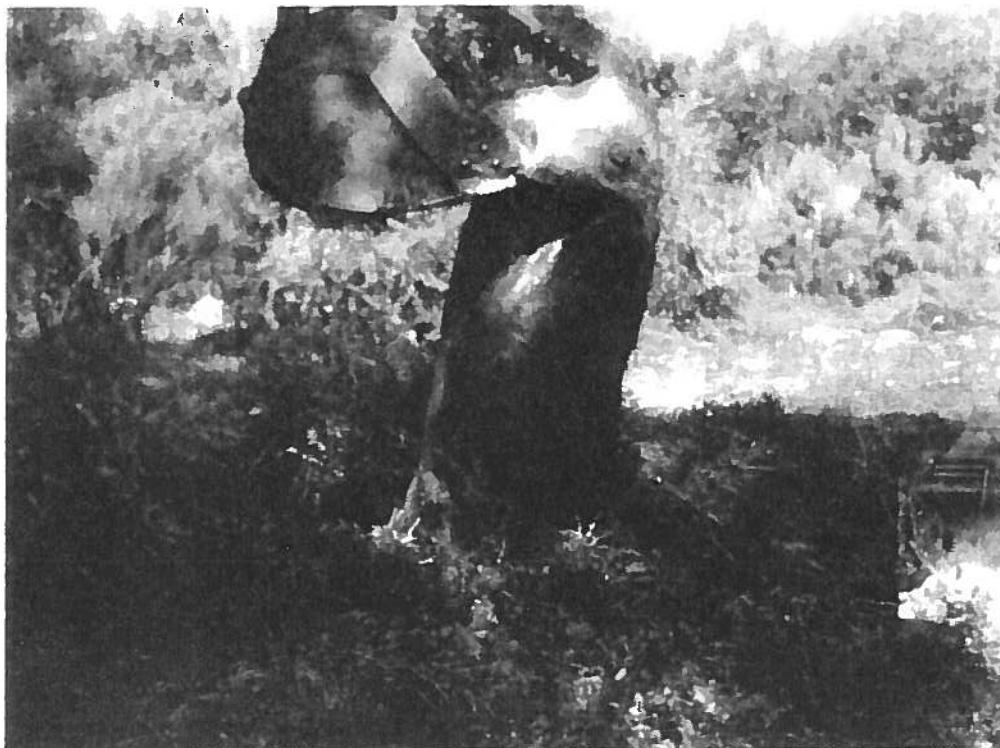
EMC PROJECT NO. 03-052730	DESCRIPTION	Track hoe digging up buried empty fuel storage tank at the southeast corner of the site	12
	SITE NAME	Huggins Property, 12206 Apache Avenue, Savannah, GA	DATE 10/21/03
	CLIENT	HUNTER MACLEAN EXLEY & DUNN, PC

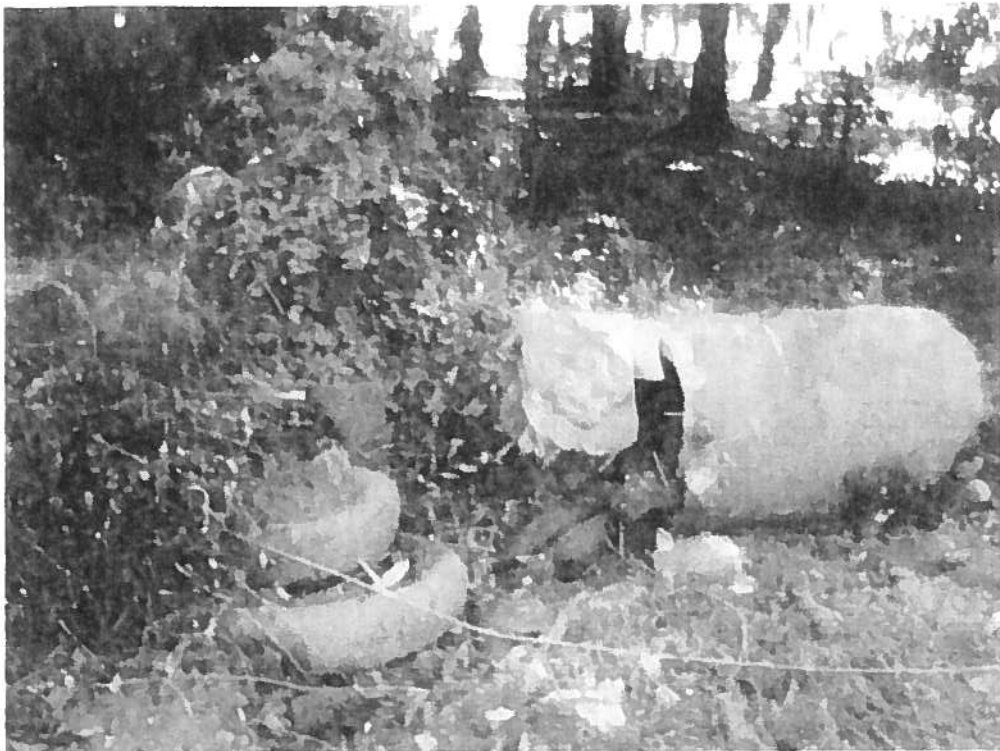
EMC PROJECT NO. 03-0527.30	DESCRIPTION	Buried tires and concrete culvert dug up on site with the track hoe	13
	SITE NAME	Huggins Property, 12206 Apache Avenue, Savannah, GA	DATE 10/21/03
	CLIENT	HUNTER MACLEAN EXLEY & DUNN, PC

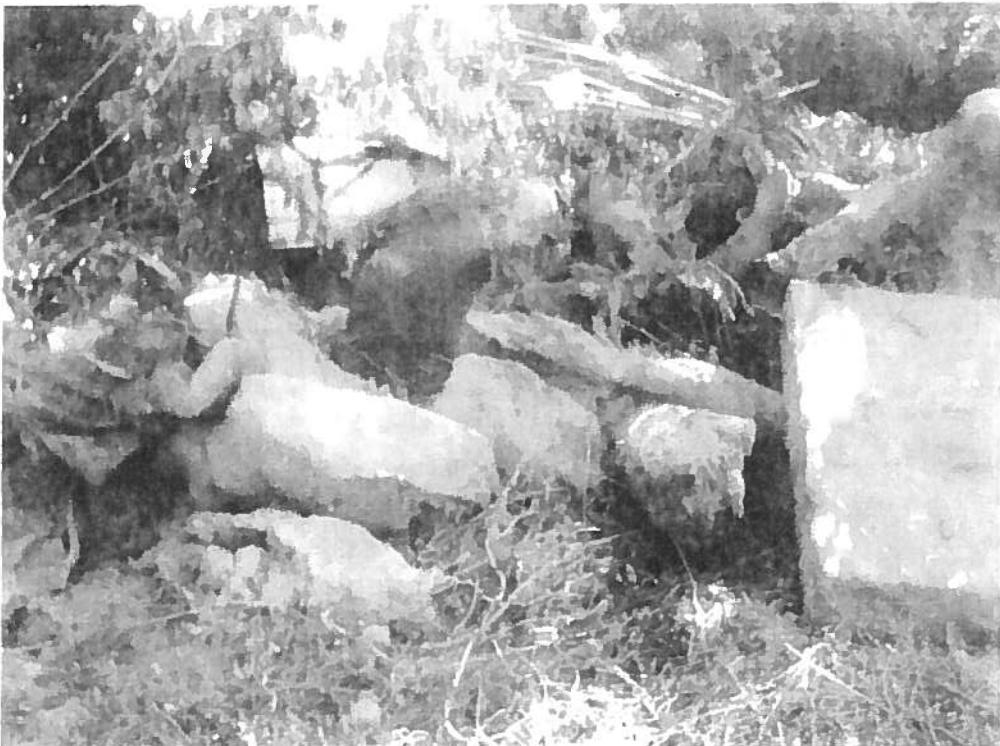
EMC PROJECT NO. 03-052730	DESCRIPTION	Buried sofa, carpet, fuel storage tank, trees, stumps, and concrete dug up on site with the track hoe	14
	SITE NAME	Huggins Property, 12206 Apache Avenue, Savannah, GA	DATE 10/21/03
	CLIENT	HUNTER MACLEAN EXLEY & DUNN, PC

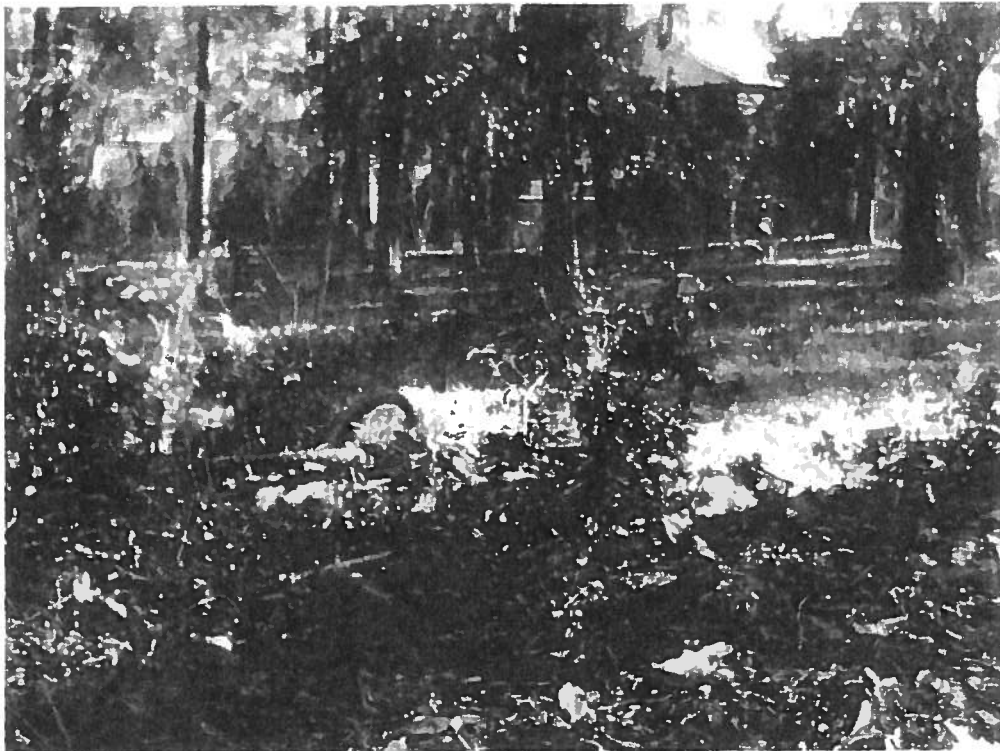
EMC PROJECT NO 03-0527.30	DESCRIPTION	Armstrong Apartments viewed from the southeast corner of Huggins property, trash in foreground.	19
	SITE NAME	Huggins Property, 12206 Apache Avenue, Savannah, GA	DATE 10/21/03
	CLIENT	HUNTER MACLEAN EXLEY & DUNN, PC
