Report of
Facility Condition Assessment

For
Lakeside Apartments
Abraham Baldwin Agricultural College
Tifton, GA 31793

September 12, 2013 (revised March 27, 2014)

Provided By:
Faithful+Gould, Inc.

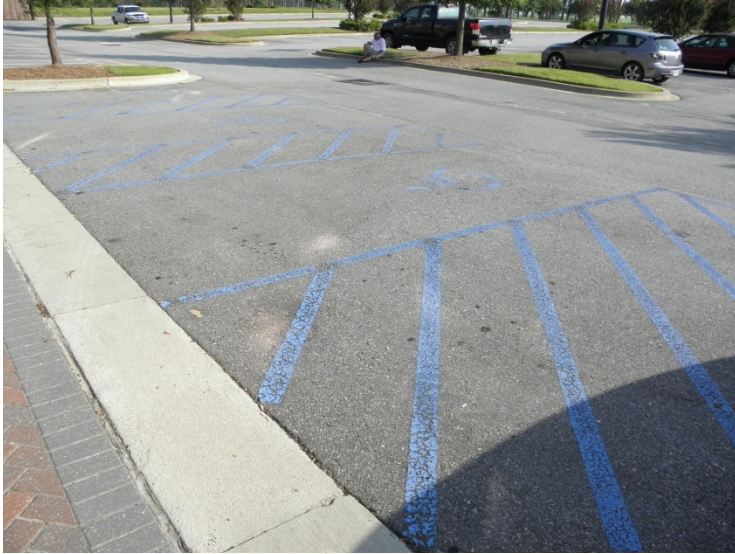
Photograph No. 7

Faded handicapped parking

1. Periodic crack fill, seal coat and restripe the parking area. 17,500 SY @ \$1.10/SY = \$19,250 in 2014, 2019 and 2024.

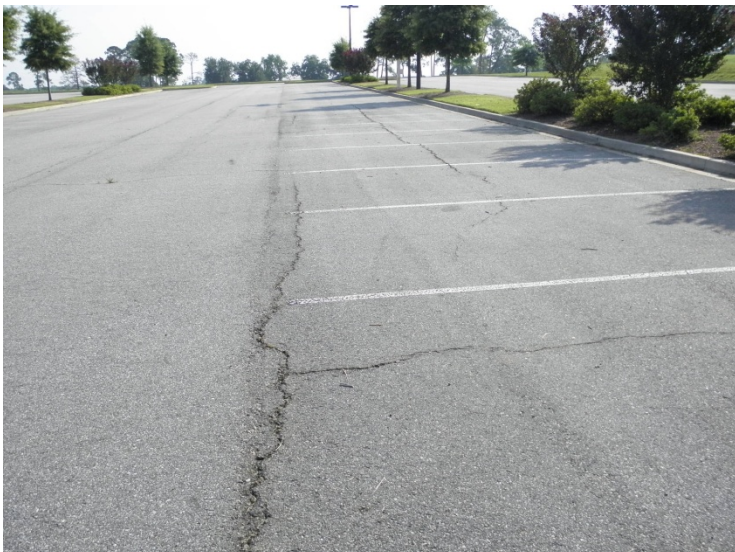
Photograph No. 9

The parking area was in fair condition with the asphalt aggregate polished and the pavement and markings faded. We noted significant cracking parallel to parking islands. We recommend a current program of crack filling, new seal coat and re-stripping the parking spaces.

Cracked pavement

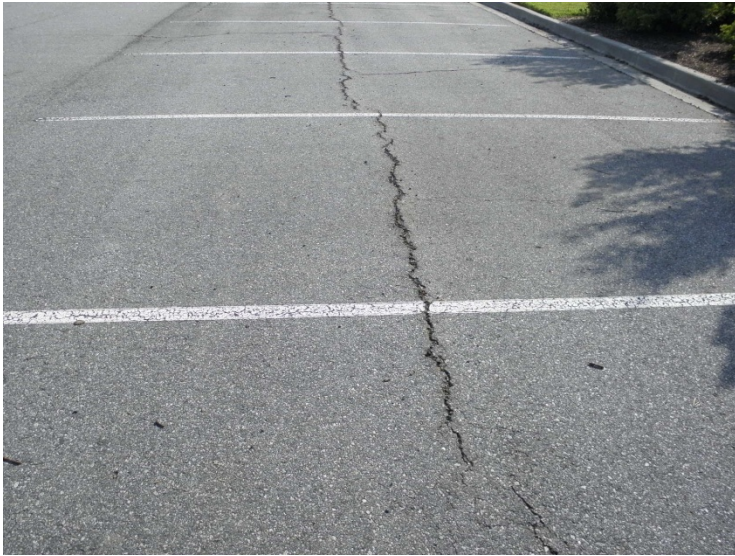
Photograph No. 10

Cracked pavement

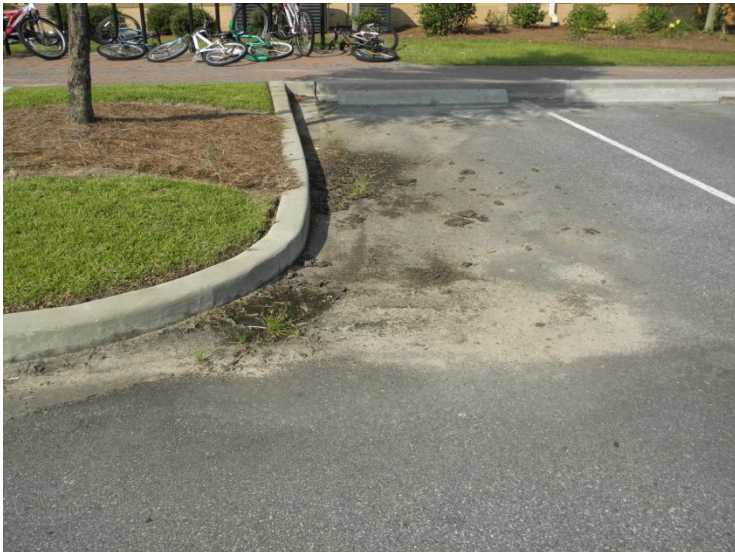
Photograph No. 11

Low area not draining properly

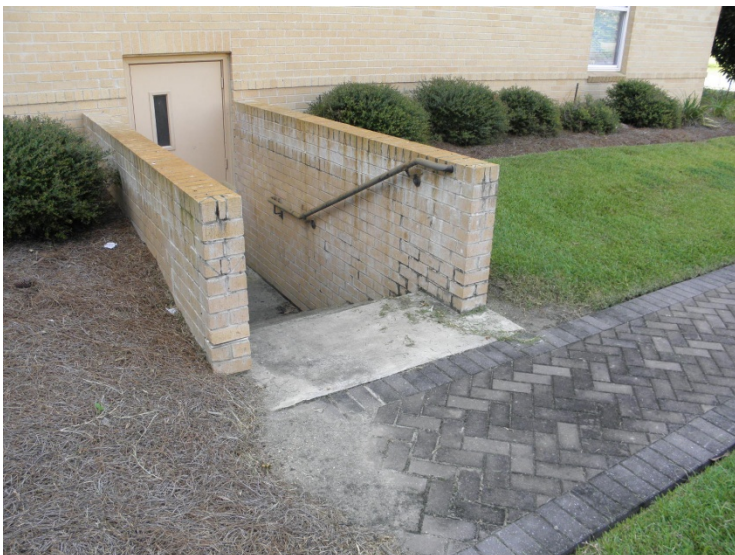
Photograph No. 12

Brick paver sidewalks and curb sections are in generally good condition. The brick retaining walls at the exit stairways in the courtyards have open mortar joints and exhibit efflorescence from moisture within the walls. We suggest tuck pointing the deficient joints and applying a clear sealer to the brick.

Exit steps at the west courtyard. Note efflorescence

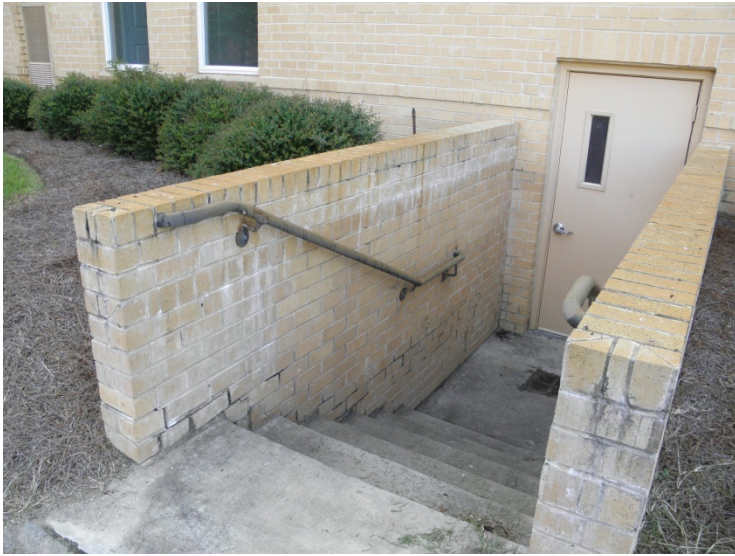
Photograph No. 13

Exit steps at the west courtyard. Note efflorescence

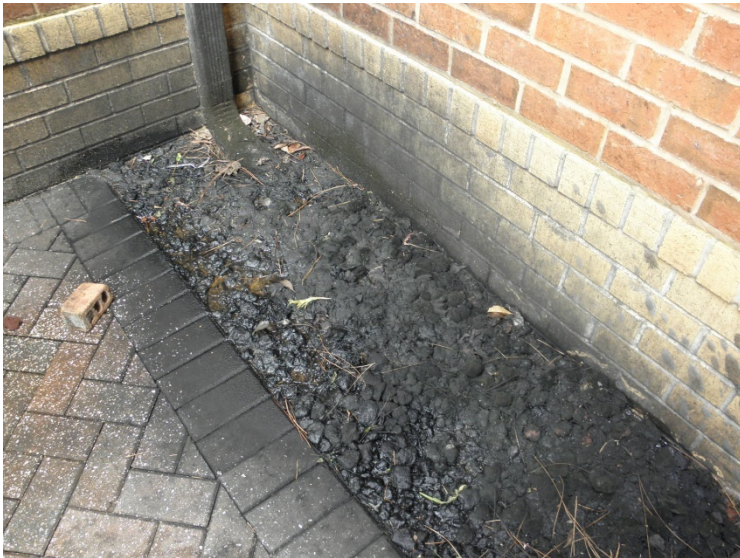
Photograph No. 14

The area outside the first floor kitchen has been used as a disposal area for used cooking oil and grease. As such the gravel area is stained. We recommend placement of a portable grease disposal container outside the door and engagement of a disposal service.

Unintended cooking grease disposal area in the east courtyard at the kitchen door.

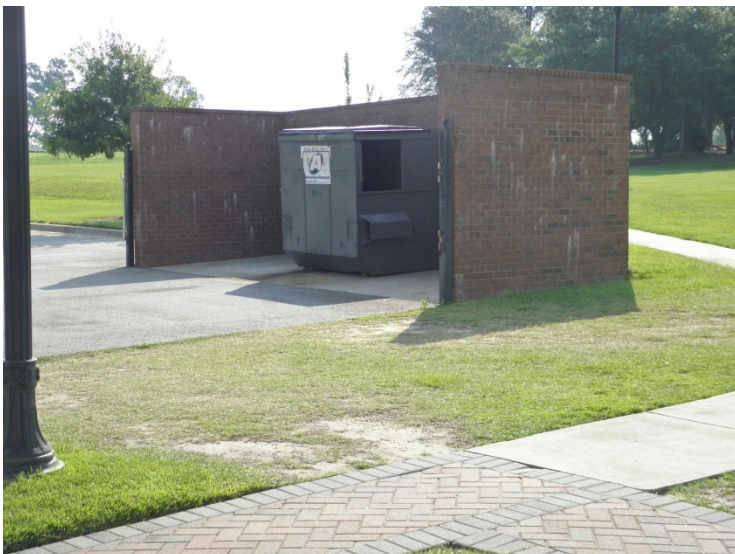
Photograph No. 15

The trash dumpster enclosures appeared in fair condition. The east enclosure had its doors removed because the hinges failed. The doors on the north enclosure were damaged. We suggest that the swing doors be replaced with smaller sliding doors that are less subject to abuse.

Dumpster enclosure at the east end

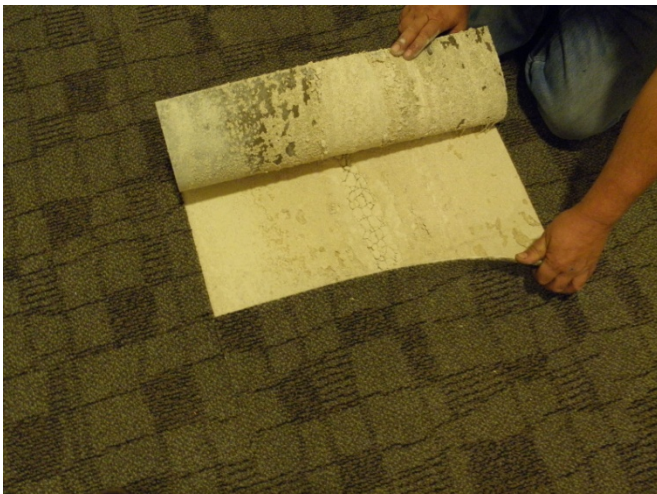
Photograph No. 18

Areas of the corridors were noted with excessive deflection feeling “spongy”. Lifting some carpet tiles revealed cracked gypsum underlayment. Reportedly this was caused by heavily loaded dollies of gypsum board being wheeled along corridors when the drywall material was being stocked during construction. Reportedly no floor protection was employed. Visibly damaged underlayment areas were reportedly patched during construction. Fractured and weakened areas probably were not noticed or replaced, resulting in the current condition. We recommend an effort to map the damaged areas and repair same to maintain the required fire rating of the floor assembly.

Damaged gypsum floor underlayment

1. Inspect all corridor floors for areas of excessive deflection and repair such areas with the proper materials. We recommend budgeting an allowance of \$15,000 (3 men 20 days @ \$200/day plus materials) for repairing the gypsum underlayment with a suitable patching compound in 2014.

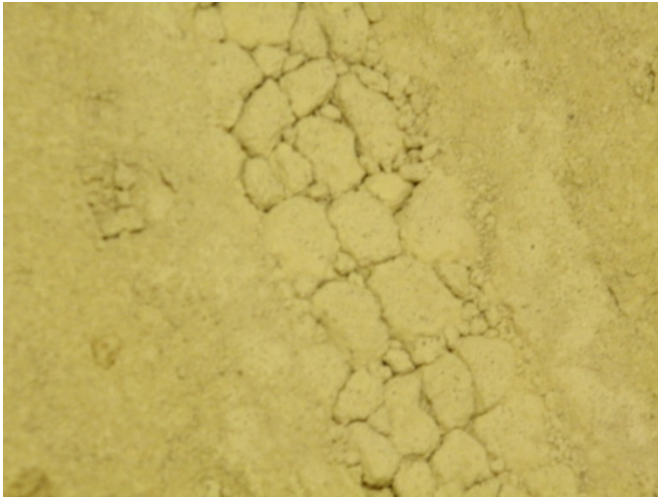
Photograph No. 19

Damaged gypsum floor underlayment

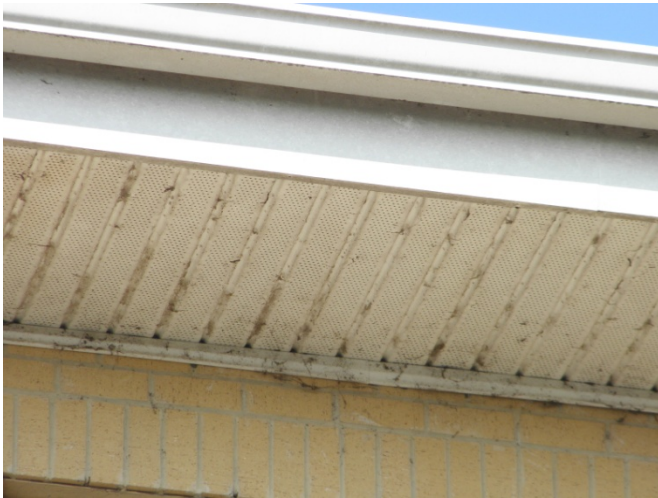
Photograph No. 23

Soffit material is very dirty

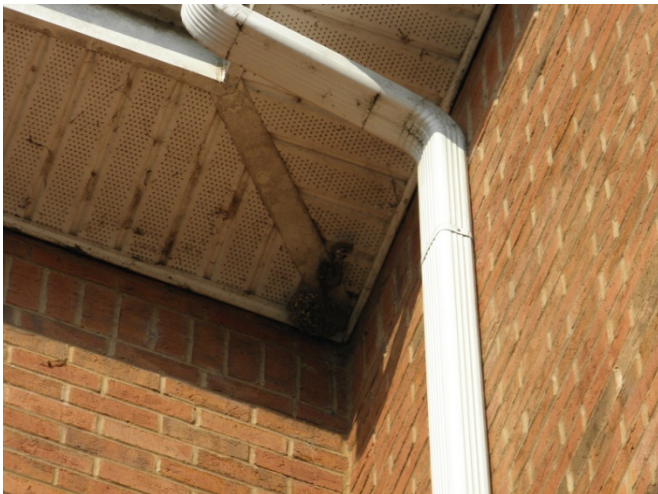
Photograph No. 24

Dirty soffit

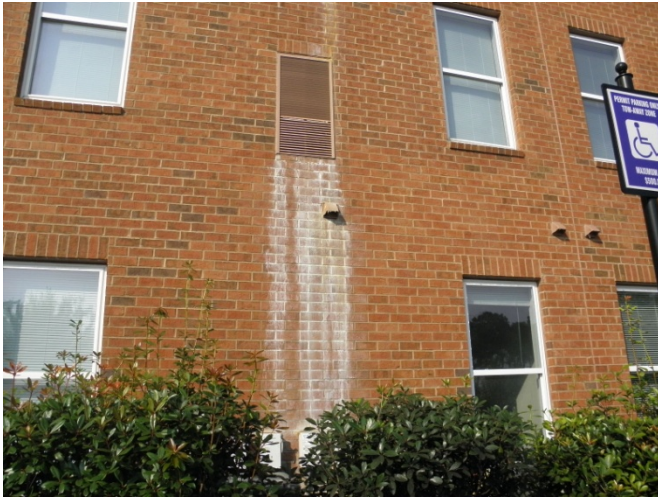
Photograph No. 25

We viewed the exteriors of the buildings from the ground using binoculars. There is extensive staining from leaking condensate at practically every through-wall heat pump location extending vertically from the bottom of the louver at all levels. This is the result of possibly incorrect heat pump installation or a product defect. Corrective measures are in progress to cure the problem. This is fully discussed in section 5.0. After correction, a program of cleaning the walls is required. Pressure washing and possibly chemical cleaning might be necessary.

Staining from heat pump condensate

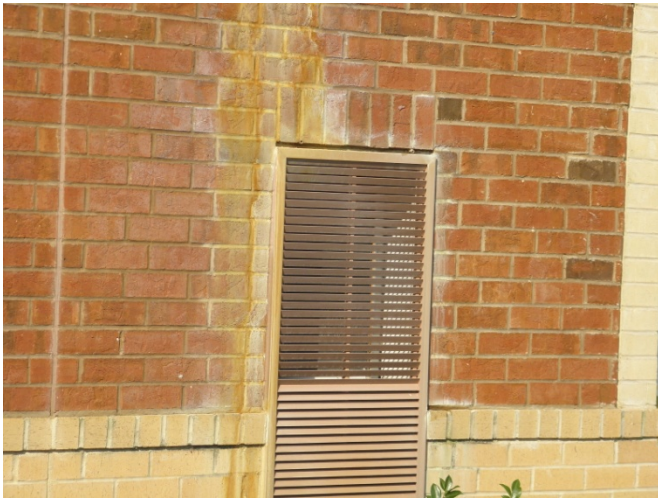
Photograph 26

Staining from heat pump condensate

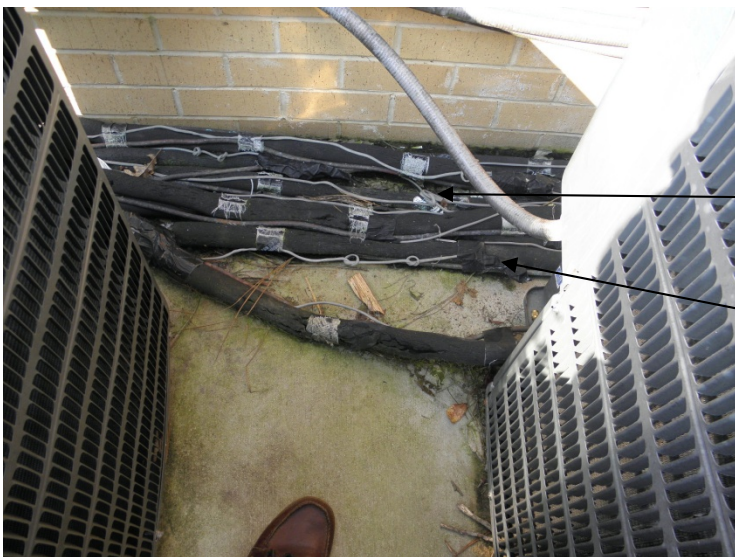
Photograph No. 6

Deteriorated refrigerant line insulation

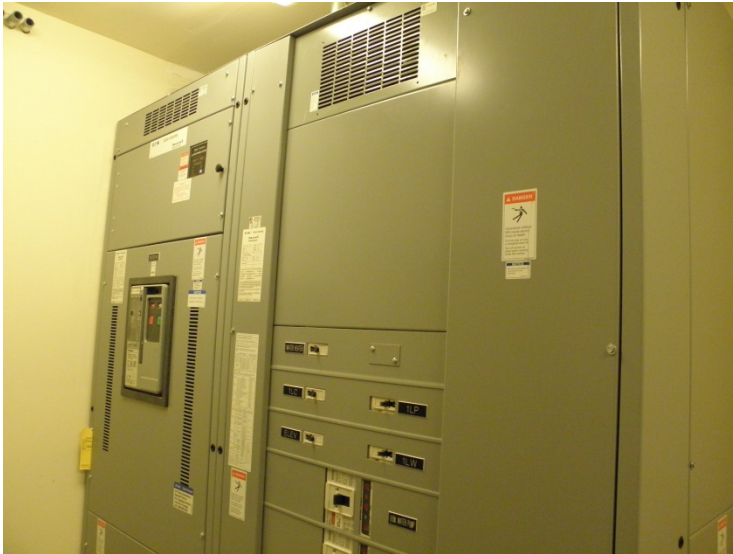
Photograph No. 7

One of two main switchboards. No warning signage posted advising there is a second electric service.

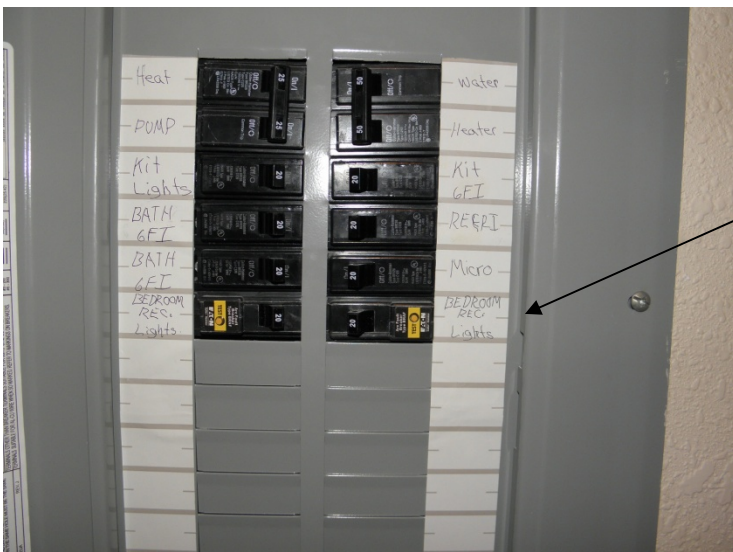
Photograph No. 9

Living unit load center. Note GFI breakers labeled for bedroom lights and receptacles.

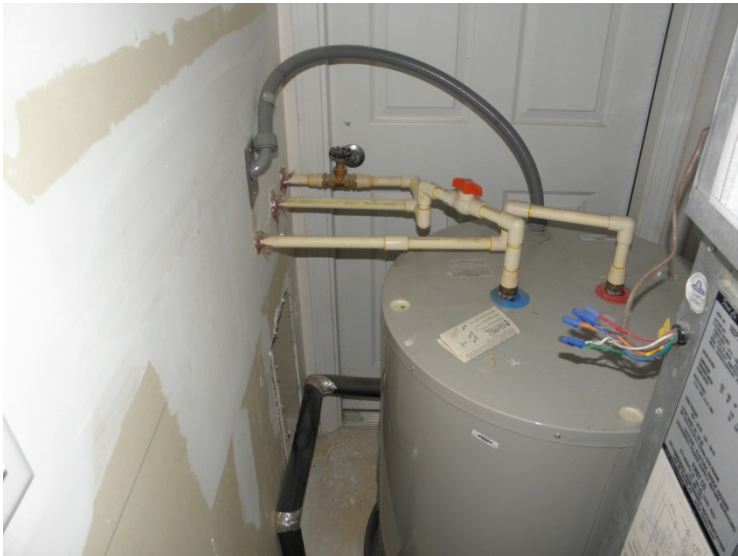
Photograph No. 14

Connections to a typical living unit hot water heater. This is directly wired with no electrical disconnect.
