Subject: Facility Condition Assessment
FCA - College of Coastal Georgia
1 College Drive
Brunswick, Georgia
Cardno ATC Project No.: 070.19150.3071

FACILITY CONDITION ASSESSMENT REPORT

**FCA - College of Coastal Georgia
Lakeside Village Student Housing
1 College Drive
Brunswick, Georgia 31520**

CARDNO ATC PROJECT NO. 070.19150.3071

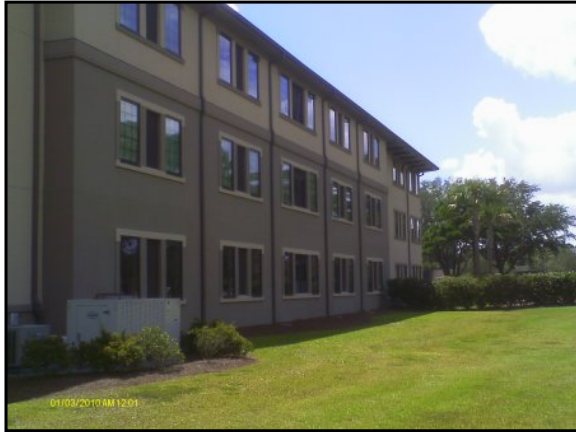
1 : East side of Wing 1, facing west.

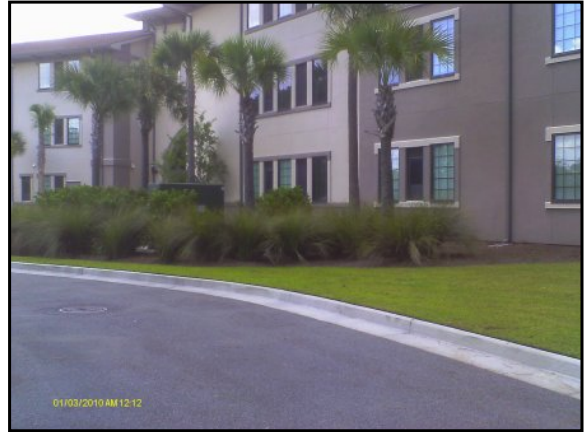
2 : West side of Wing 3, facing northeast.

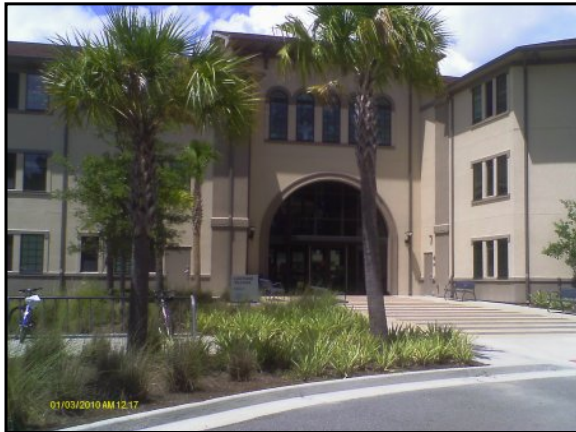
3 : Overview of the entrance to the building.

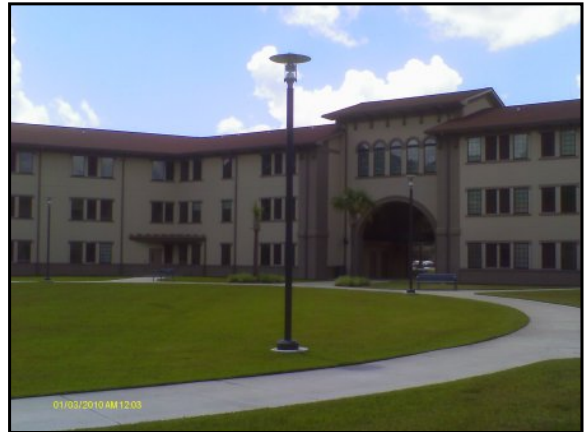
4 : The east side of Wing 2, facing southwest.

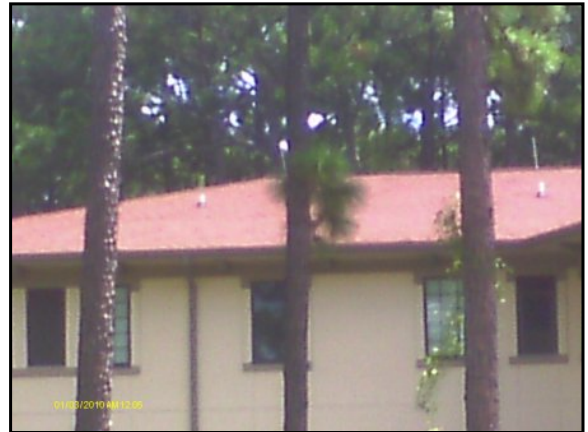
10 : Asphalt shingle roof of the building.

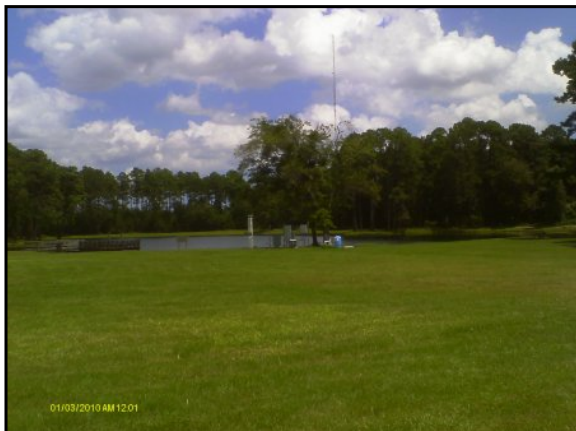
11 : East adjacent pond.

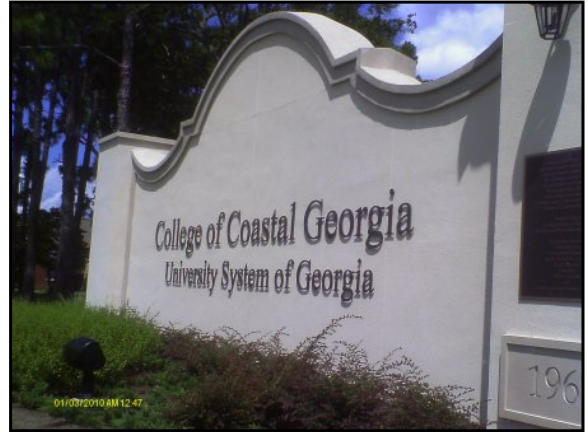
The Property contains signage indicating the name and wing (1 through 3) of the building. The Property and building signage is in good condition with no significant deficiencies.

14 : Main Signage for the College.

Repair and replacement of the signage is considered a part of routine maintenance; no action is required.

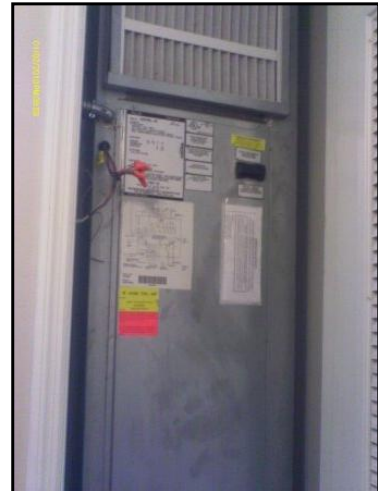
40 : Typical HVAC unit in each dorm room.

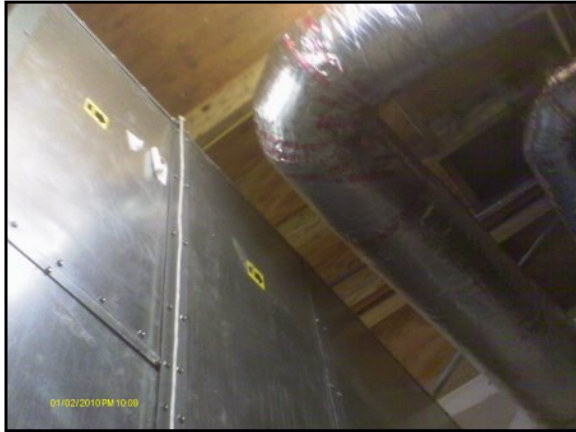
43 : Common area air handler unit in attic area.

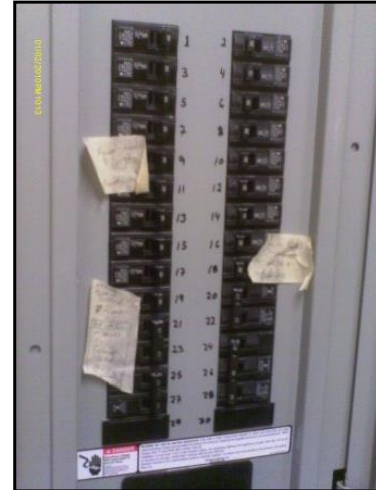
44 : Typical electrical panel.

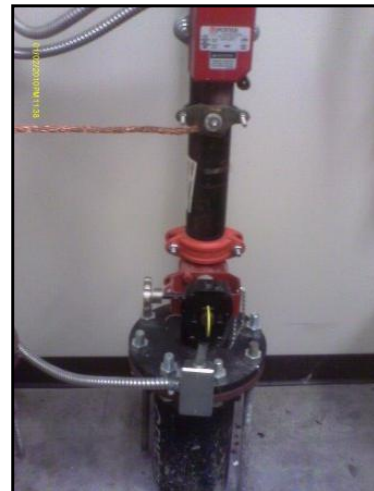
52 : Main fire suppression riser in Wing 1.

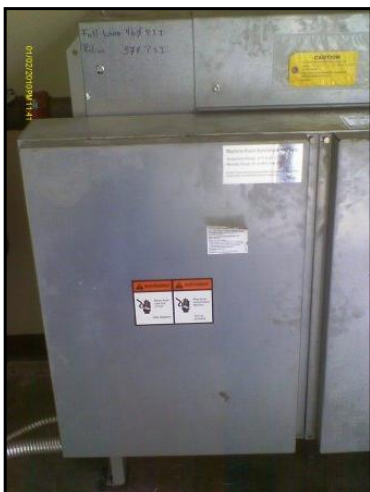
53 : Elevator room/motor in Wing 1.

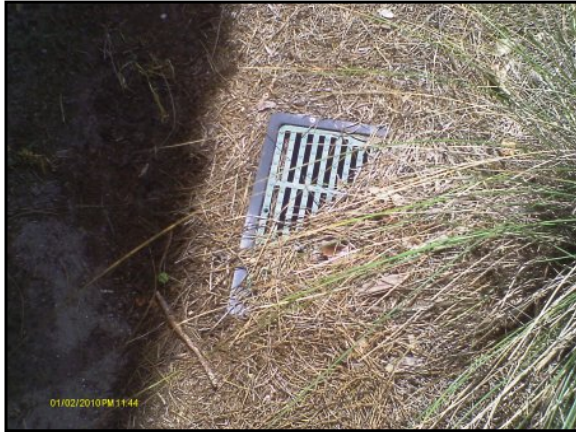
55 : Exterior drain grates.

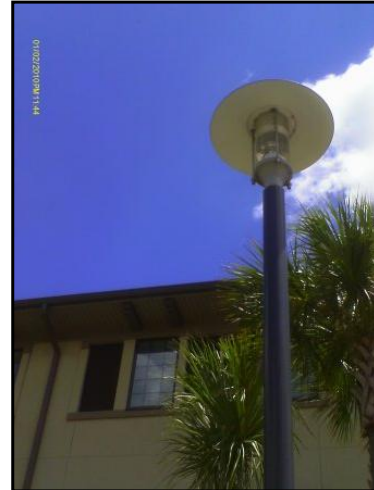
Exterior lighting consists of building-mounted and pole-mounted high intensity discharge fixtures that appeared to be in good condition. Since the survey was conducted during daylight hours, Property lighting levels could not be accurately assessed; however, the lighting layout appears to provide adequate coverage and the site contact reported no deficiencies.

56 : Exterior pole mounted lighting.

The exterior light fixtures can be expected to last through the term with periodic repairs and replacement as part of routine maintenance, no other action is currently recommended.

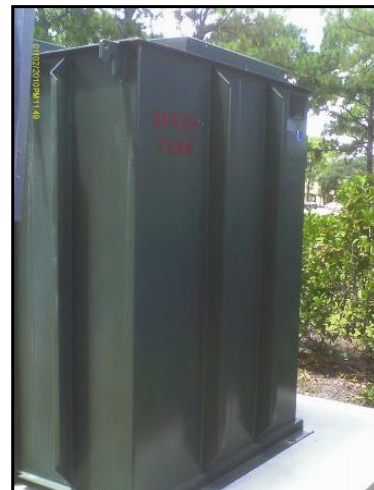
60 : Pad mounted transformer at the north end of Wing 1.

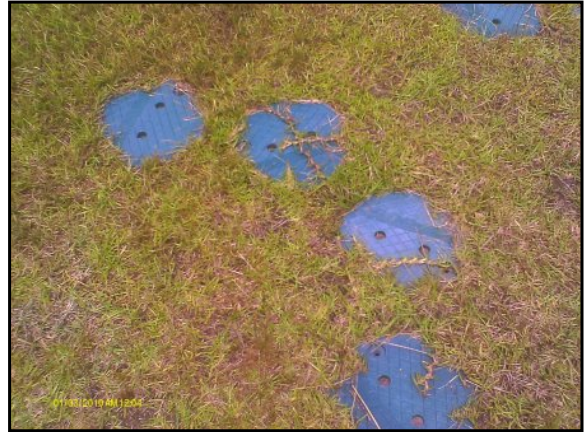
Observations: The landscaping consists primarily of ground cover, grass turf, shrubs, flowers and trees. The Property has an irrigation system fed from the adjoining freshwater pond that services the landscaped areas. While the irrigation system was not observed in operation, no significant deficiencies were observed or reported. The landscaping components appeared to be generally in good condition with no significant deficiencies.

62 : Irrigation heads for the grassed areas of the property.

Recommendations: Repair and replacement of landscaping components is considered to be a part of routine maintenance; no action is required.

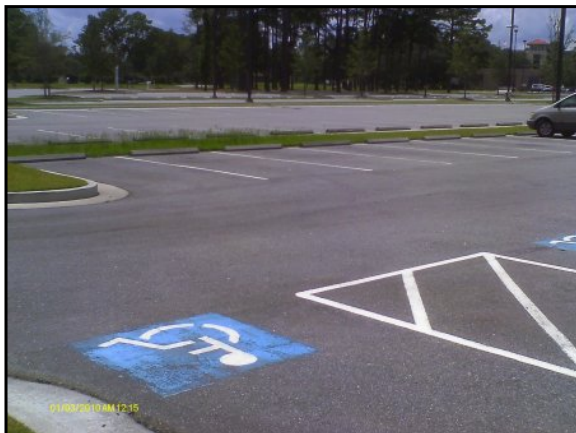
Parking for an observed total of 328 vehicles is provided at the southwest side of the Building. Eight ADA parking spaces were observed in the parking area: four adjacent to Wing II and Wing II, respectively. The existing parking design and

71 : ADA spaces in the parking area.

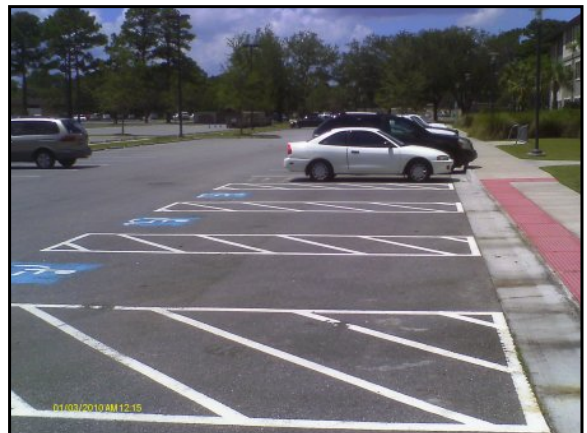
The asphalt pavement and striping appeared to be generally in good condition with localized low severity cracking observed throughout the parking area. In general, asphalt pavement can be expected to provide approximately 25 years of useful life, with sealcoating and restriping of the pavement conducted every five years.

The paved areas are bordered by cast-in-place concrete curbing. The curbing appeared to be in good condition throughout the parking area.

72 : Overview of the parking area.

Recommendations: Based on the condition and EUL of the asphalt pavement, Cardno ATC recommends that the asphalt pavement be scheduled for sealcoat and restriping during the term.

Based on the observed condition of the curbing, the curbing will require only routine maintenance during the evaluation period; no other action is currently recommended.

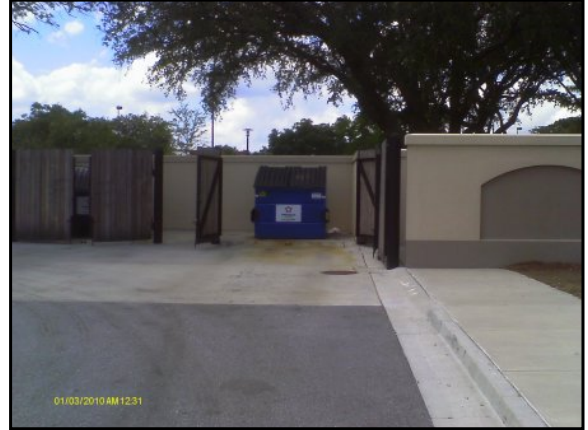
A locking enclosure for trash dumpsters is located west of the Property within the parking area. The dumpsters are placed directly on asphalt pavement that appeared to be in good condition. No trip hazards or other areas of damage were observed. The enclosure is addressed in Section 3.3.6.

No walls, fencing or railing were observed with the exception of the fence/enclosure surrounding the dumpster area. The enclosure walls were constructed of EIFS material and were noted in good condition with no significant deficiencies.

74 : Trash dumpster area on the northwest corner of the parking area adjacent to Wing 1.

Repair and replacement of the dumpster enclosure is considered a part of routine maintenance; no action is required.

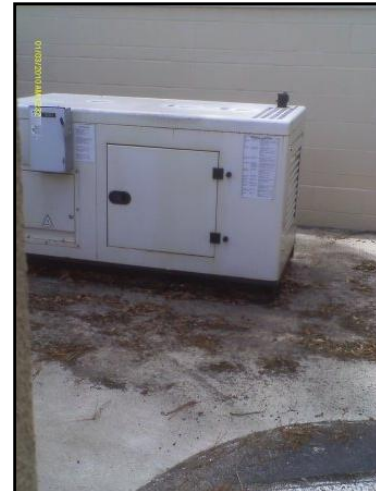
76 : Diesel emergency generator within the dumpster compound.
