Deferred Maintenance Self-assessment

An Application to Public Private Ventures

The University of Georgia
Office of the University Architects for Facilities Planning

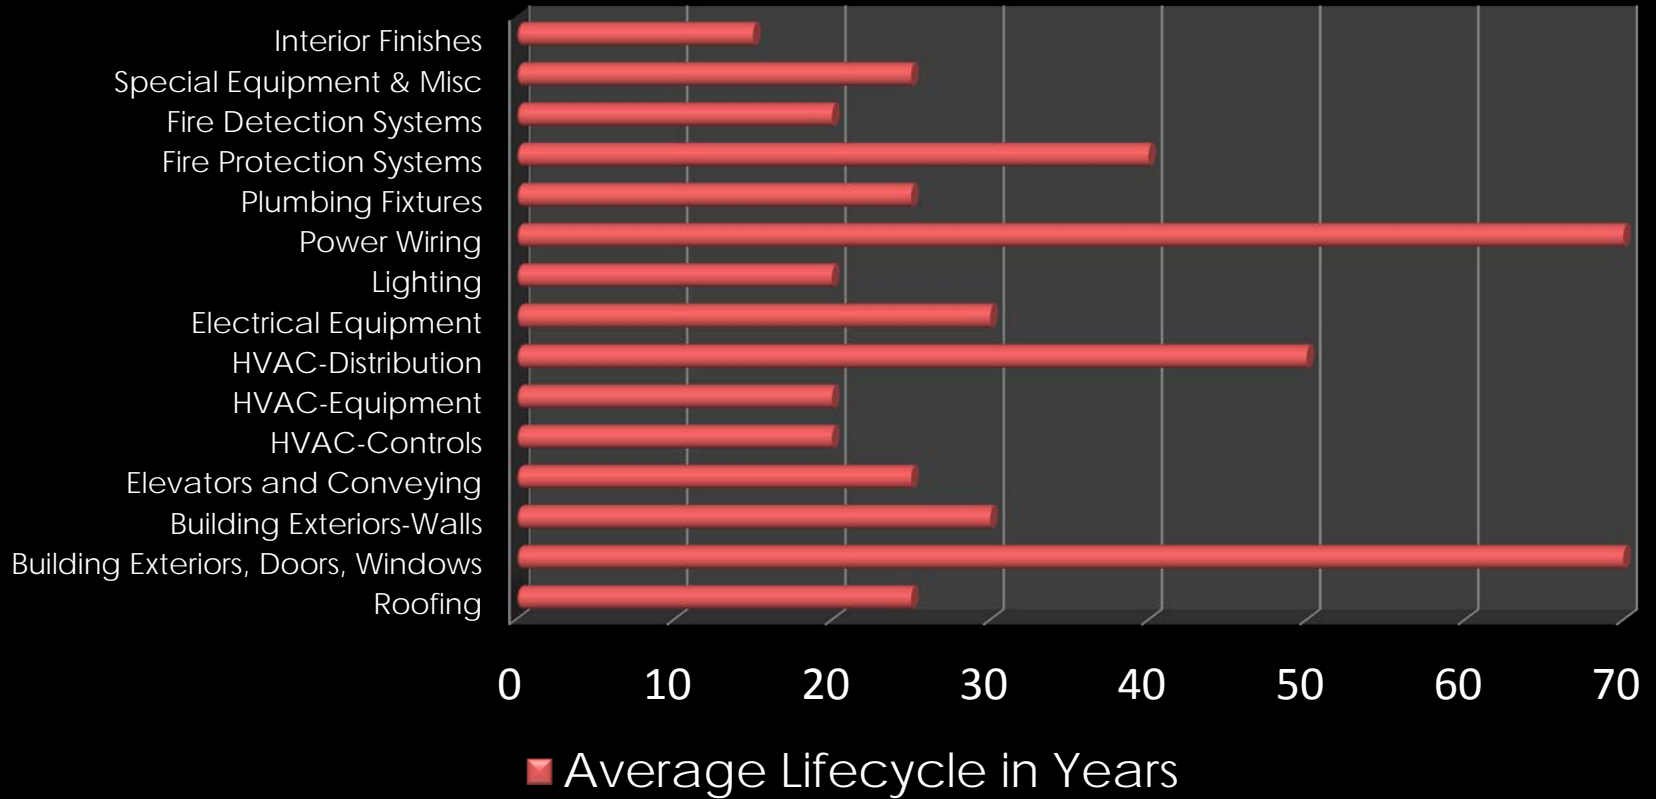
Stanford University Subsystem Lifecycle Study

- Average building subsystem (i.e. HVAC, plumbing, exteriors) has a lifecycle between 20 and 50 years.

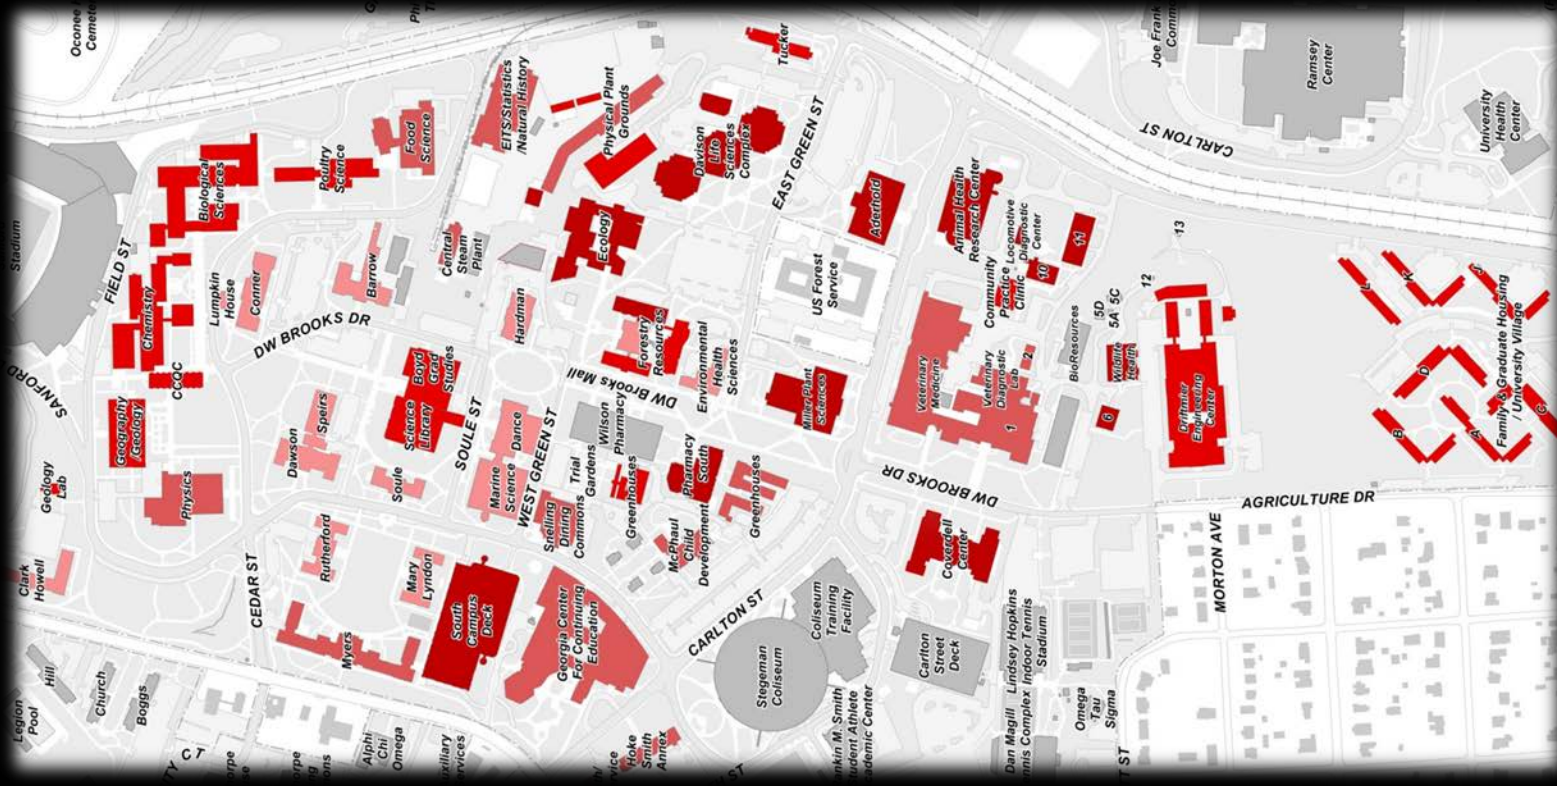
South Campus Buildings by Decade

- 1901-1939
- 1940-1959
- 1960-1969
- 1970-2009

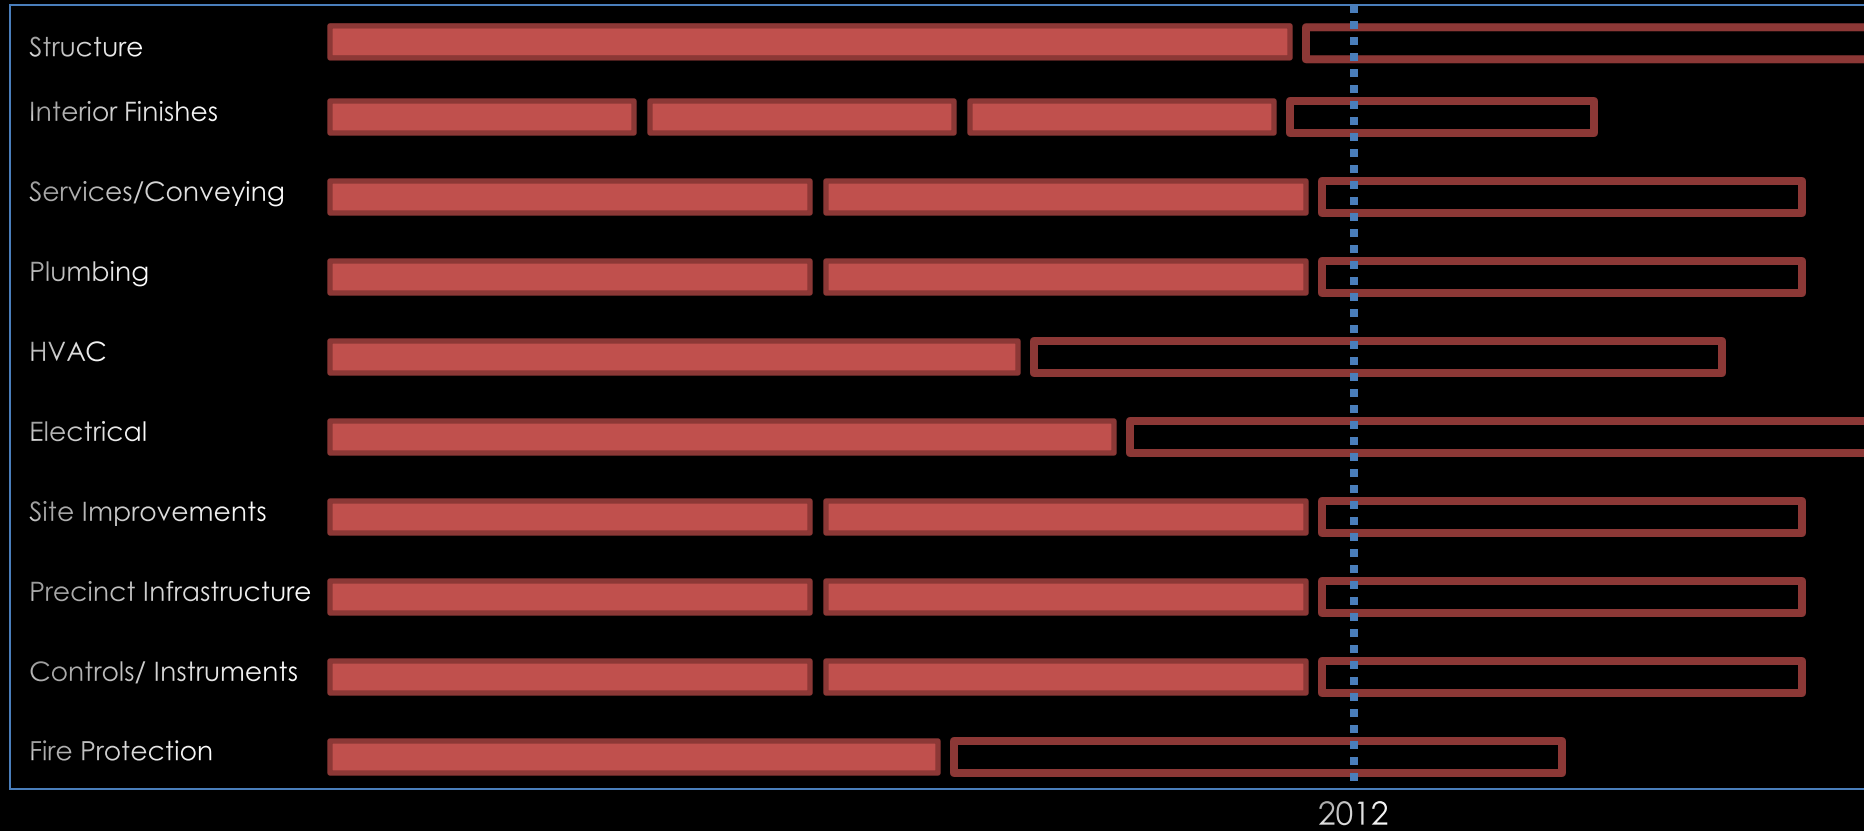
Science Hill Buildings Subsystem Lifecycle Study

1960 1965 1970 1980 1975 1985 1990 1995 2000 2005 2010 2015 2020 2025 2030

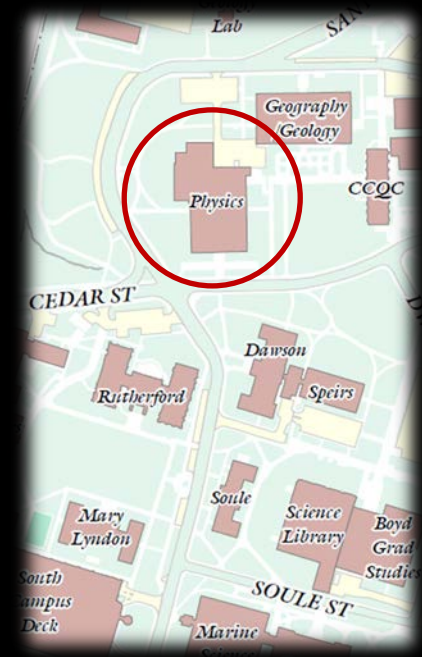
Science Hill Building Subsystem Assessment - Physics

1 (Fail)	2 (Poor)	3 (Avg.)	4 (Good)	5 (New)
Structure			●		
Interior Finishes			●		
Services/Conveying		●			
Plumbing		●			
HVAC			●		
Electrical		●			
Site Improvements		●			
Precinct Infrastructure		●			
Controls/ Instruments		●			
Fire Protection		●

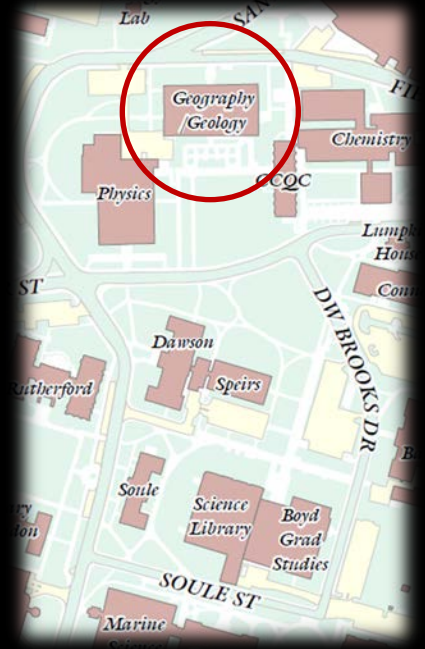
Subsystem Renewal and Replacement Costs Geography/Geology Building

Acad Space Type	Office Cost/SF (Low)	Office Cost/SF (High)	Classroom Cost/SF (Low)	Classroom Cost/SF (High)	Laboratory Cost/SF (Low)	Laboratory Cost/SF (High)	Circulation Cost/SF (Low)	Circulation Cost/SF (High)	Services/Conveying Cost/SF (Low)	Services/Conveying Cost/SF (High)	Restroom/Custodial Cost/SF (Low)	Restroom/Custodial Cost/SF (High)	Mechanical/Utility/MDF Rm Cost/SF (Low)	Mechanical/Utility/MDF Rm Cost/SF (High)	Special Use Cost/SF (Low)
Area (SF)	24,943		10,628		24,513		18,473		4,414		2,135		2,940		0
Structure	\$ -	\$ 149,658	\$ -	\$ 63,768	\$ -	\$ 147,078	\$ -	\$ 110,838	\$ -	\$ 26,484	\$ -	\$ 12,810	\$ -	\$ 17,640	\$ -
Skin	\$ -	\$ -	\$ -	\$ -	\$ -	\$ -	\$ -	\$ -	\$ -	\$ 4,414	\$ -	\$ -	\$ -	\$ -	\$ -
Services/Conveying	\$ -	\$ 149,658	\$ -	\$ 21,256	\$ -	\$ 49,026	\$ -	\$ 36,946	\$ -	\$ 8,828	\$ -	\$ 4,270	\$ -	\$ 5,880	\$ -
Plumbing	\$ -	\$ 149,658	\$ -	\$ 127,536	\$ -	\$ 294,156	\$ -	\$ 221,676	\$ -	\$ 52,968	\$ -	\$ 25,620	\$ -	\$ 35,280	\$ -

HVAC	\$ -	\$ 723,347	\$ -	\$ 265,700	\$ -	\$ 2,255,196	\$ -	\$ 535,717	\$ -	\$ 128,006	\$ -	\$ 61,915	\$ -	\$ 85,260	\$ -
Controls	\$ -	\$ 124,715	\$ -	\$ 21,256	\$ -	\$ 49,026	\$ -	\$ 36,946	\$ -	\$ 8,828	\$ -	\$ 4,270	\$ -	\$ 5,880	\$ -
Electrical	\$ -	\$ 573,689	\$ -	\$ 244,444	\$ -	\$ 1,127,598	\$ -	\$ 480,298	\$ -	\$ 114,764	\$ -	\$ 55,510	\$ -	\$ 76,440	\$ -
Site improvements	\$ -	\$ 49,886	\$ -	\$ 21,256	\$ -	\$ 49,026	\$ -	\$ 36,946	\$ -	\$ 8,828	\$ -	\$ 4,270	\$ -	\$ 5,880	\$ -
Precinct infrastructure	\$ 49,886	\$ 149,658	\$ 21,256	\$ 127,536	\$ 49,026	\$ 294,156	\$ 36,946	\$ 221,676	\$ 8,828	\$ 52,968	\$ 4,270	\$ 25,620	\$ 5,880	\$ 35,280	\$ -
Interior Finishes/FFE	\$ 873,005	\$ 1,297,036	\$ 371,980	\$ 552,656	\$ 857,955	\$ 3,529,872	\$ 646,555	\$ 960,596	\$ 154,490	\$ 229,528	\$ 111,020	\$ 183,610	\$ 67,620	\$ 152,880	\$ -
Code compliance-Electrical	\$ -	\$ 149,658	\$ -	\$ 63,768	\$ -	\$ 294,156	\$ -	\$ 110,838	\$ -	\$ 26,484	\$ -	\$ 12,810	\$ -	\$ 17,640	\$ -

Code compliance-Mechanical	\$ -	\$ 149,658	\$ -	\$ 63,768	\$ -	\$ 294,156	\$ -	\$ 110,838	\$ -	\$ 26,484	\$ -	\$ 12,810	\$ -	\$ 17,640	\$ -
Code compliance-Fire safety	\$ -	\$ 74,829	\$ -	\$ 31,884	\$ -	\$ 147,078	\$ -	\$ 55,419	\$ -	\$ 13,242	\$ -	\$ 6,405	\$ -	\$ 8,820	\$ -
Code compliance-ADA	\$ -	\$ 74,829	\$ -	\$ 31,884	\$ -	\$ 73,539	\$ -	\$ 55,419	\$ -	\$ 13,242	\$ -	\$ 6,405	\$ -	\$ 8,820	\$ -
Audio Visual Equipment	\$ -	\$ -	\$ -	\$ -	\$ -	\$ -	\$ -	\$ -	\$ -	\$ -	\$ -	\$ -	\$ -	\$ -	\$ -
Abatement	\$ -	\$ -	\$ -	\$ -	\$ -	\$ -	\$ -	\$ -	\$ -	\$ -	\$ -	\$ -	\$ -	\$ -	\$ -
Demo	\$ -	\$ -	\$ -	\$ -	\$ -	\$ -	\$ -	\$ -	\$ -	\$ -	\$ -	\$ -	\$ -	\$ -	\$ -
TOTALS	\$ 922,891	\$ 3,816,279	\$ 393,236	\$ 1,636,712	\$ 906,981	\$ 8,604,063	\$ 683,501	\$ 2,974,153	\$ 163,318	\$ 715,068	\$ 115,290	\$ 416,325	\$ 73,500	\$ 473,340	\$ -
TOTALS (LOW)	\$ 3,258,717														
TOTALS (HIGH)	\$ 18,635,940
