Mid-Century Modern: The Challenges for a CM to Add Value

Ronald D. Staley, FAPT
Senior Vice President
The Christman Company

Mid-20th Century Buildings Workshop

Facility Officers Conference/ Columbus, Ga./ 26 October 2011

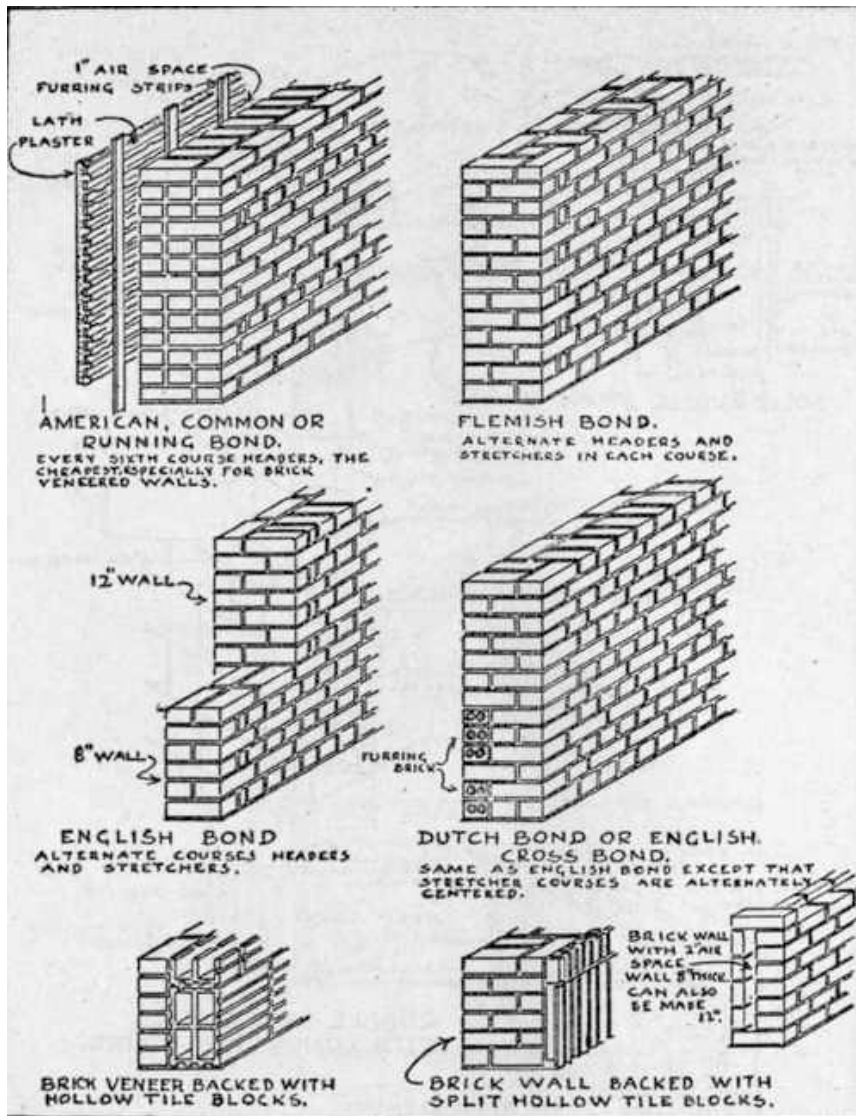
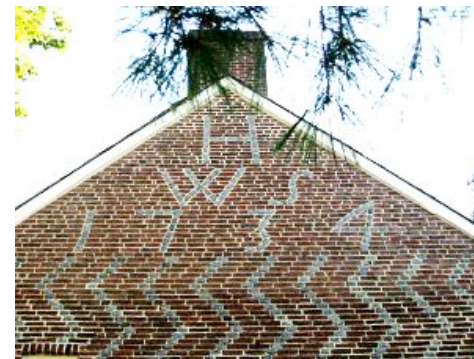
“Traditional” Wall Design

- Understood allowance for movement and cross connection of wythes of masonry.
- Moisture is separated from inside to outside based upon material volume.
- Flexible mortar is self healing and eliminated the need for expansion joints.
- System is water tolerant.

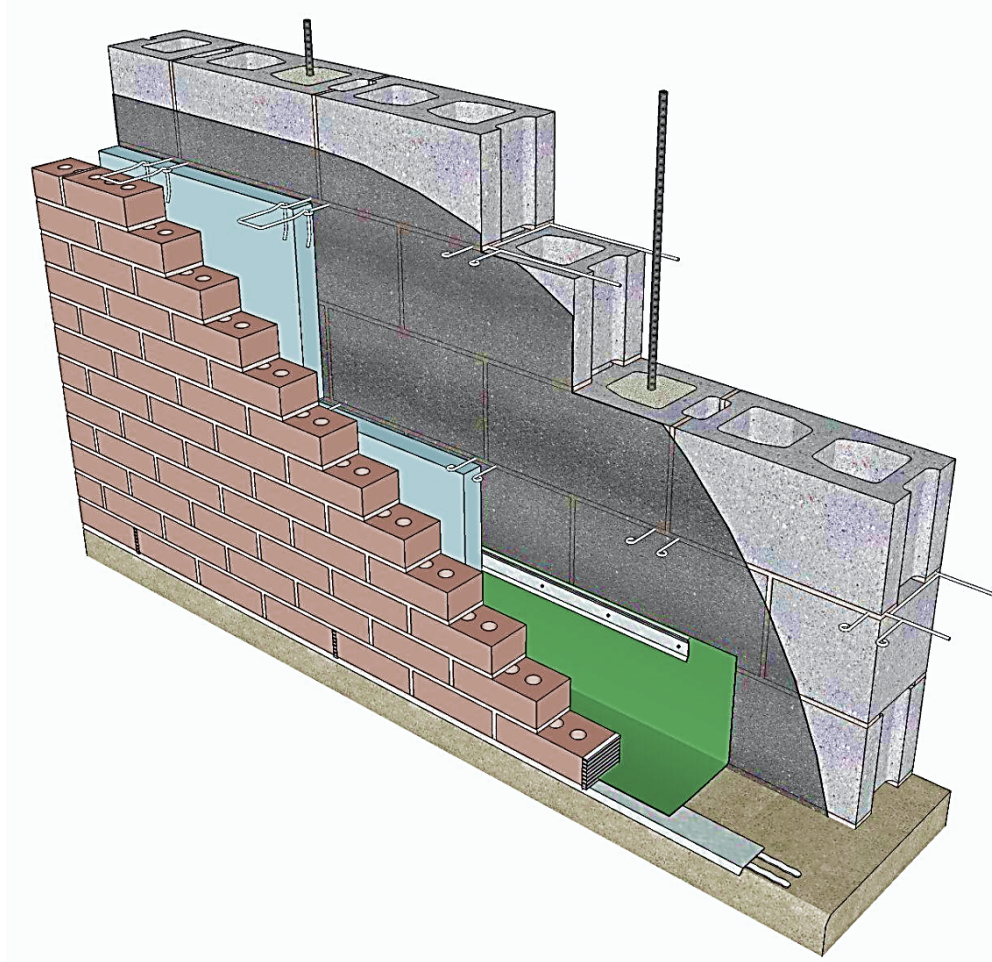
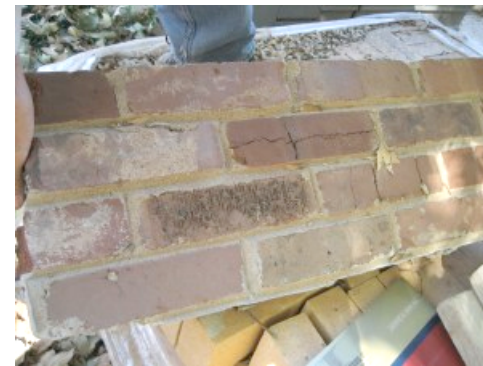
Common Mid-Century Wall Details

- Rain screen masonry or panel system
- Materials with different coefficients of expansion
- Hard mortar that requires expansion joints
- Thin cross section connections subject to corrosion
- Detailed engineered system
- Death by water

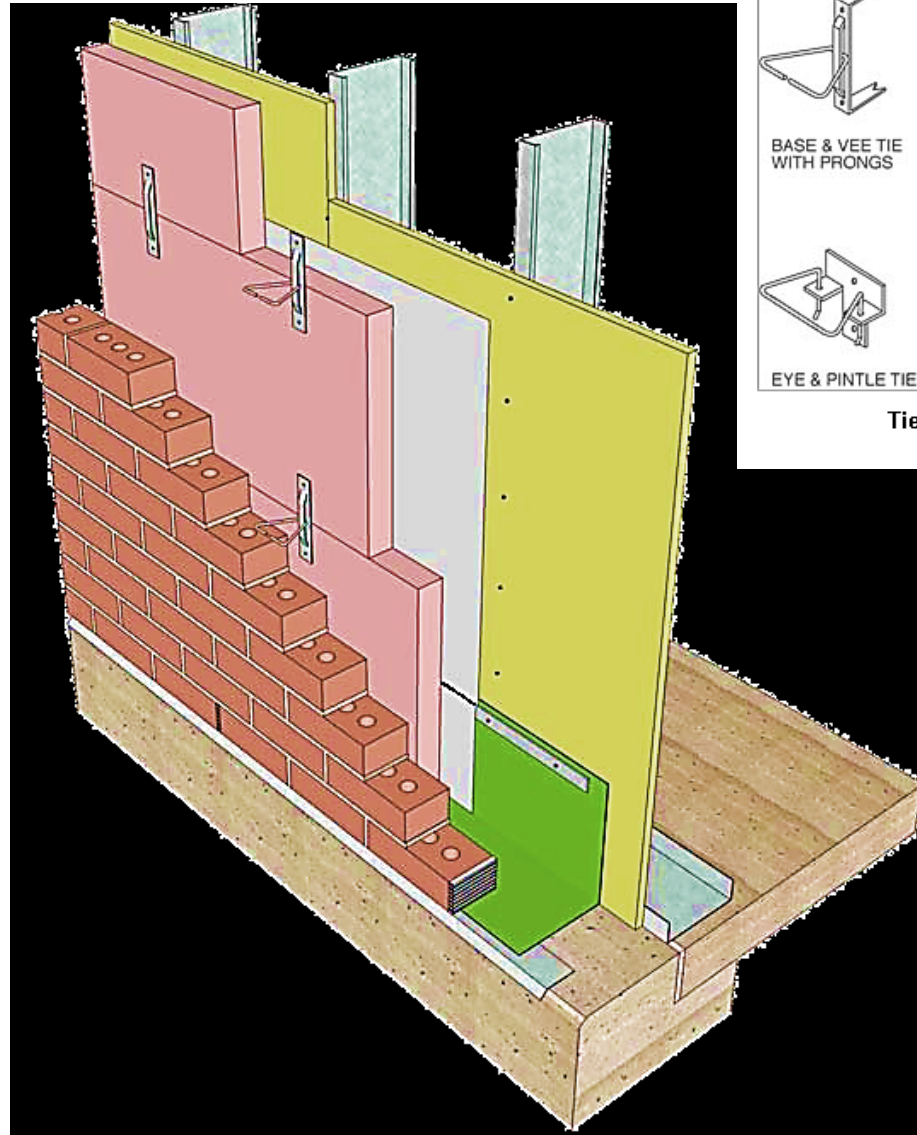
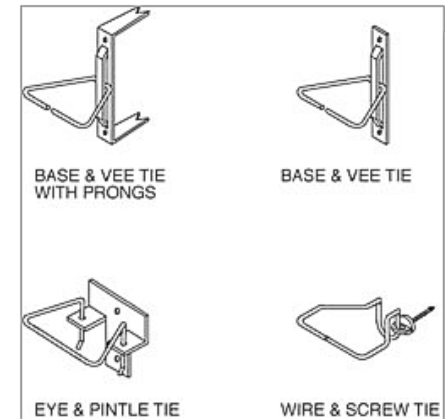
Tie Assemblies
Fig. 5

Detail Economies

- Over time details have changed and continue to change to lessen cost.
- Modifications to an interior stud wall can now have serious implications to the exterior masonry support.
- A system's performance can now be a success or failure based upon the placement or deterioration of a single screw.

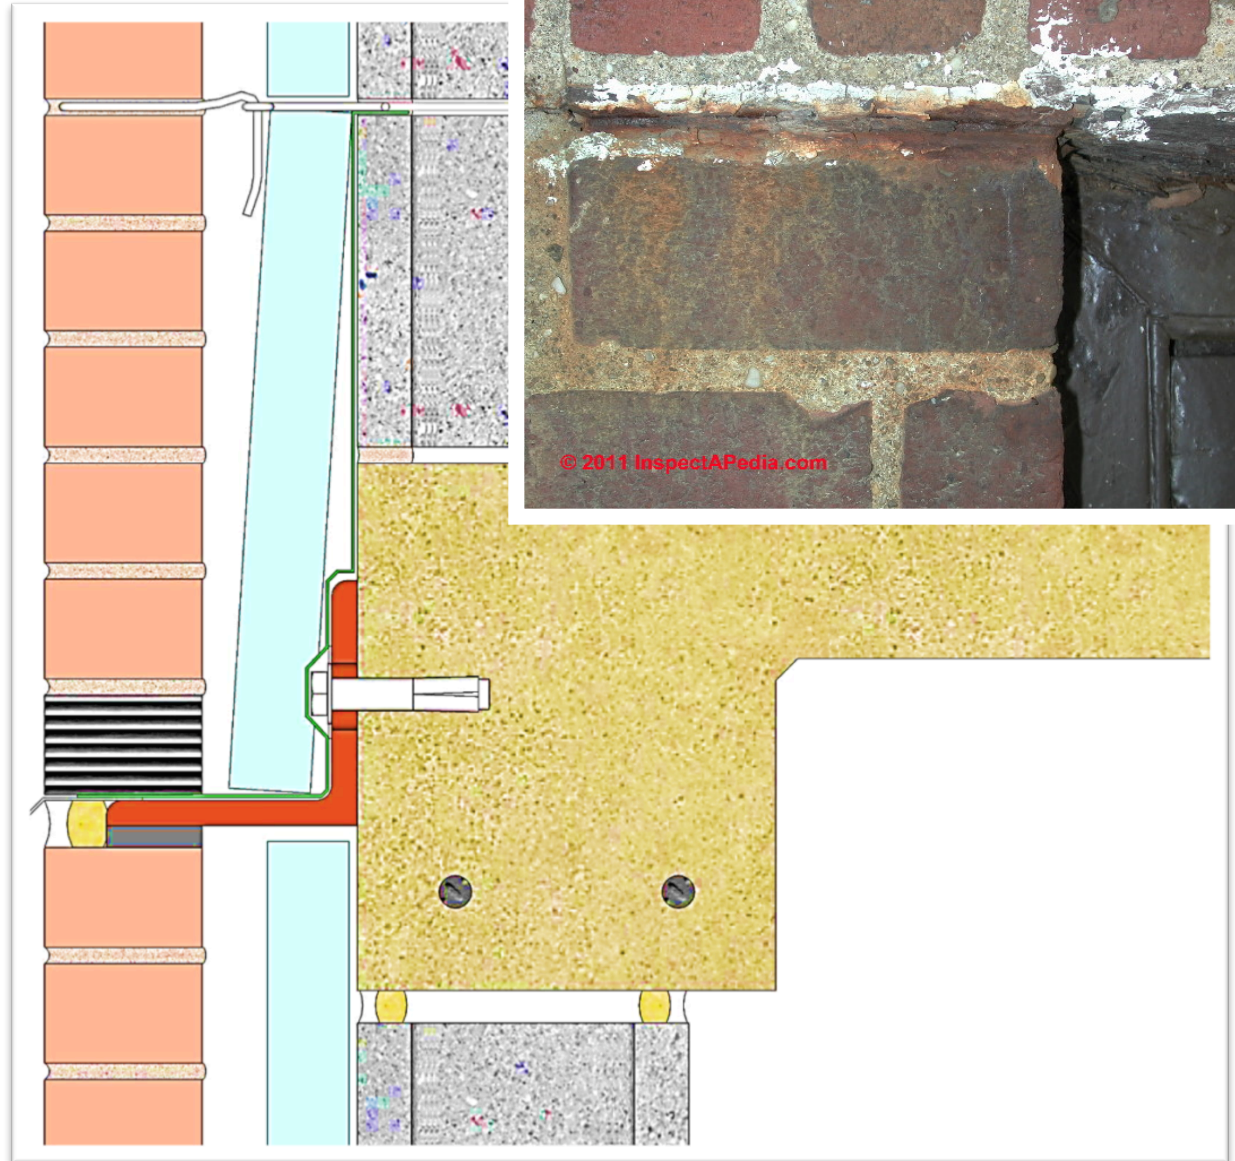
The Shelf Angle Weakness

- Failure to provide underside soft joint
- Failure to get moisture “all” the way out
- Rust jacking of shelf due to condensation or other moisture
- Differential shrinkage of concrete, block and brick
- Wire tie failure

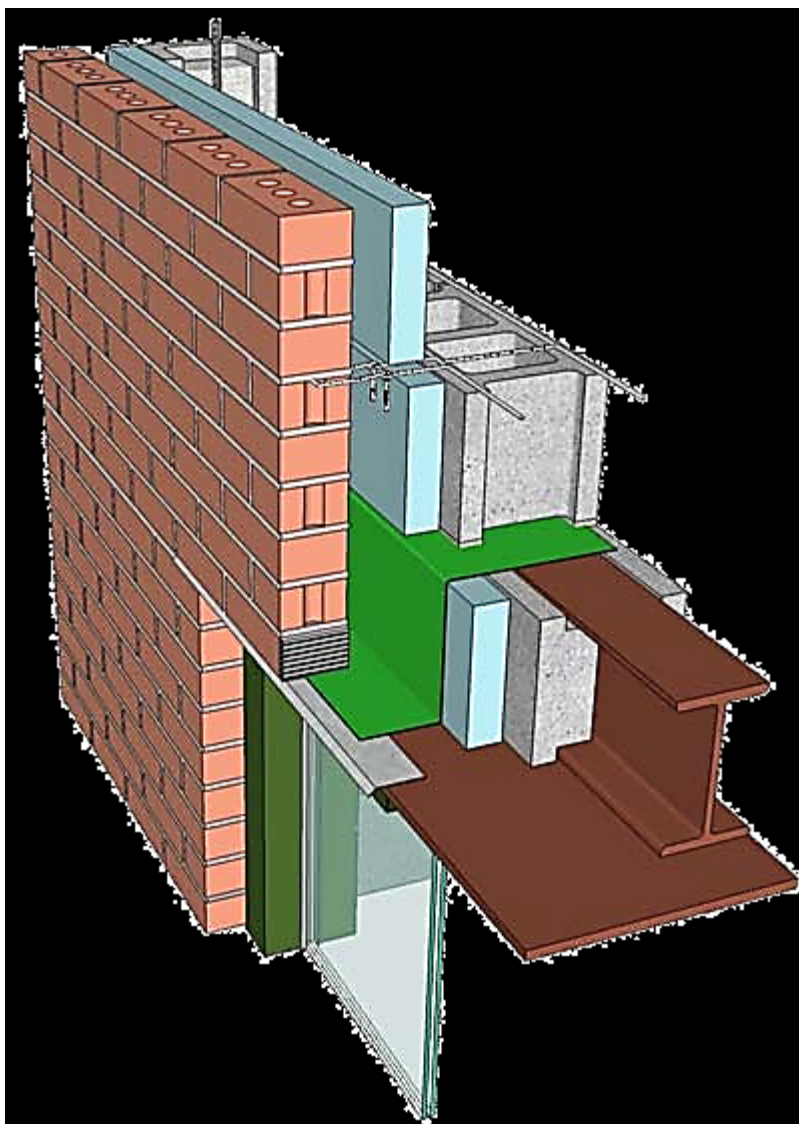
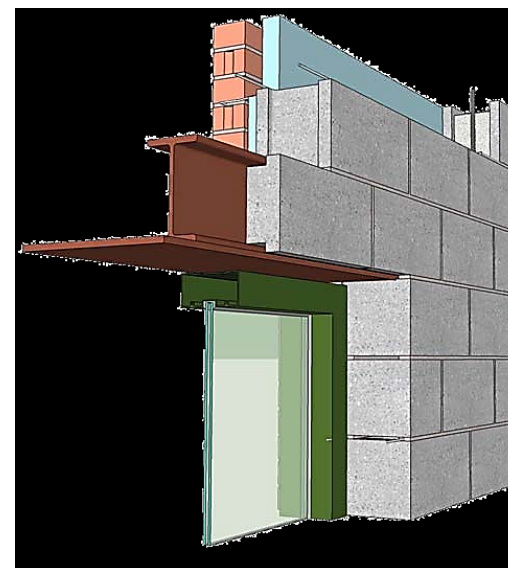
Hidden Lintel Conditions

- Extent of oxidation cannot be seen without investigation.
- Were the lintels installed as designed or could double angles have been used.
- How do you stop oxidation once it starts and budget its accurate repair?

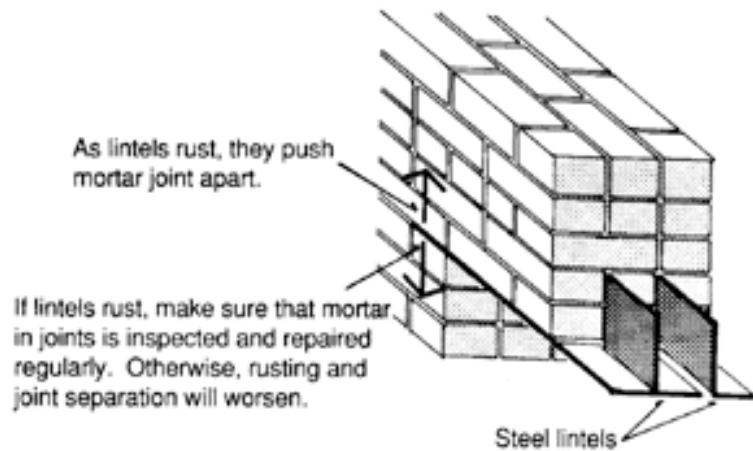
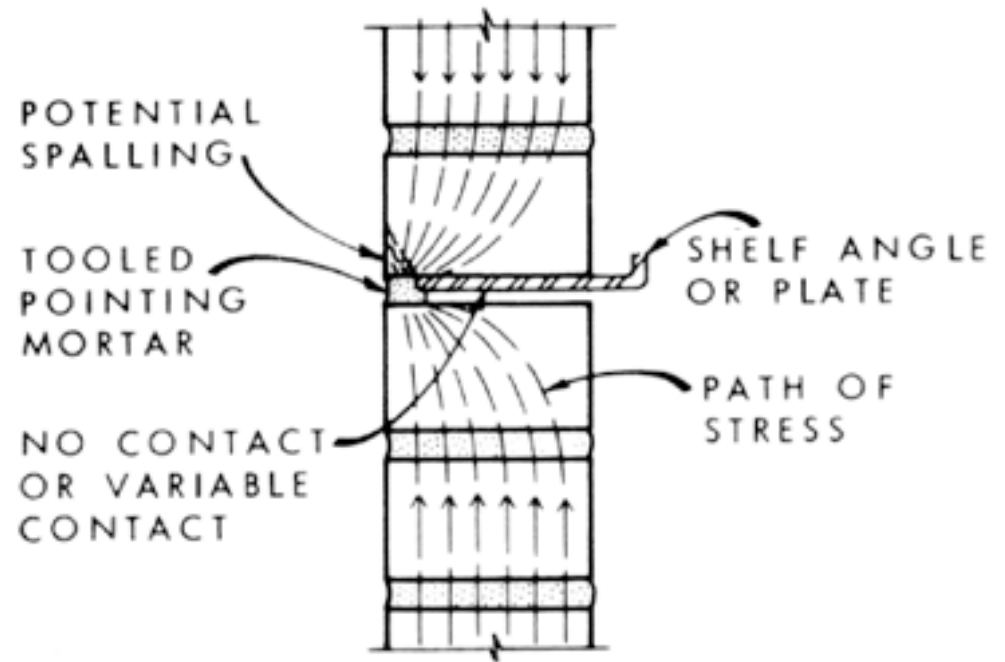
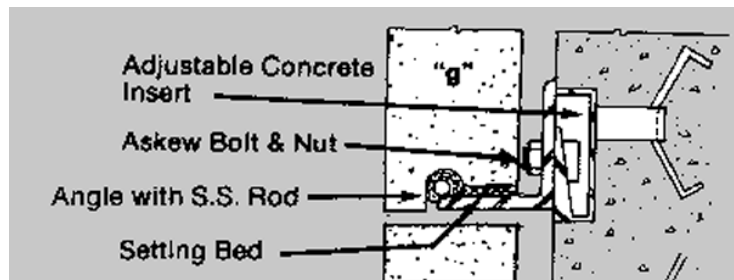
- Once deterioration starts, common “fix” is to caulk or point, sealing in more moisture.
- Patented systems will likely be even less understood by construction or maintenance personnel

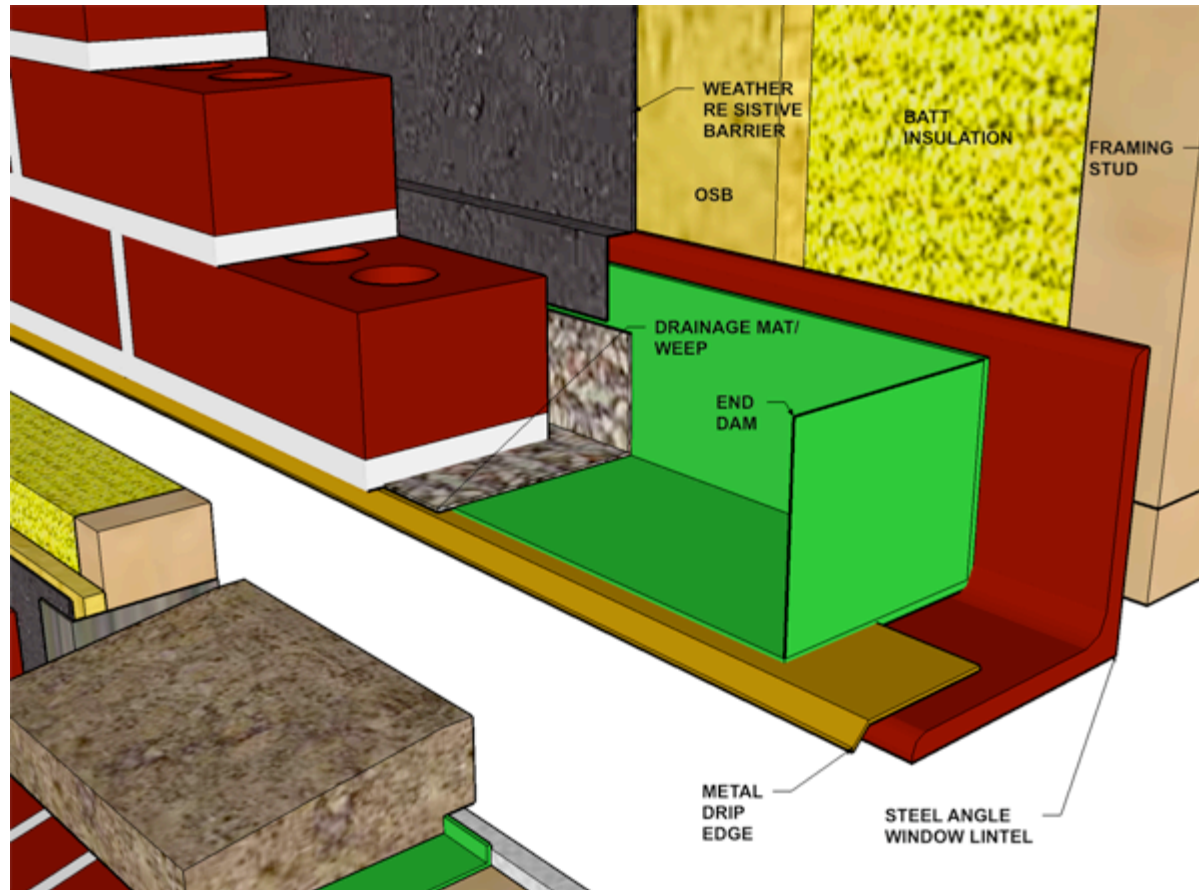
Mid-Century Challenges – End Dams

- On shelf angles
- At corners and offsets
- On window curtain walls
- On windows
- Critical to short and long term performance

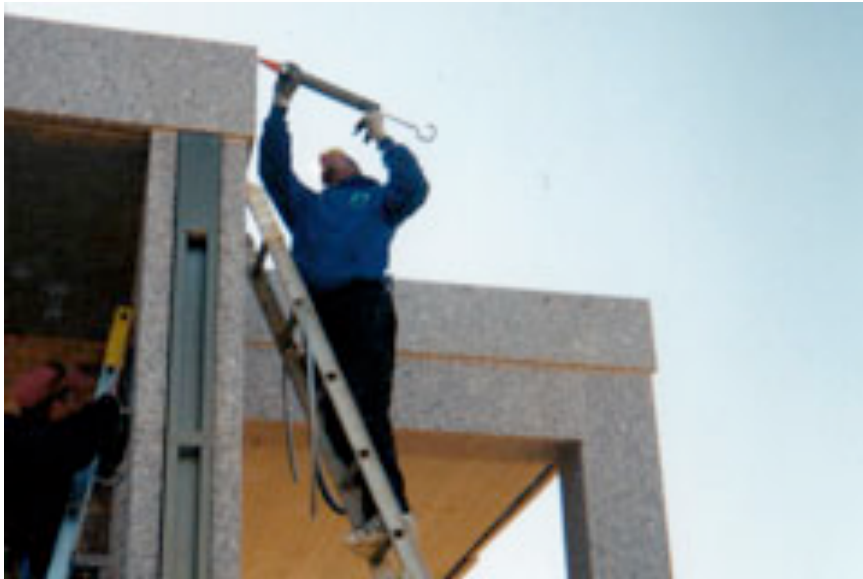
The Construction Material of the Mid-Century, and Beyond?

How did we build for centuries and keep water out of buildings without sealants?

This single product is misused, inappropriately installed and not maintained to create the most problems in mid-century buildings.

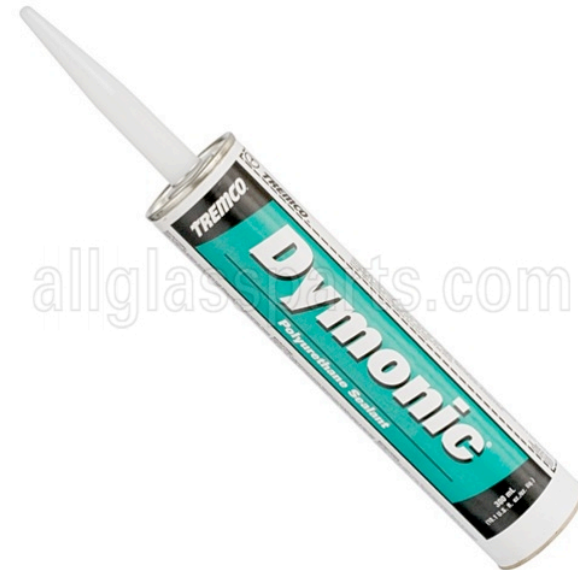
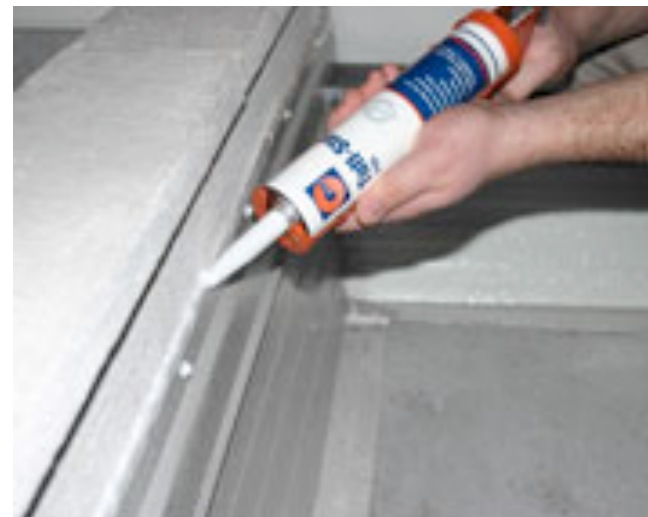
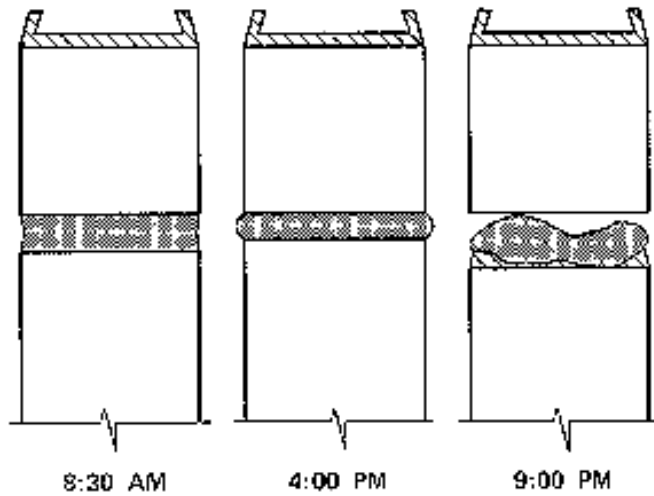
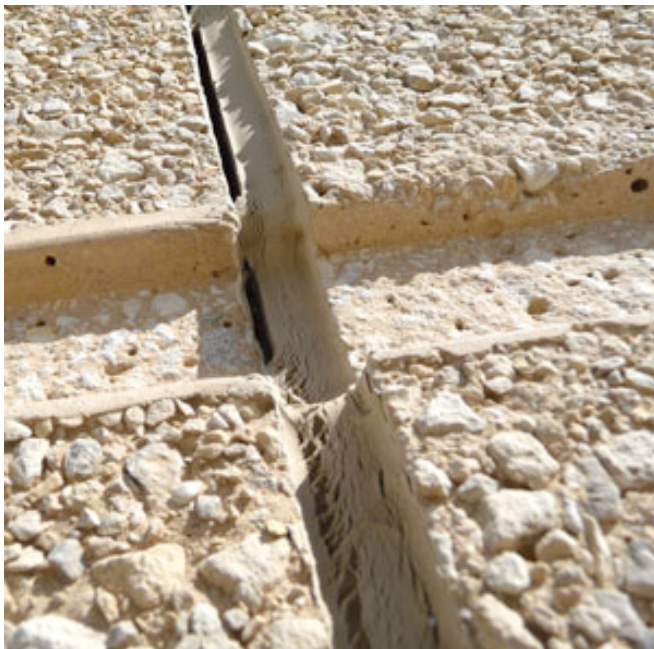
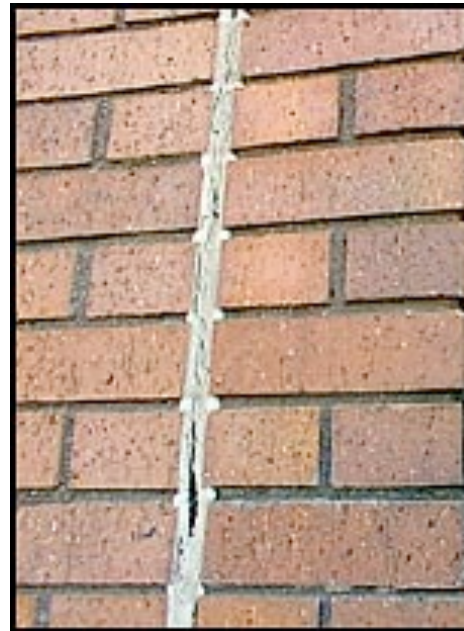
Importance of Sealant System Design

- Material compatibility
- System requirements for performance
- Maintenance requirements
- Implications of failure ... where's the water and air going?

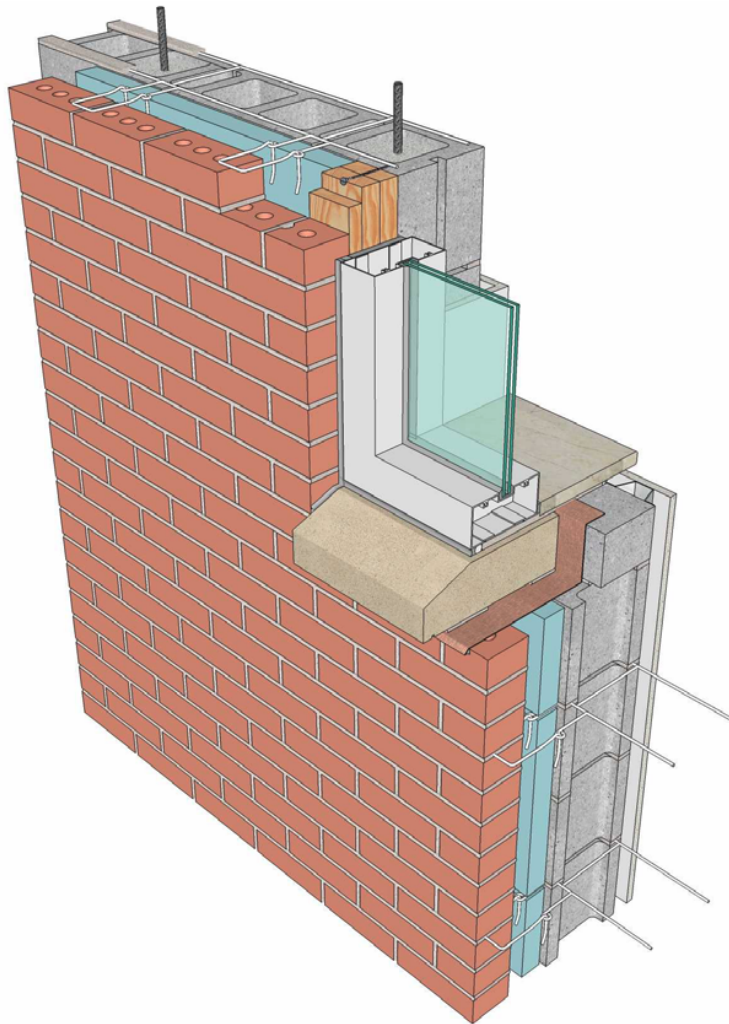
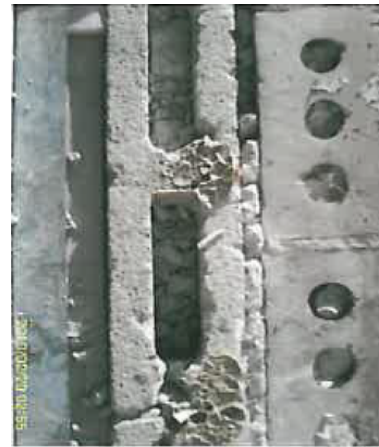
Case Study on Mid-Century Window Upgrade

- Need for better thermal performance
- Gasket failure / replacement
- Desire to match previous design of glass and spandrel panels

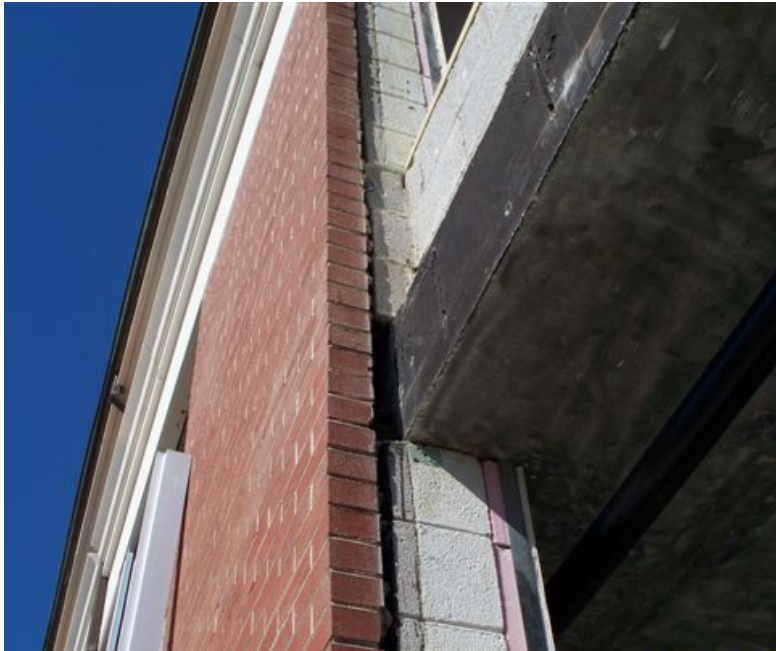
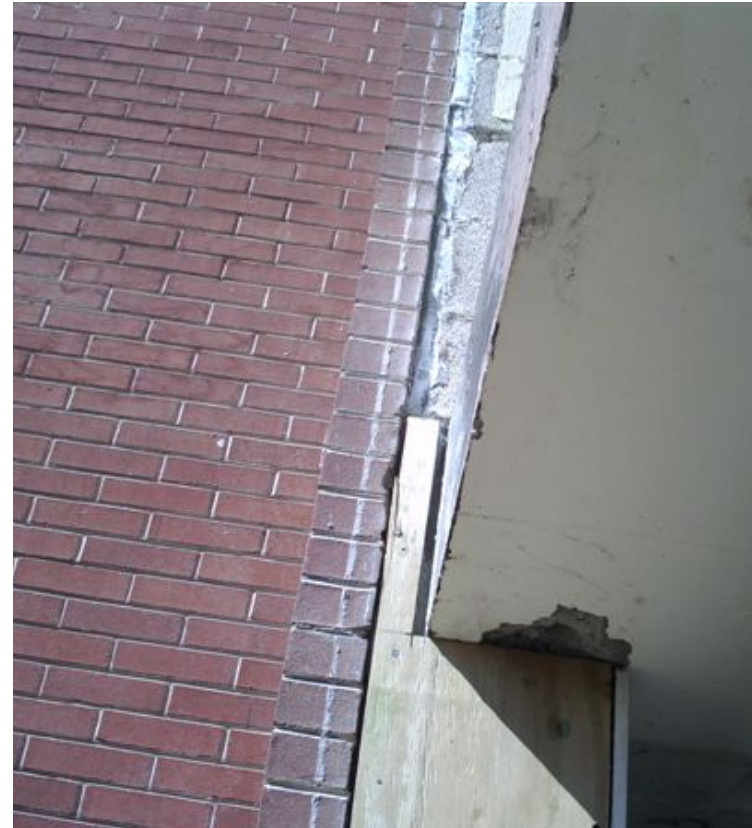
A “simple window replacement” opens many details ...

- Lack of a nailer to secure new design
- Width of system to cover previous sealant joint
- Fire stop floor to floor
- Connection / interface with previous moisture control systems

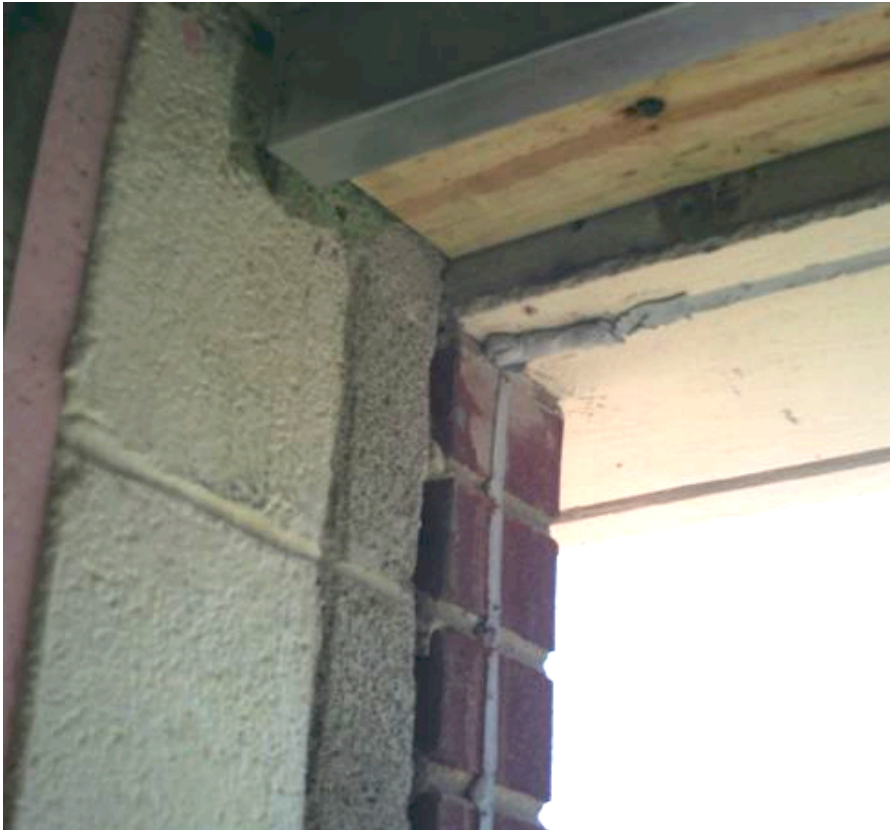
A “simple window replacement” opens many details ...

- Head offset discovery
- Existing sealants which would be near impossible to remove

The best opportunity for success is to:

- 1. Discover these issues early*
- 2. Engineer the solution as part of the bid*
