# ***Mid-Century Modern: The Challenges for a CM to Add Value***

**Ronald D. Staley, FAPT**  
Senior Vice President  
***The Christman Company***

## **Mid-20<sup>th</sup> Century Buildings Workshop**

*Facility Officers Conference/ Columbus, Ga./ 26 October 2011*

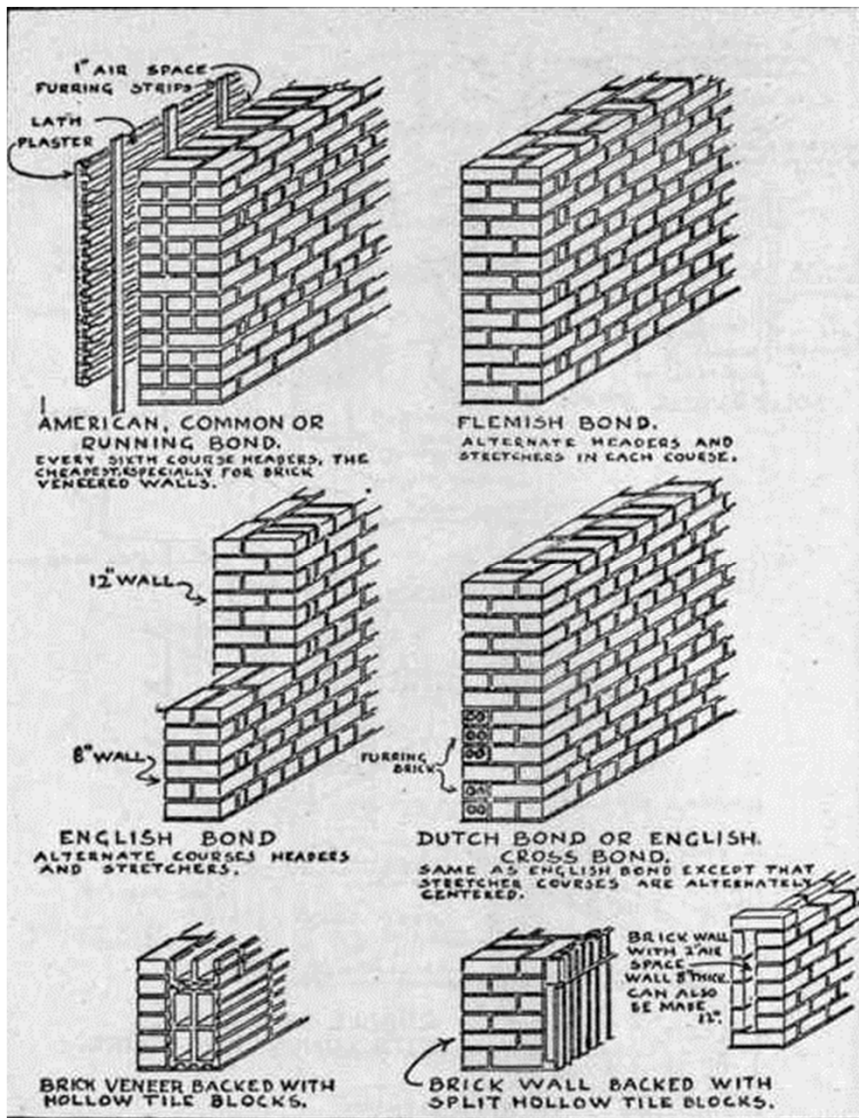
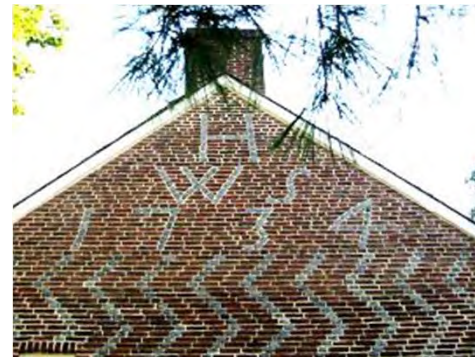
## “Traditional” Wall Design

- Understood allowance for movement and cross connection of wythes of masonry.
- Moisture is separated from inside to outside based upon material volume.
- Flexible mortar is self healing and eliminated the need for expansion joints.
- System is water tolerant.

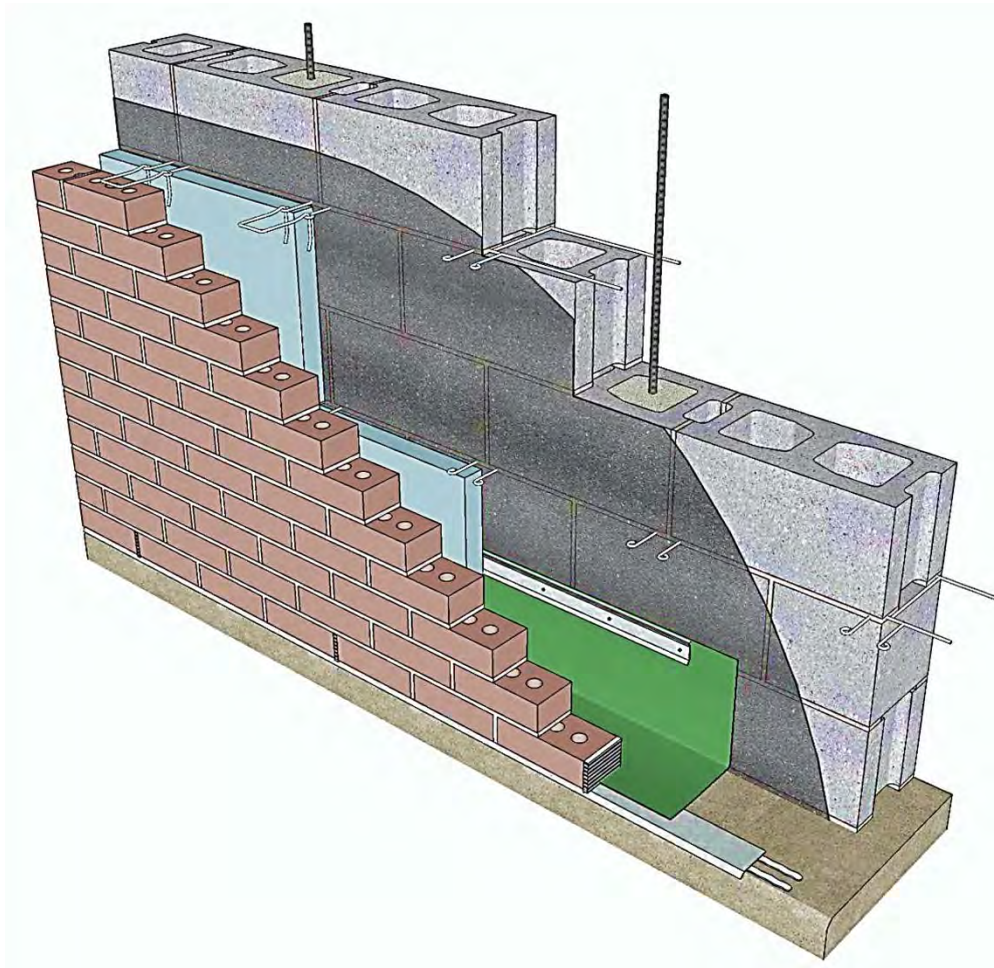
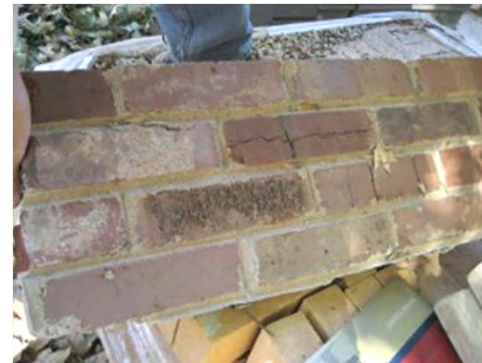
## Common Mid-Century Wall Details

- Rain screen masonry or panel system
- Materials with different coefficients of expansion
- Hard mortar that requires expansion joints
- Thin cross section connections subject to corrosion
- Detailed engineered system
- Death by water

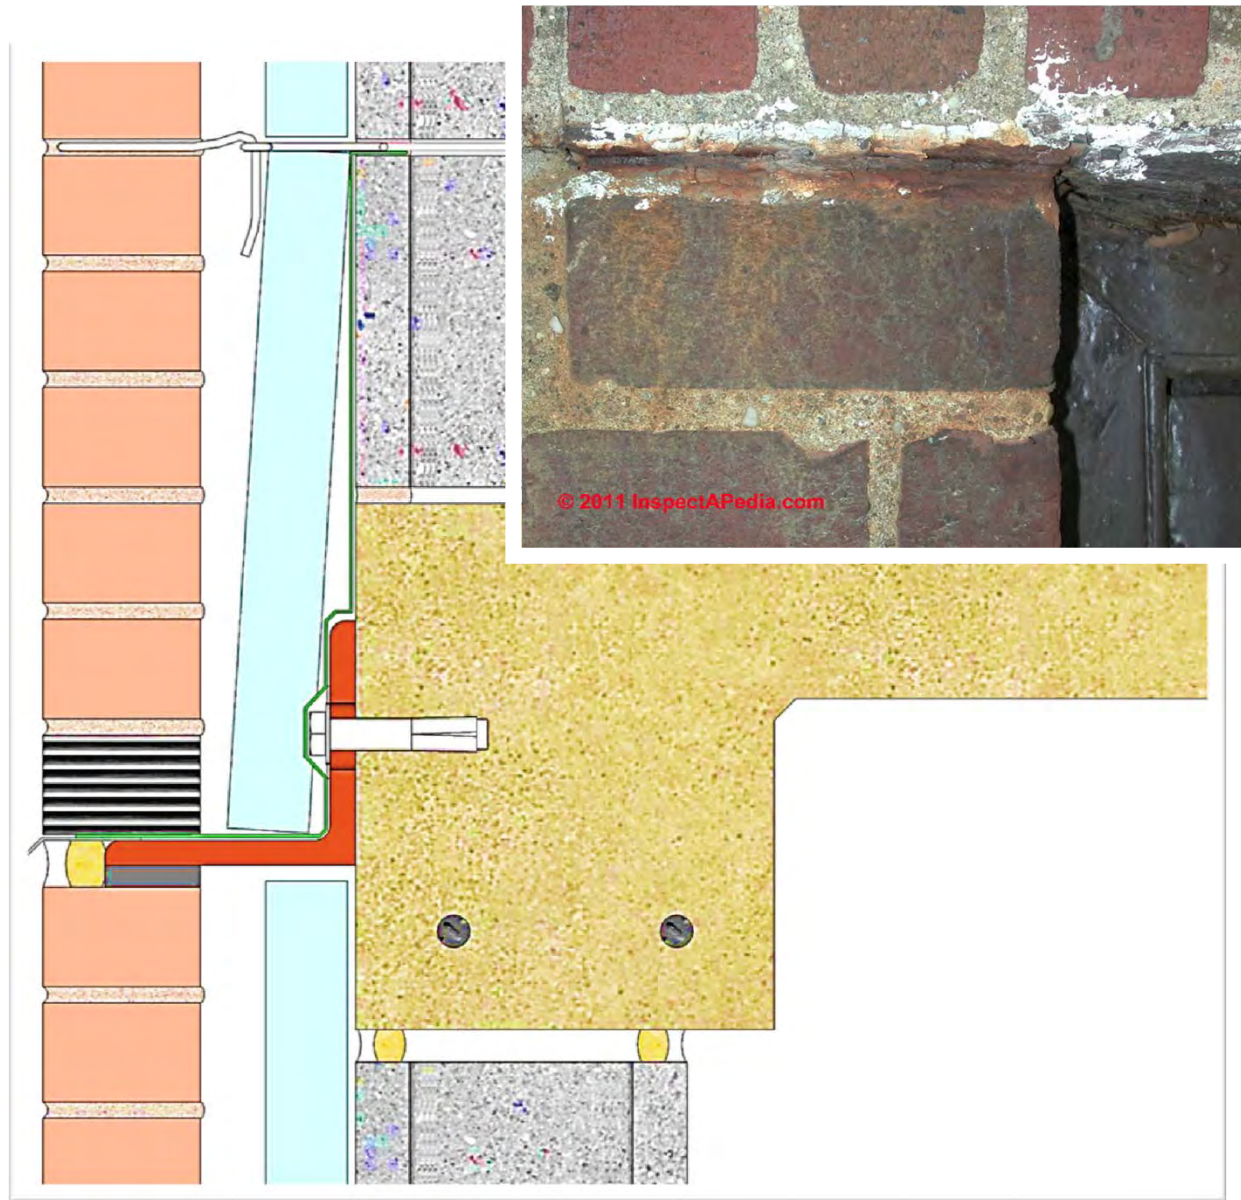
## The Shelf Angle Weakness

- Failure to provide underside soft joint
- Failure to get moisture “all” the way out
- Rust jacking of shelf due to condensation or other moisture
- Differential shrinkage of concrete, block and brick
- Wire tie failure

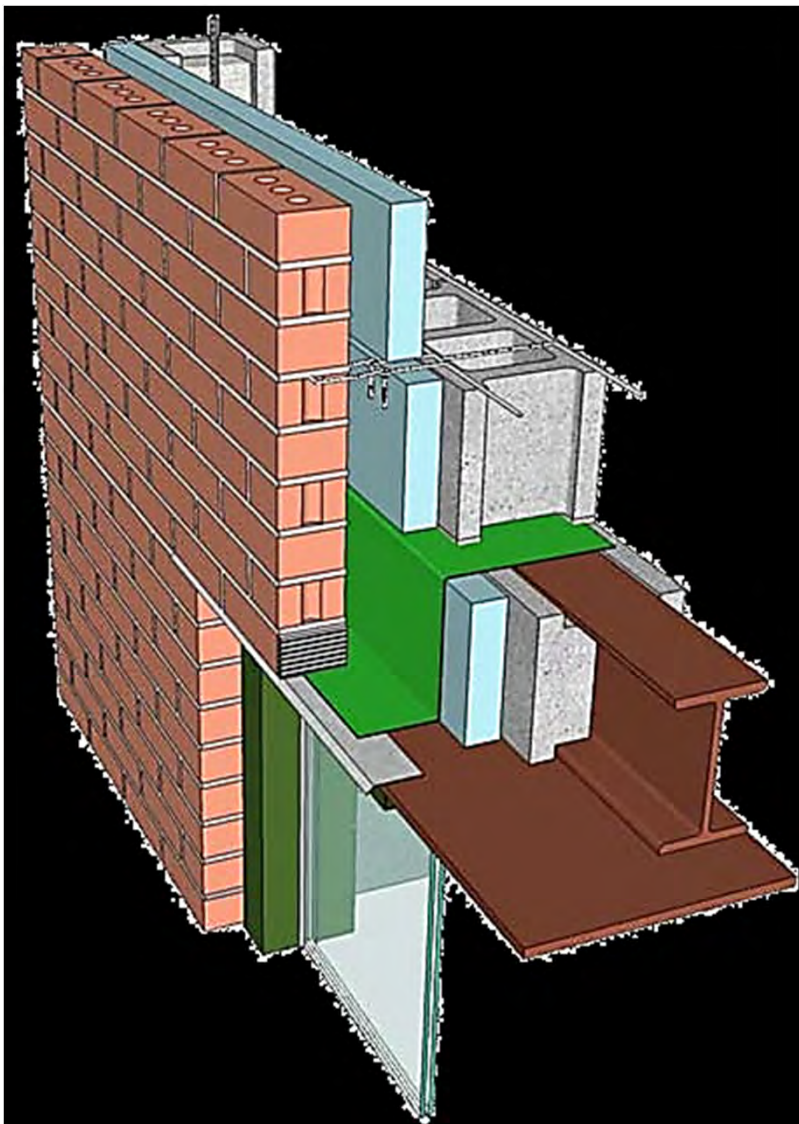
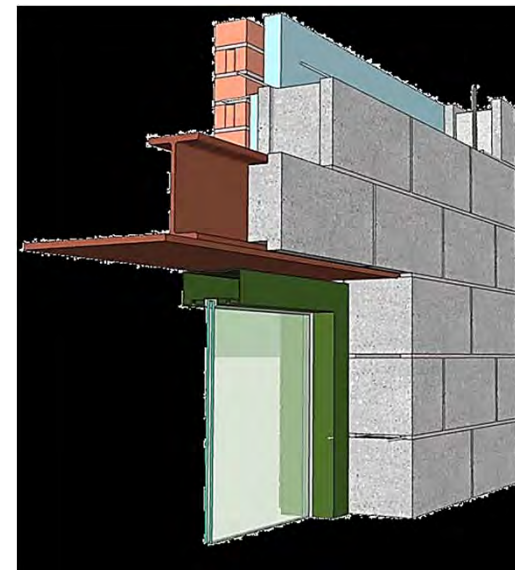
## Hidden Lintel Conditions

- Extent of oxidation cannot be seen without investigation.
- Were the lintels installed as designed or could double angles have been used.
- How do you stop oxidation once it starts and budget its accurate repair?

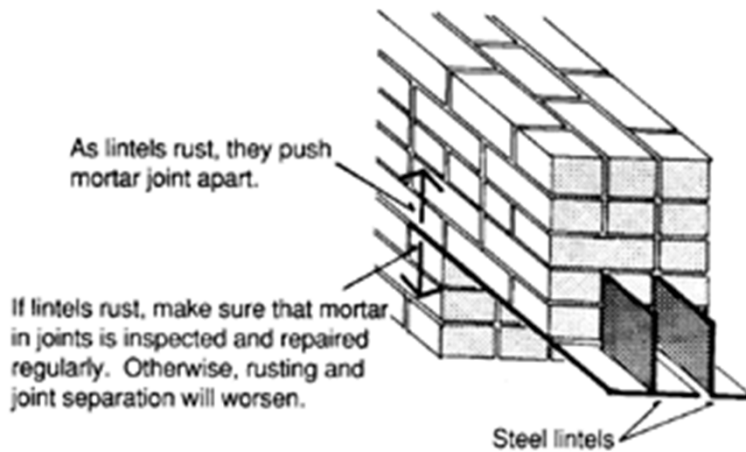
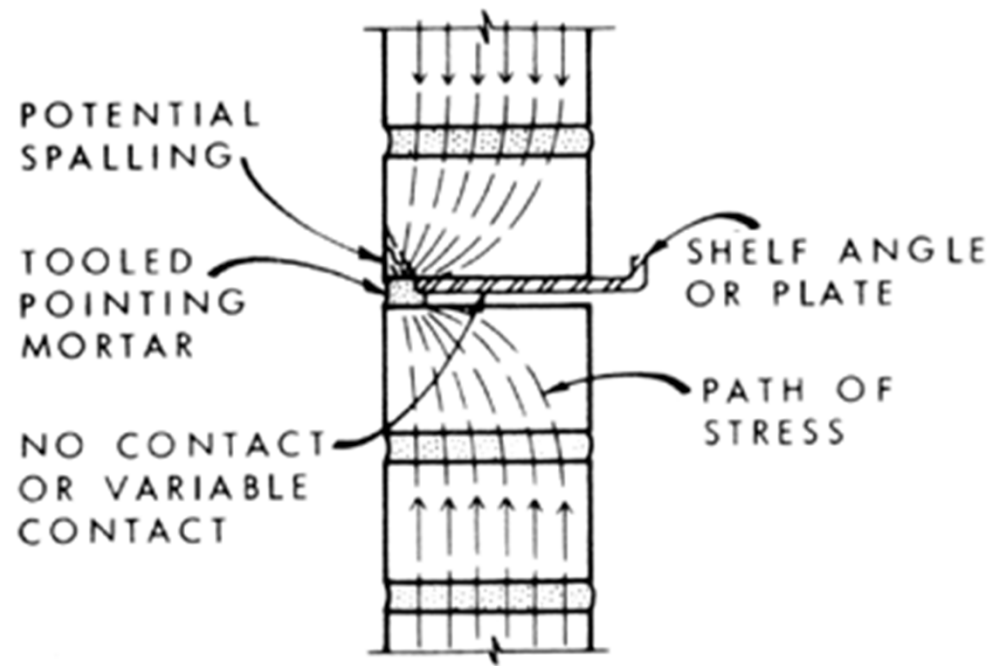
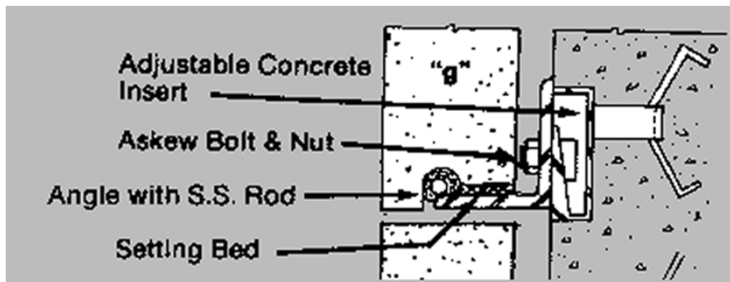
- Once deterioration starts, common “fix” is to caulk or point, sealing in more moisture.

- Patented systems will likely be even less understood by construction or maintenance personnel

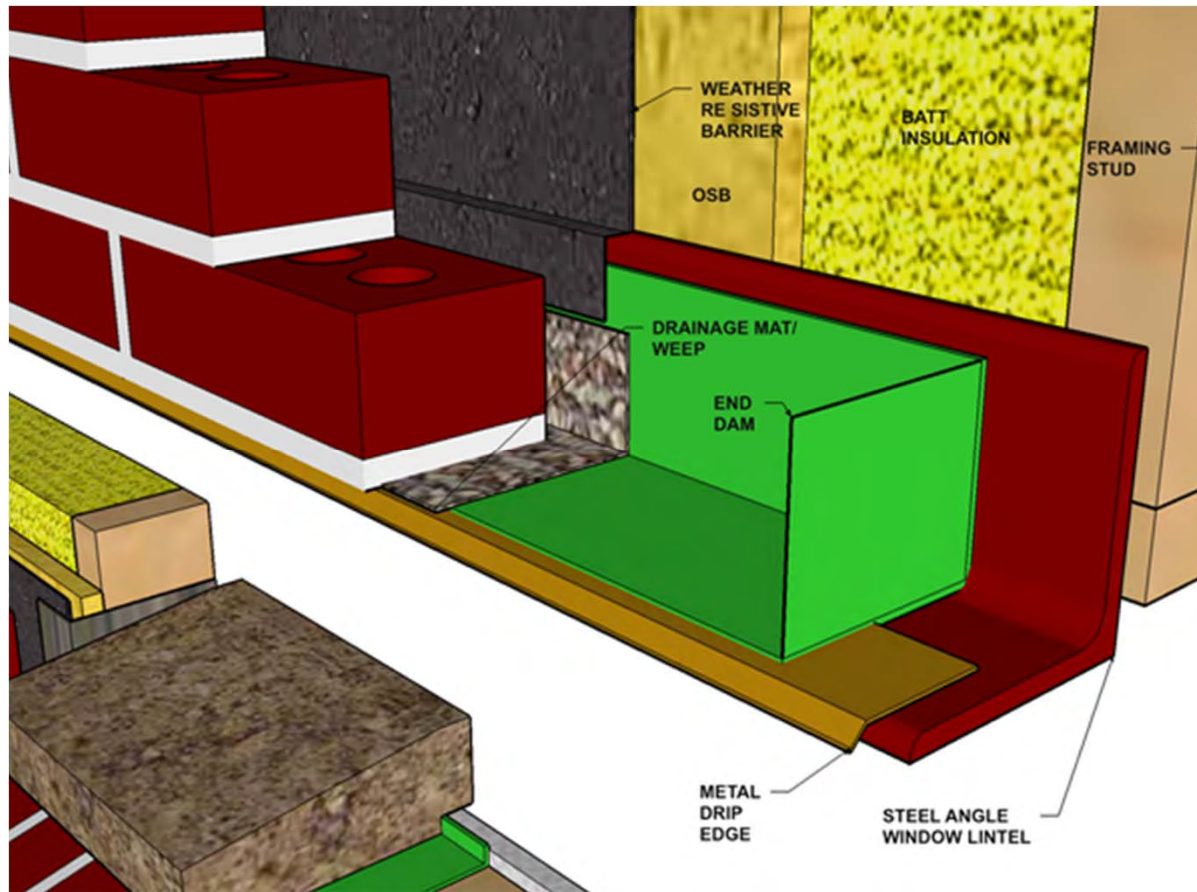
# Mid-Century Challenges – End Dams

- On shelf angles
- At corners and offsets
- On window curtain walls
- On windows
- Critical to short and long term performance

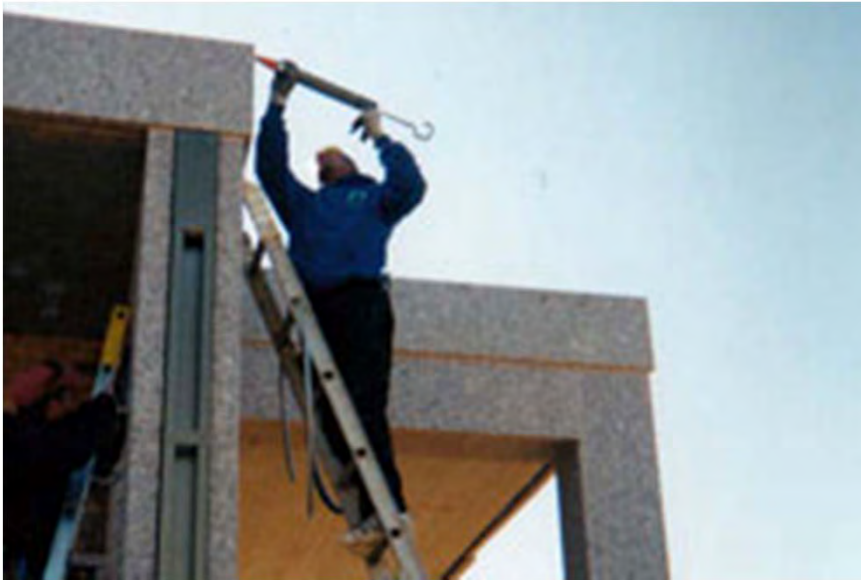
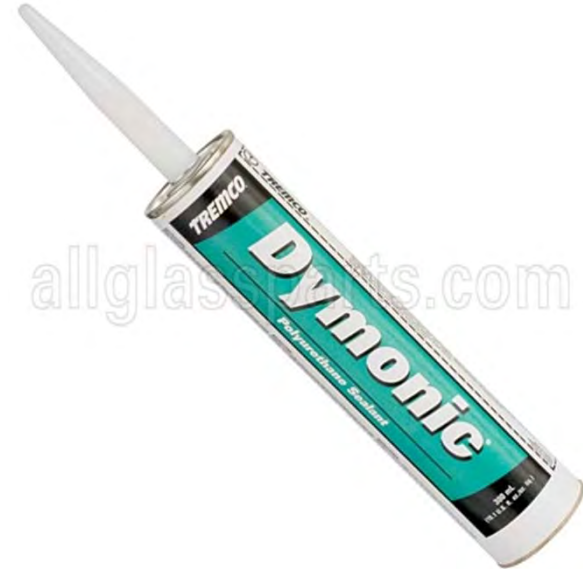
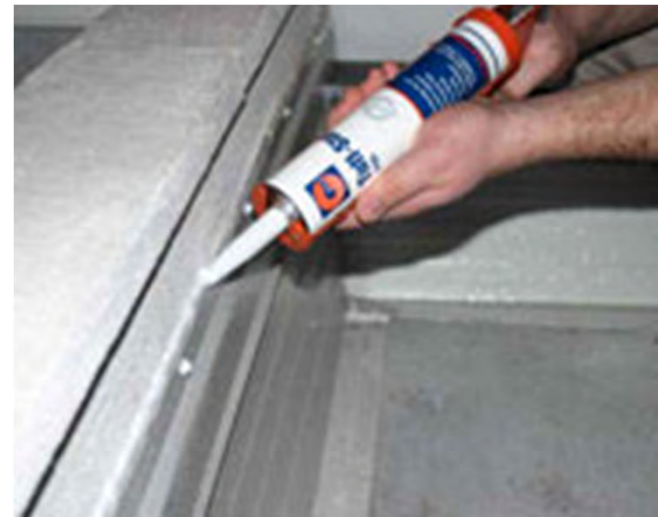
# The Construction Material of the Mid-Century, and Beyond?

How did we build for centuries and keep water out of buildings without sealants?

*This single product is misused, inappropriately installed and not maintained to create the most problems in mid-century buildings.*

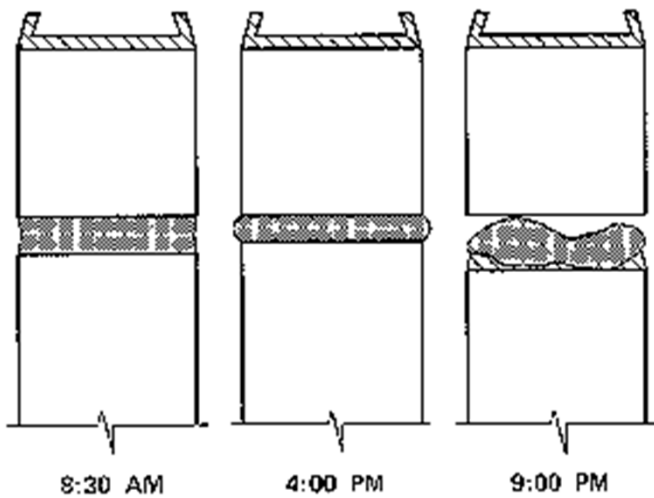
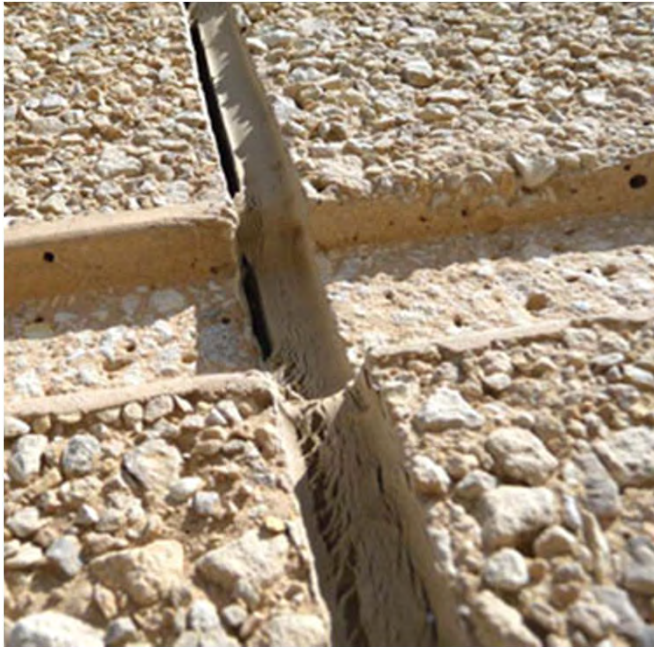
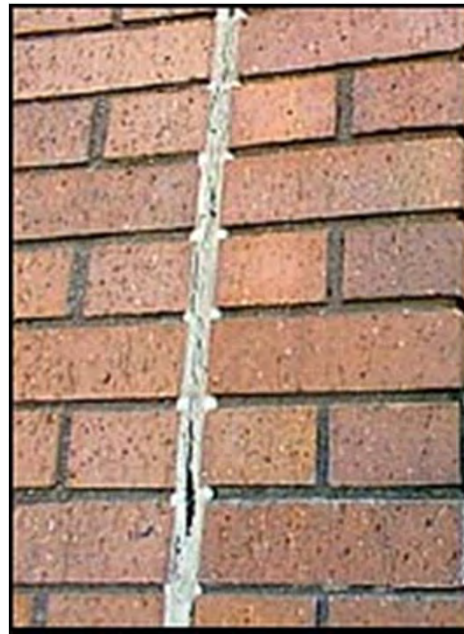
## Importance of Sealant System Design

- Material compatibility
- System requirements for performance
- Maintenance requirements
- Implications of failure ... where's the water and air going?

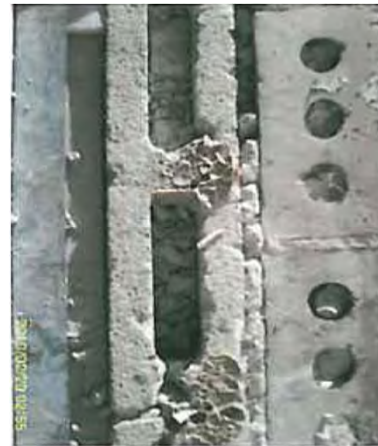
## Case Study on Mid-Century Window Upgrade

- Need for better thermal performance
- Gasket failure / replacement
- Desire to match previous design of glass and spandrel panels

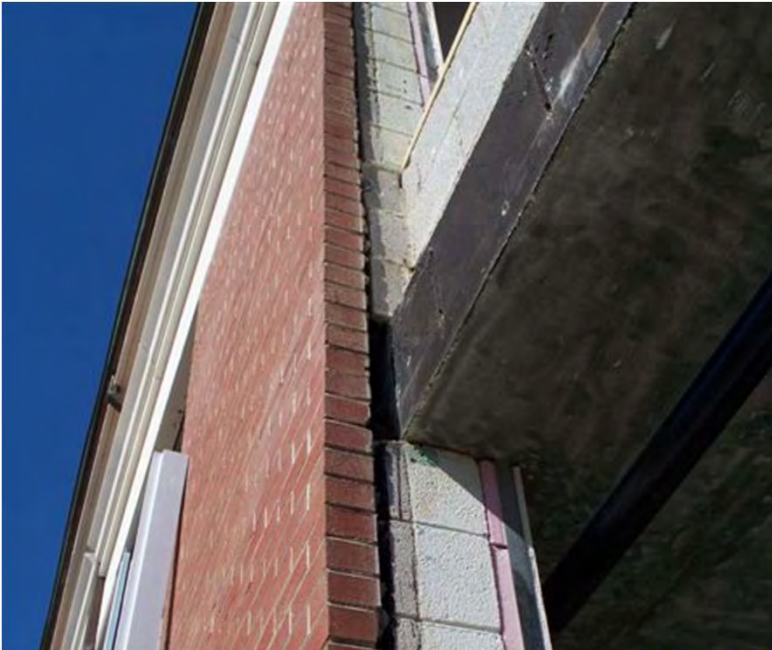
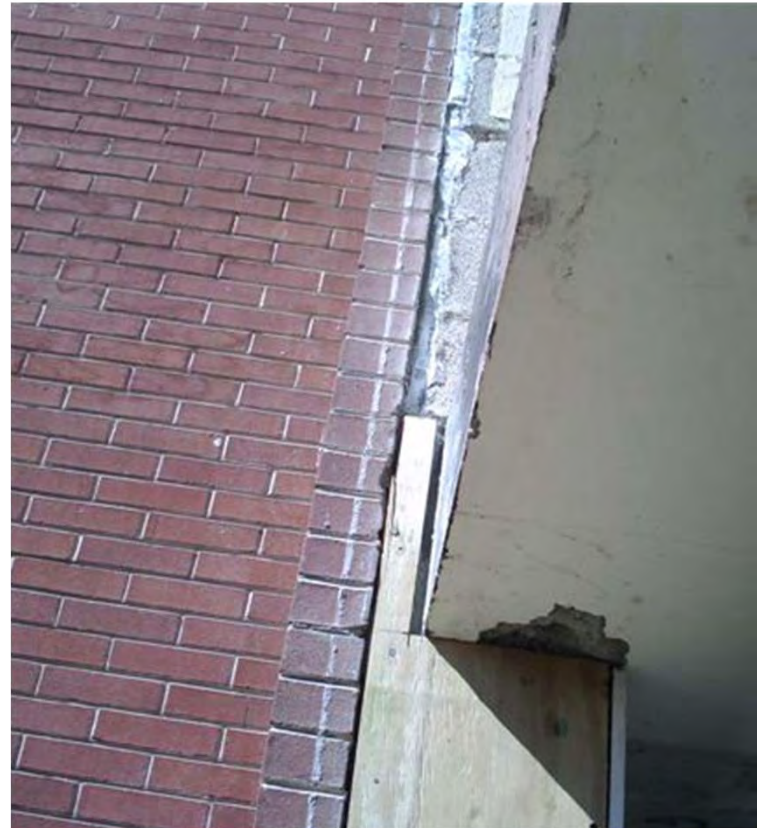
## A “simple window replacement” opens many details ...

- Lack of a nailer to secure new design
- Width of system to cover previous sealant joint
- Fire stop floor to floor
- Connection / interface with previous moisture control systems

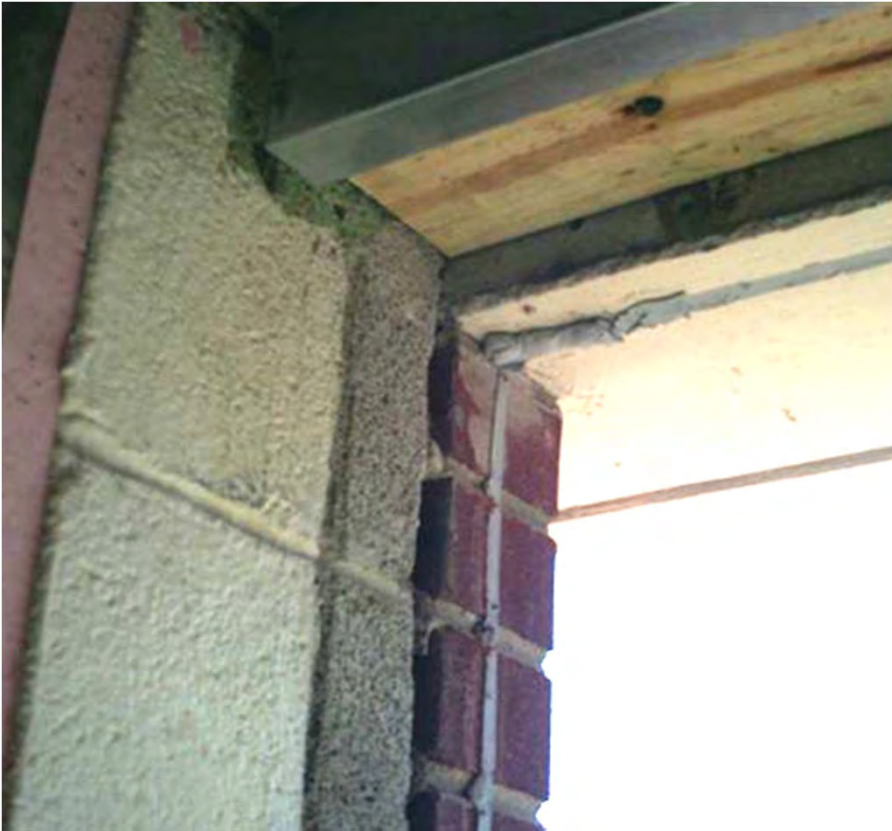
## A “simple window replacement” opens many details ...

- Head offset discovery
- Existing sealants which would be near impossible to remove

*The best opportunity for success is to:*

- 1. Discover these issues early*
- 2. Engineer the solution as part of the bid*
