PHASE I ENVIRONMENTAL SITE ASSESSMENT (ESA) & GEORGIA ENVIRONMENTAL POLICY ACT (GEPA) EVALUATION

NEW DORMITORY ON COMPASS POINT DRIVE PARKING LOT AND NEW PARKING LOT SITE ARMSTRONG ATLANTIC STATE UNIVERSITY SAVANNAH, GEORGIA

FEBRUARY 2009

EMC PROJECT NUMBER 08-3049

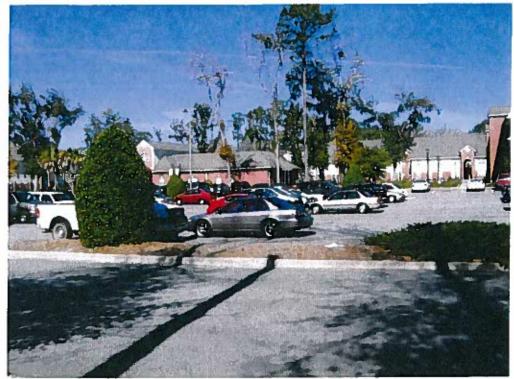
EMC PROJECT	DESCRIPTION	Proposed Dormitory Site Looking Towards the North	1
NO.	SITE NAME	New Dormitory and Parking Lot at Armstrong Atlantic State University	DATE
08-3049.31	CLIENT	University Housing Services for Freshman Housing Project	2/12/09

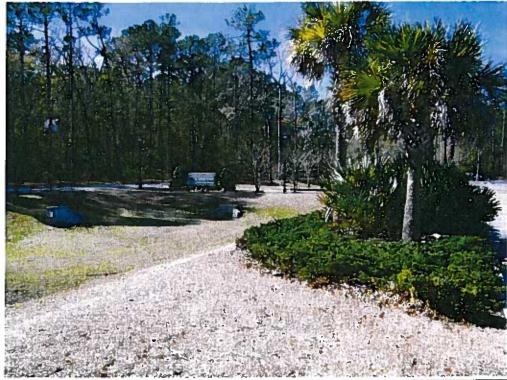
ŀ	 	Application of the second section of the section of the second section of the section of t		
	EMC PROJECT	DESCRIPTION	Proposed Dormitory Site Looking Towards the Southwest Across the Detention Pond Towards Compass Point Drive	2
	NO.	SITE NAME	New Dormitory and Parking Lot at Armstrong Atlantic State University	DATE
	08-3049.31	CLIENT	University Housing Services for Freshman Housing Project	2/12/09

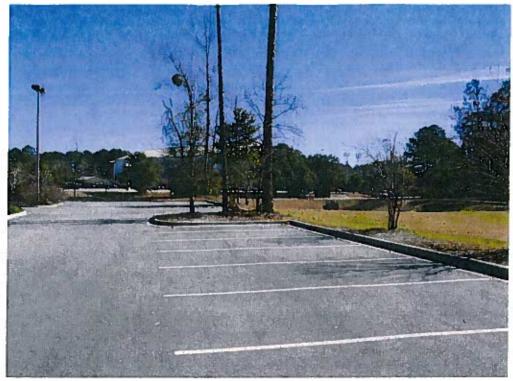
ľ	EMC PROJECT	DESCRIPTION	Proposed Dormitory Site Looking Towards the East	3
ı	NO.	SITE NAME	New Dormitory and Parking Lot at Armstrong Atlantic State University	DATE
	08-3049.31	CLIENT	University Housing Services for Freshman Housing Project	2/12/09

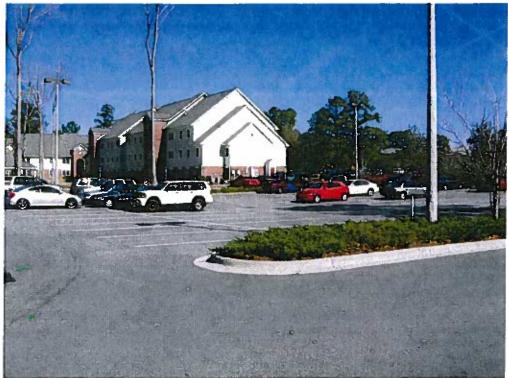
EMC PROJECT	DESCRIPTION	Proposed Dormitory Site Looking Towards the North Towards Existing Student Housing	4
NO.	SITE NAME	New Dormitory and Parking Lot at Armstrong Atlantic State University	DATE
08-3049.31	CLIENT	University Housing Services for Freshman Housing Project	2/12/09

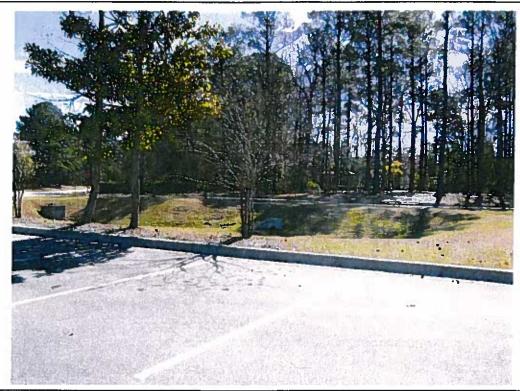
EMC PROJECT	DESCRIPTION	Proposed Dormitory Site Looking Across Detention Pond Towards the South	5
NO.	SITE NAME	New Dormitory and Parking Lot at Armstrong Atlantic State University	DATE
08-3049.31	CLIENT	University Housing Services for Freshman Housing Project	2/12/09

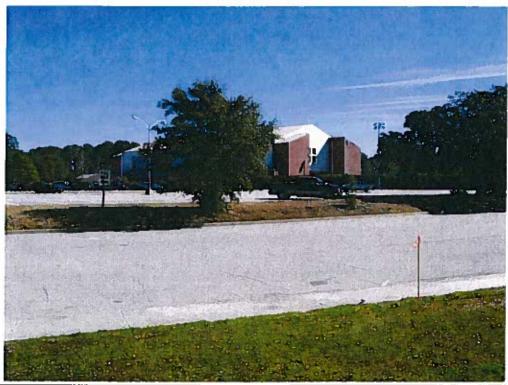
EMC PROJECT	DESCRIPTION	Proposed Dormitory Site Looking Across Science Drive Towards the East	6
NO.	SITE NAME	New Dormitory and Parking Lot at Armstrong Atlantic State University	DATE
08-3049.31	CLIENT	University Housing Services for Freshman Housing Project	2/12/09

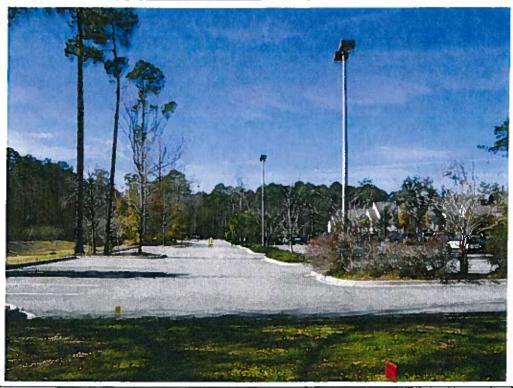
EMC PROJECT	DESCRIPTION	Proposed Dormitory Site Looking From Science Drive Towards the West	7
NO.	SITE NAME	New Dormitory and Parking Lot at Armstrong Atlantic State University	DATE
08-3049.31	CLIENT	University Housing Services for Freshman Housing Project	2/12/09

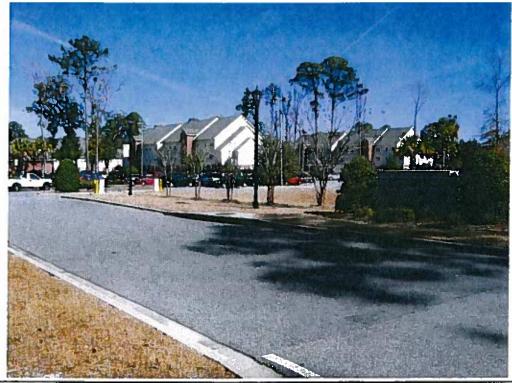
EMC PROJECT NO.	DESCRIPTION	Proposed Dormitory Site Looking From the Compass Point Drive Entrance	8
NO.	SITE NAME	New Dormitory and Parking Lot at Armstrong Atlantic State University	DATE
08-3049.31	CLIENT	University Housing Services for Freshman Housing Project	1/12/09

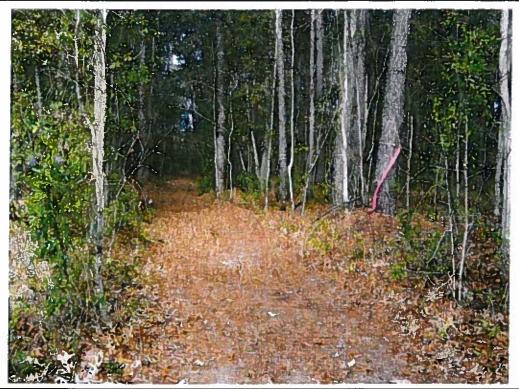
EMC PROJECT	DESCRIPTION	Trail on the west side of the wooded parking area site	9
NO.	SITE NAME	New Dormitory and Parking Lot at Armstrong Atlantic State University	DATE
08-3049.31	CLIENT	University Housing Services for Freshman Housing Project	1/12/09

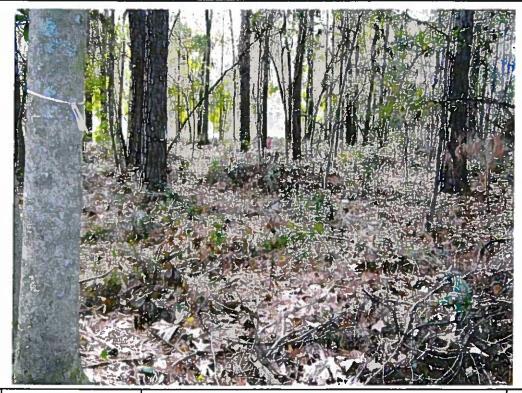
EMC PROJECT NO.
08-3049.31

DESCRIPTION	Wooded parking area site	10
SITE NAME	New Dormitory and Parking Lot at Armstrong Atlantic State University	DATE
CLIENT	University Housing Services for Freshman Housing Project	1/12/09

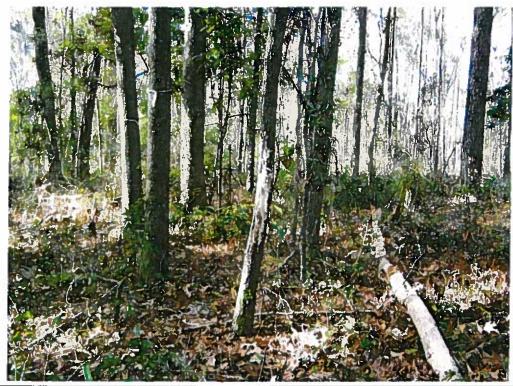
EMC PROJECT	DESCRIPTION	Wooded parking area site	11
NO.	SITE NAME	New Dormitory and Parking Lot at Armstrong Atlantic State University	DATE
08-3049.31	CLIENT	University Housing Services for Freshman Housing Project	1/12/09

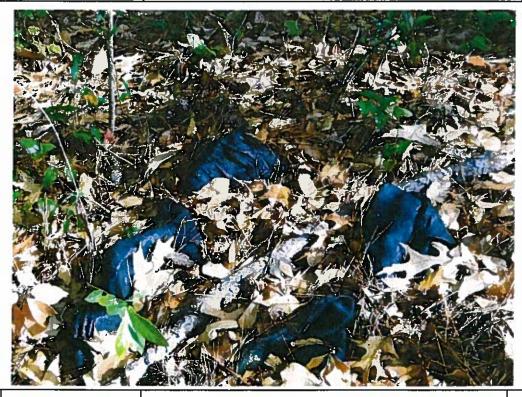
DESCRIPTION	Buried debris in wooded parking area site	12
SITE NAME	New Dormitory and Parking Lot at Armstrong Atlantic State University	DATE
CLIENT	University Housing Services for Freshman Housing Project	1/12/09

The subject property was inspected for evidence of solid waste disposal, e.g. hummocky ground or surface debris. Hummocky ground was observed on the proposed parking lot site but buried debris is not suspected to be on the site.

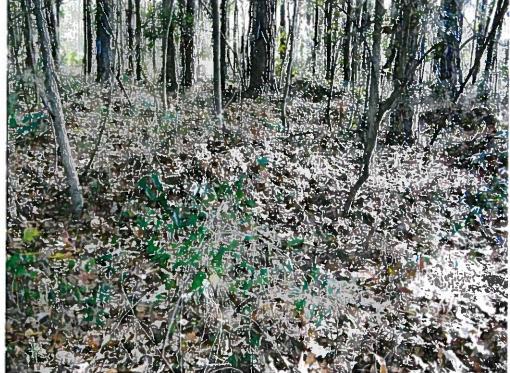
DESCRIPTION	Hummocky ground at wooded parking area site	14
SITE NAME	New Dormitory and Parking Lot at Armstrong Atlantic State University	DATE
CLIENT	University Housing Services for Freshman Housing Project	1/12/09

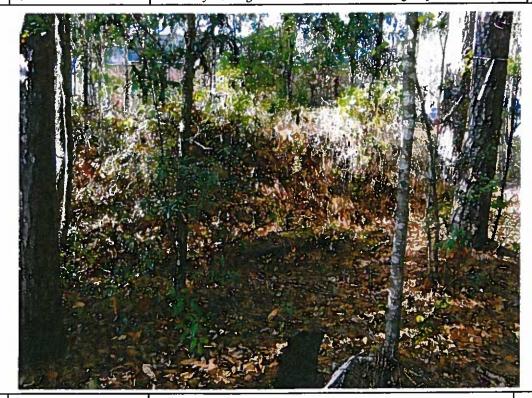
DESCRIPTION	Hummocky ground in wooded parking area site	16
SITE NAME	New Dormitory and Parking Lot at Armstrong Atlantic State University	DATE 1/12/09

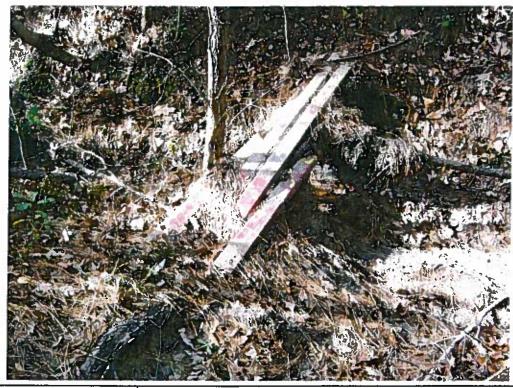
EMC PROJECT	DESCRIPTION	Ditch on west side of wooded parking area site	17
NO.	SITE NAME	New Dormitory and Parking Lot at Armstrong Atlantic State University	DATE
08-3049.31	CLIENT	University Housing Services for Freshman Housing Project	1/12/09

The proposed parking lot site was visited on January 12, 2009. The entire site is wooded. Several low mounds covered with pine needles were observed on the site. Some silt fencing and a shallow ditch were also observed on the site. We do not suspect there is buried debris on the site.

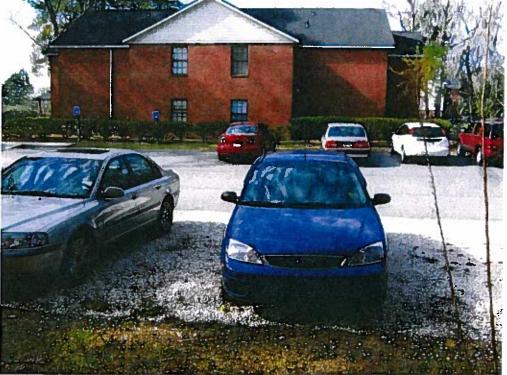
The state of the s			
EMC PROJECT	DESCRIPTION	University Terrace Apartments west of wooded parking area site	18
NO.	SITE NAME	New Dormitory and Parking Lot at Armstrong Atlantic State University	DATE
08-3049.31	CLIENT	University Housing Services for Freshman Housing Project	1/12/09

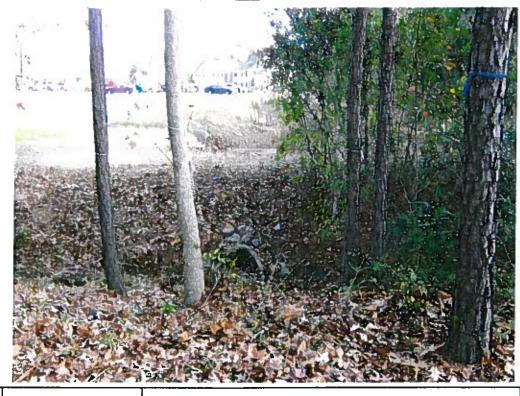
EMC PROJECT	DESCRIPTION	North side of wooded parking area site	19
NO.	SITE NAME	New Dormitory and Parking Lot at Armstrong Atlantic State University	DATE
08-3049.31	CLIENT	University Housing Services for Freshman Housing Project	1/12/09

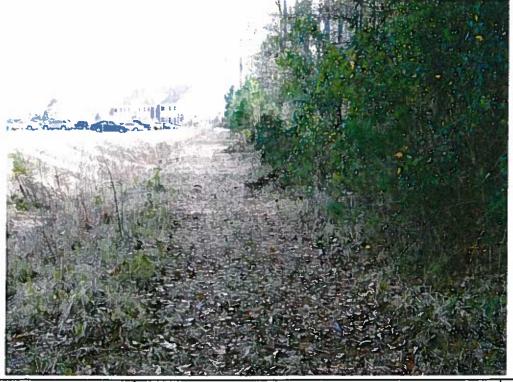
EMC PROJECT	DESCRIPTION	Trail on north side of wooded parking area site	20
NO.	SITE NAME	New Dormitory and Parking Lot at Armstrong Atlantic State University	DATE
08-3049.31	CLIENT	University Housing Services for Freshman Housing Project	I/12/09

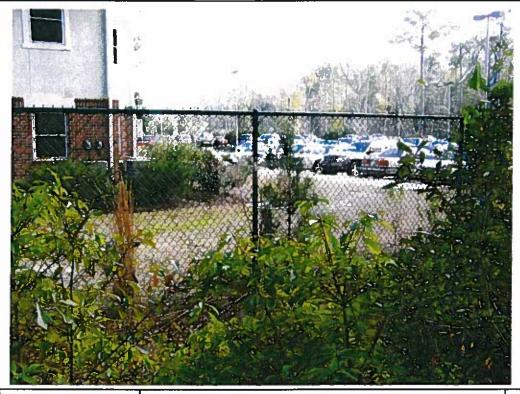
EMC PROJECT NO.
08-3049.31

DESCRIPTION	Apartments east of wooded parking area site	22
SITE NAME	New Dormitory and Parking Lot at Armstrong Atlantic State University	DATE
CLIENT	University Housing Services for Freshman Housing Project	1/12/09

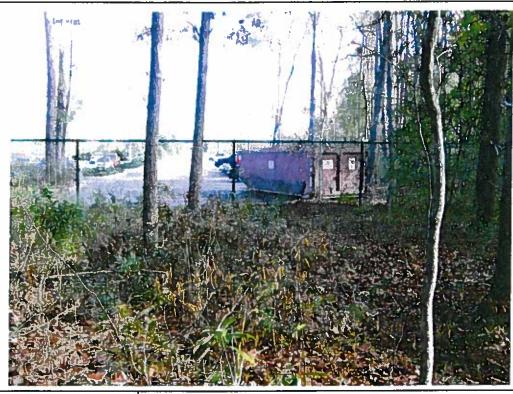
EMC PROJECT NO.	DESCRIPTION	Parking area and dumpster east of the wooded parking area site	23
	SITE NAME	New Dormitory and Parking Lot at Armstrong Atlantic State University	DATE
08-3049.31	CLIENT	University Housing Services for Freshman Housing Project	1/12/09

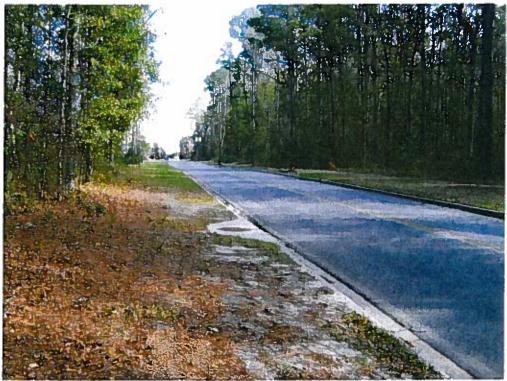
EMC PROJECT	DESCRIPTION	Looking SE along Compass Point Dr. at wooded parking area site	24		
NO.	SITE NAME	New Dormitory and Parking Lot at Armstrong Atlantic State University	DATE 1/12/09		
08-3049.31	CLIENT	University Housing Services for Freshman Housing Project
