**REPORT OF PHASE I  
ENVIRONMENTAL SITE ASSESSMENT  
AND GEPA EVALUATION**

**ABRAHAM BALDWIN AGRICULTURAL  
COLLEGE  
STUDENT HOUSING PROJECT (SITE "A")**

**TIFTON, GEORGIA**

**TTL Project No. 060705251**

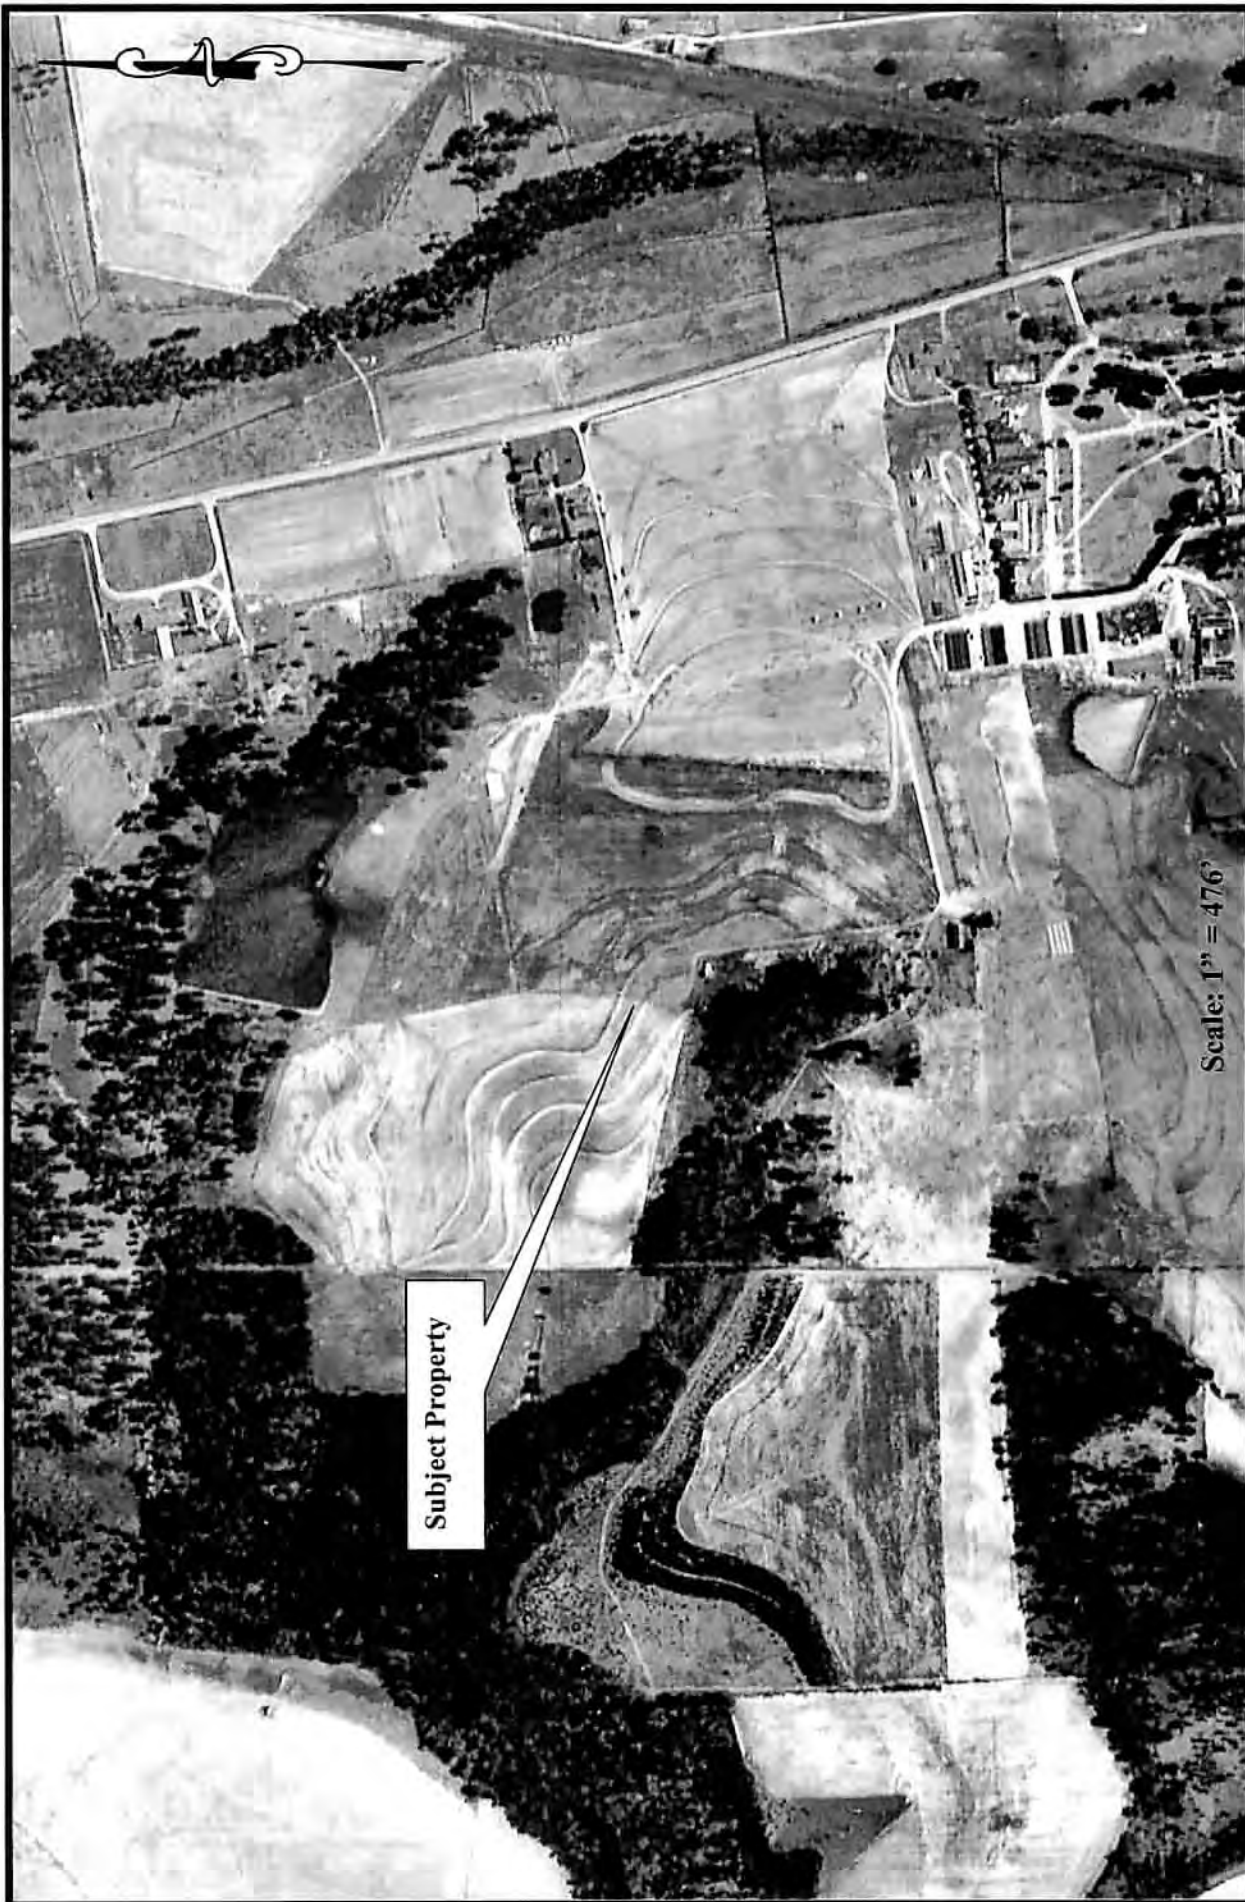
Figure 3  
1937 Aerial Photograph  
ABAC – Student Housing Project (Site "A")  
Tifton, Georgia  
TTL Project No.: 060705251

TTL reviewed aerial photographs of the subject property and surrounding area dated 1937, 1948, 1962, 1969, 1972, 1988 and 1993 (Appendix I, Figures 3 through 7). Based on the 1937 to 1972 aerial photographs the subject property appears to be an undeveloped grassed field with no apparent structures. The 1988 and 1993 aerial photographs depict the subject property as it generally appears today. According to the 1969 and 1972 aerial photographs, a dirt path or road ran through the center portion of the site. The pavilion currently located at the northwest end of the site appears to have been constructed prior to 1988. Based on this review of the aerial photographs, no evidence of environmental concerns was noted on the subject property.

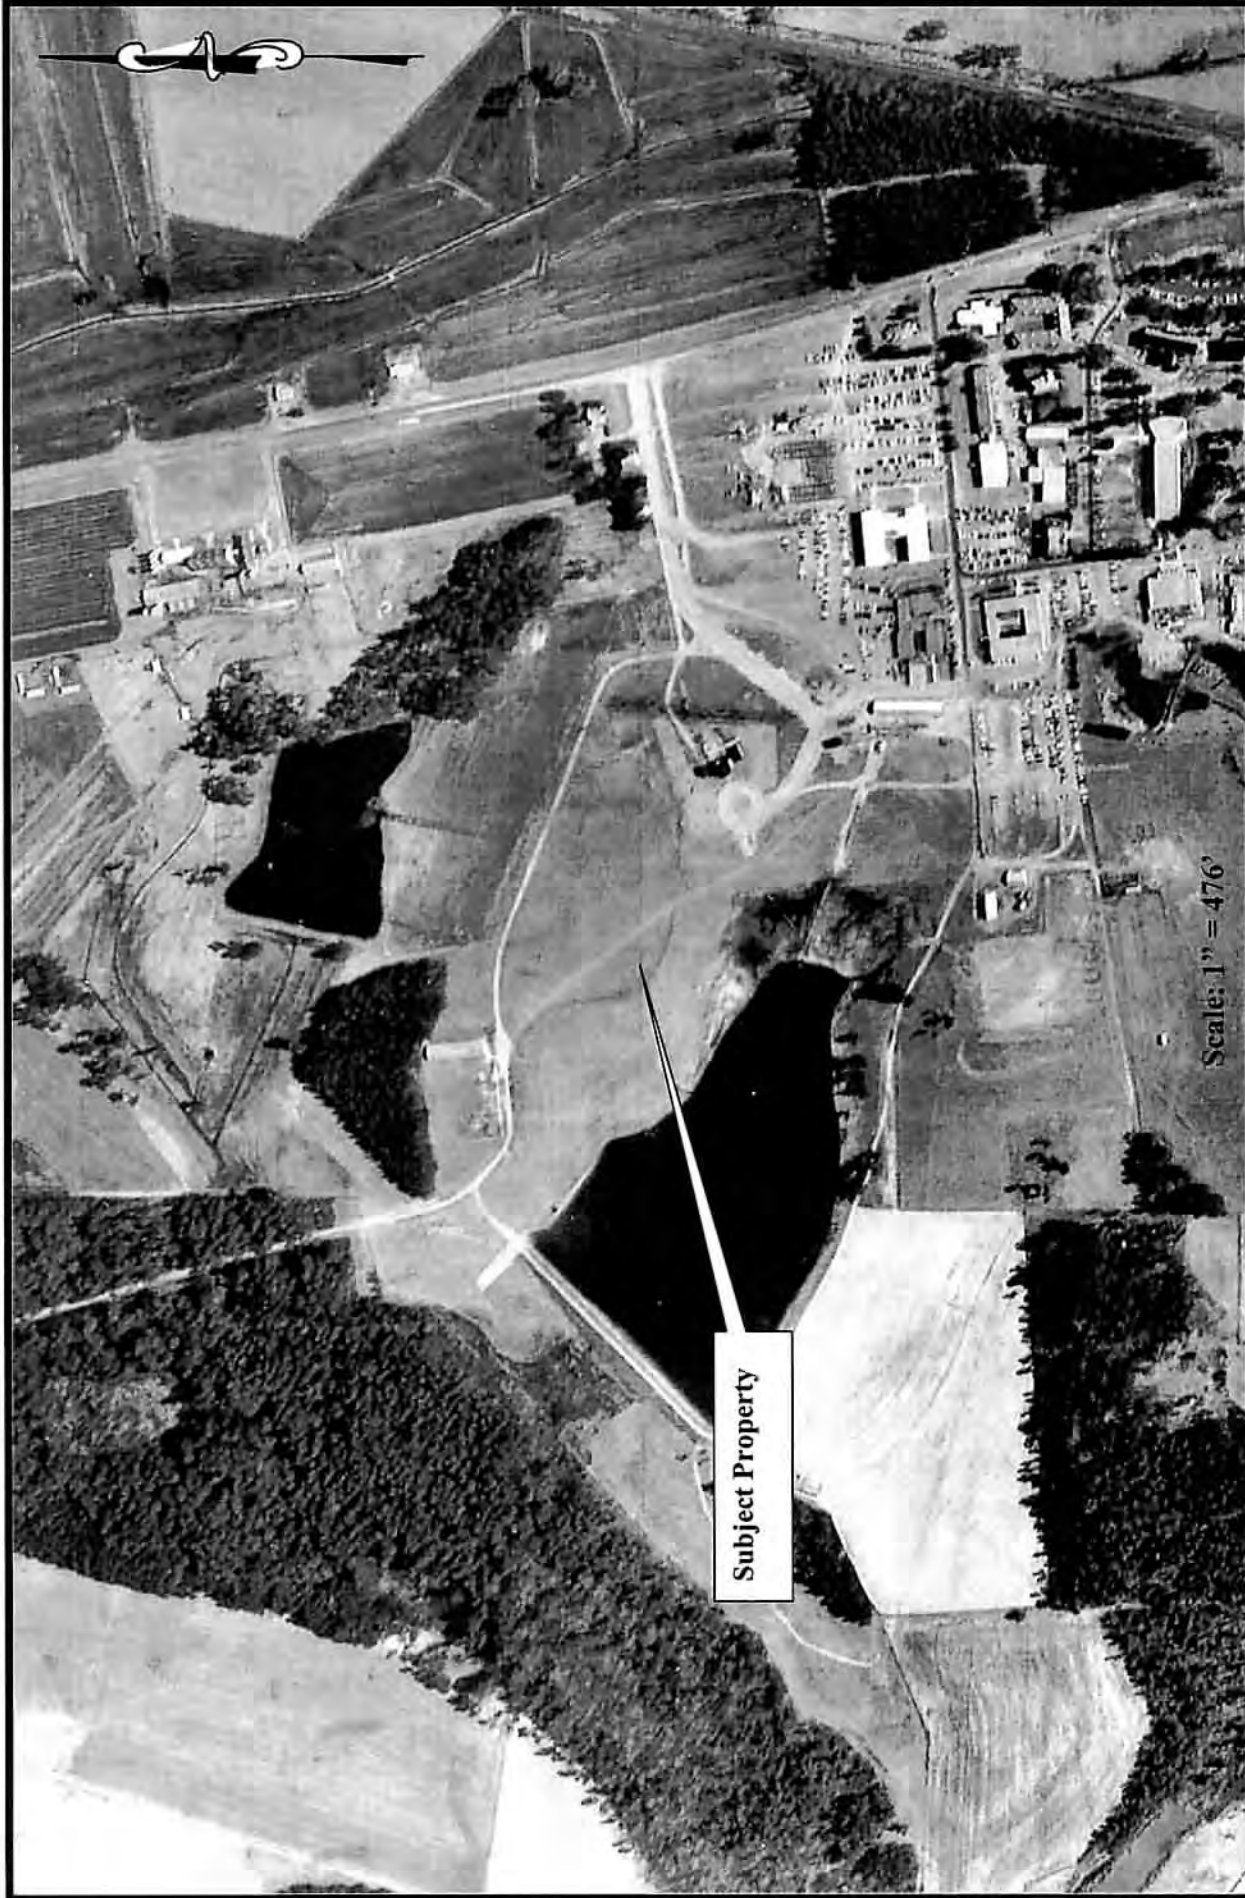
Figure 5

1962 Aerial Photograph  
ABAC – Student Housing Project (Site “A”)  
Tifton, Georgia  
TTL Project No.: 060705251

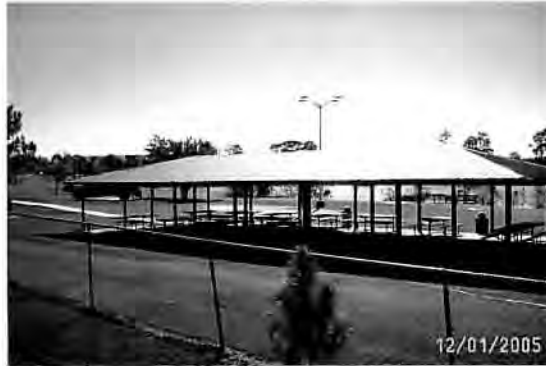
**Photograph 10**  
**Pavilion located at the southwest end of the site.**

The subject property is primarily an open, grassed field with several medium to large trees and shrubs located at the west end of the property. A chain-link fence currently surrounds the middle and eastern portions of the site. A covered pavilion and picnic area along with several concrete slabs containing picnic tables were observed at the west end of the property.

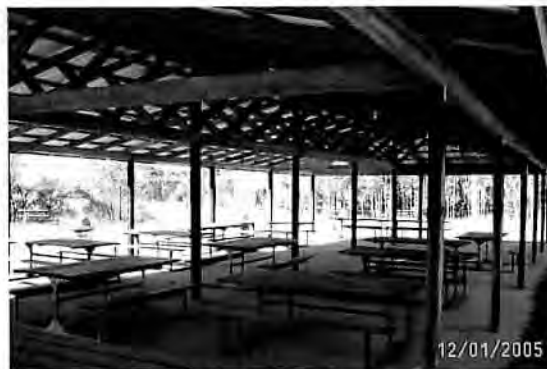
**Photograph 12**  
**Interior view of the pavilion.**

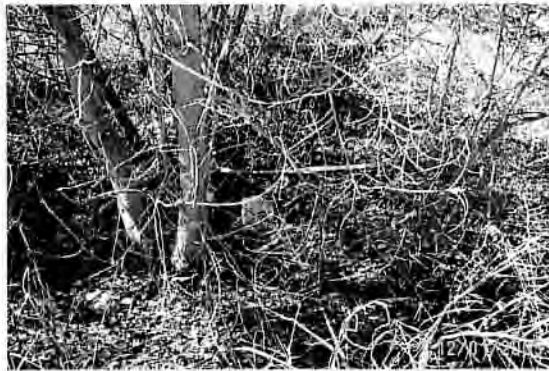
**Photograph 14**  
**Miscellaneous trash observed along the southwest  
boundary line.**

During the site reconnaissance, some miscellaneous trash was found along the southwest corner of the property, adjacent to Baldwin Lake. Several pieces of machinery were observed at the southeast end of the property. It appears the machinery is primarily used for the existing driving range. A row of concrete blocks were observed partially buried in the ground just southeast of the covered pavilion. During our site reconnaissance, buried electrical and water lines (marked by utility locators) were observed crossing the property from east to west.

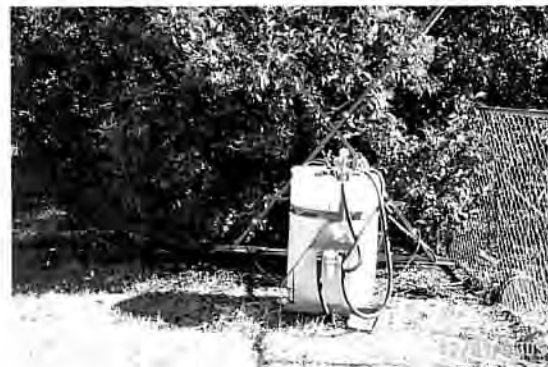
**Photograph 19**  
**Sprayer observed at the southeast corner of the site.**

TTL did not observe any evidence of contracted maintenance performed on the property. However, sprayers and lawn mowers were observed on the subject property and appear to be used by ABAC personnel for maintenance purposes.

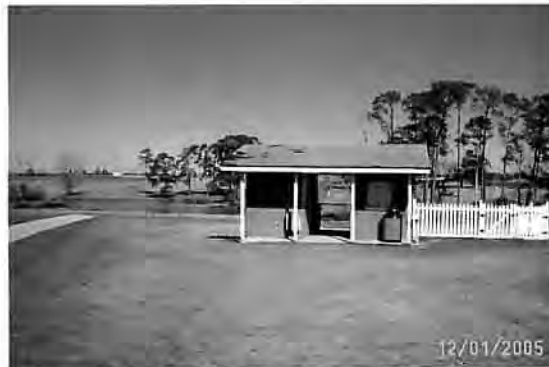
**Photograph 20**

TTL did not note the evidence of any septic tanks on the subject property during our reconnaissance. It should be noted that during our site reconnaissance, indications of a septic tank were observed located adjacent to the subject property, to the northeast at the existing golf driving range. Based on our phone interviews with Mr. Melvin Merrill and Mr. Duane Weeks with ABAC, a septic tank is in use at the main driving range building located northeast of the subject property.

**Structure located at the adjacent golf driving range.  
Septic tank observed at the northwest end of the building.**

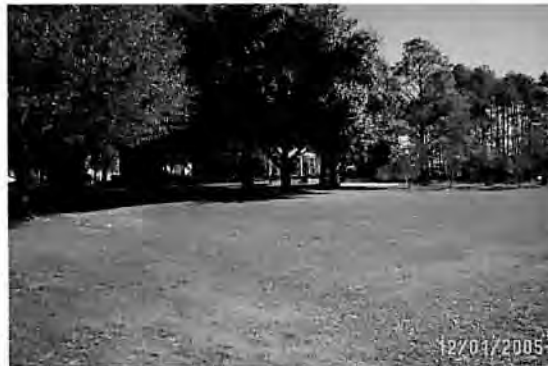
**Photograph 21**

**Alumni house located southeast of the subject site.**
