# FACILITY CONDITON ASSESSMENT SERVICES REPORT

## University Crossings

ARMSTRONG ATLANTIC STATE UNIVERSITY

October 15, 2013

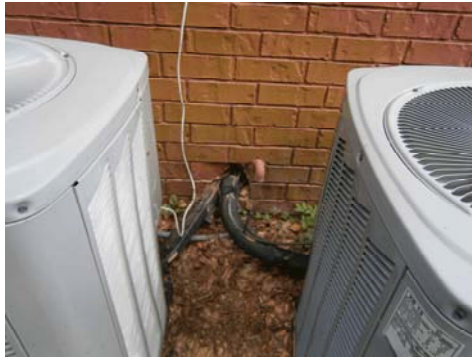
Figure 1: Typical condition of opening in wall at HVAC penetration

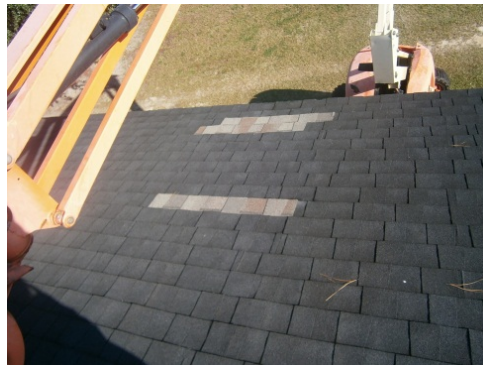
Figure 12: Typical condition of small scale roof patch

4. Numerous patched areas and faulty repairs are evident on the roofs. (See Fig. 12 – 14)

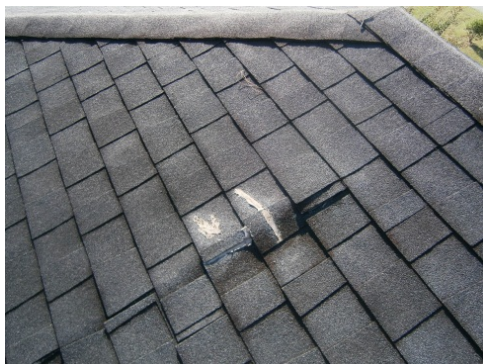
Figure 14: Typical condition for faulty roof patch attempt in disrepair

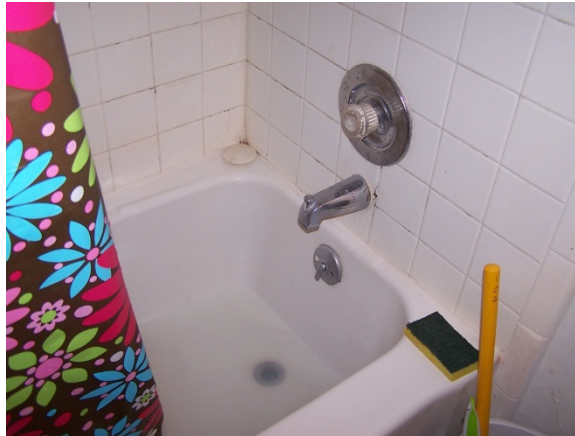
1. The tub/shower is not draining properly.

Figure 25: Unit 102 – Tub/Shower not Draining Properly

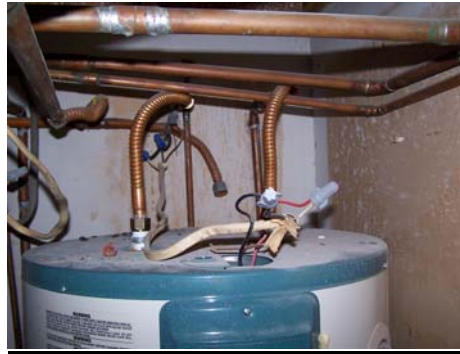
1. The water heaters for this building are located in the storage closet below the interior stairwell. These water heaters need their respective pop-off valves piped either to a drain or the exterior of the building. When not properly connected this is a code violation. We can verify that some are not connected while others disappear into wall.
2. Two of the water heaters need their respective pop-off valves installed.

Figure 26: Missing Pop-off Valves

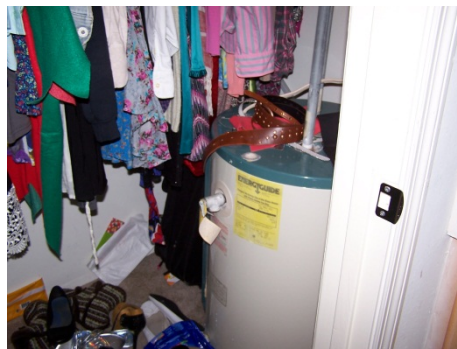
1. The water heaters for this building have been installed in the clothes closets. Students are using these water heaters in many cases as places of storage, which can lead maintenance problems due to the exposed piping.

Figure 28: Water Heater Installed in Clothes Closet

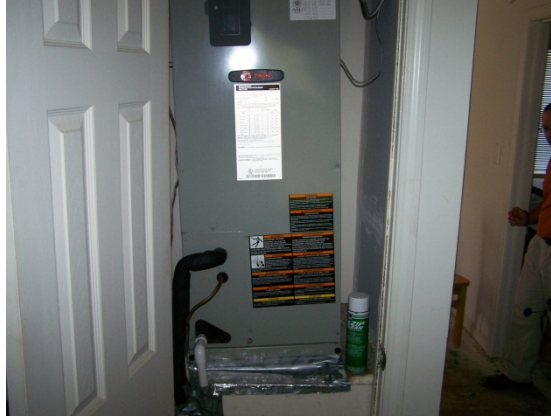
1. The outdoor heat pump (Trane - 2007) has five years left before reaching the minimum expected service life.
2. The air handler (Trane - 2007) has five years left before reaching the minimum expected service life.
3. Mechanical system uses R-22 refrigerant.
4. Apartment has a mechanical thermostat.
5. Indoor air handler appears to be leaning.

Figure 36: Leaning Air Handler Issue

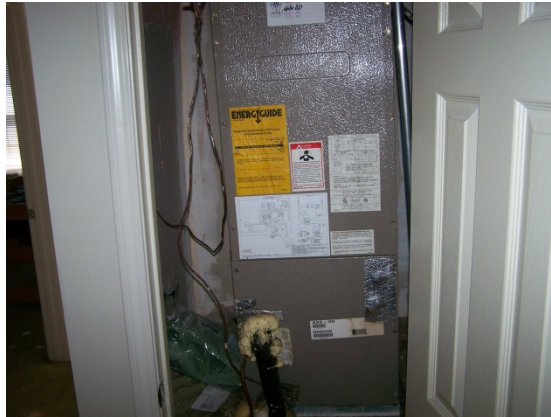
1. The outdoor heat pump (Goodman - 1998) has exceeded the expected service life.
2. The air handler (Goodman - 1998) has exceeded the expected service life.
3. Mechanical system uses R-22 refrigerant.
4. Apartment has a mechanical thermostat.
5. The bathroom exhaust fan is not working.
6. Indoor air handler appears to be leaning.

Figure 37: Leaning Air Handler Issue

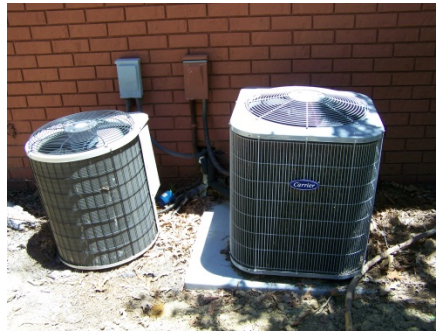
1. System 1 the outdoor heat pump (Payne - 2006) has four years left before reaching the minimum expected service life.
2. System 1 the air handler (Payne - 2006) has four years left before reaching the minimum expected service life.
3. System 2 the outdoor heat pump (Payne – 2006) has four years left before reaching the minimum expected service life.
4. System 2 the air handler (Payne – 2006) has four years left before reaching the minimum expected service life.
5. System 3 the outdoor heat pump (Carrier – 2013) has ten years left before reaching the minimum expected service life.
6. System 3 the air handler (Carrier – 2013) has ten years left before reaching the minimum expected service life.
7. One of the Heat Pumps located outside of the office space in not placed on a pad. The other unit is placed on a pad; however the pad is not level.

Figure 38: Heat Pumps outside Office of Community Building

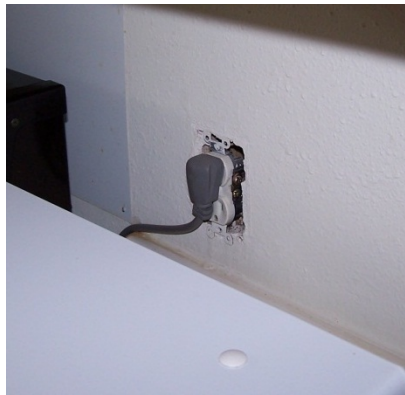
1. There are many various fixture types utilized throughout the University Crossings Housing complex. Most of these fixtures are utilizing A19 screw-in incandescent lamps.
2. There are missing and damaged device plates throughout the University Crossings Housing complex in all buildings.

Figure 39: Unit 101 Missing Device Plate (Typical Condition in Most Units)

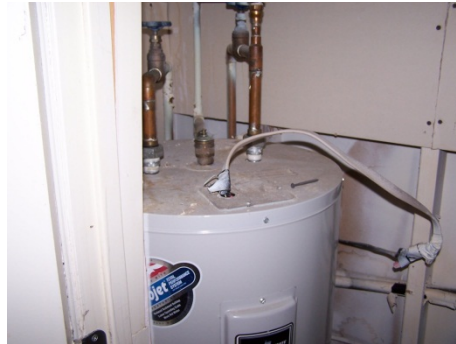
1. In the mechanical closet there is an open splice in the NM cable connecting the water heater. This does not meet code.

Figure 44: Building 1 – Unit 102 Open Splices

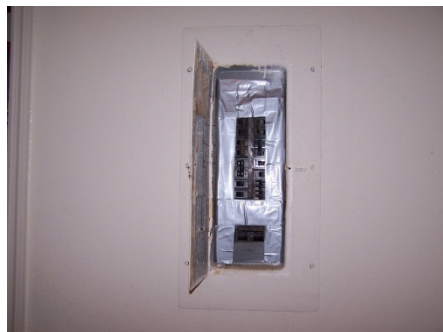
Figure 45: Unit 104 – Altered Panel Cover

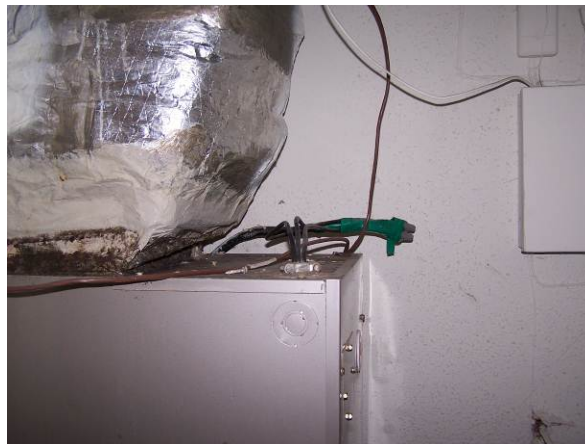
1. In the mechanical closet there is an open splice in the NM cable connecting the air handler. Also the conductors installed through the NM connector are not rated for this use.

Figure 48: Unit 303 – Open Splice and Incorrect Conductor Usage
