PHASE I ENVIRONMENTAL SITE ASSESSMENT AND
LIMITED SUBSURFACE INVESTIGATION

HOOVER CREEK VILLAS, 12202 APACHE AVE.,
& HUGGINS PROPERTY, 12206 APACHE AVE.
SAVANNAH, GEORGIA

NOVEMBER 2003

EMC PROJECT NO. 03-0527.30

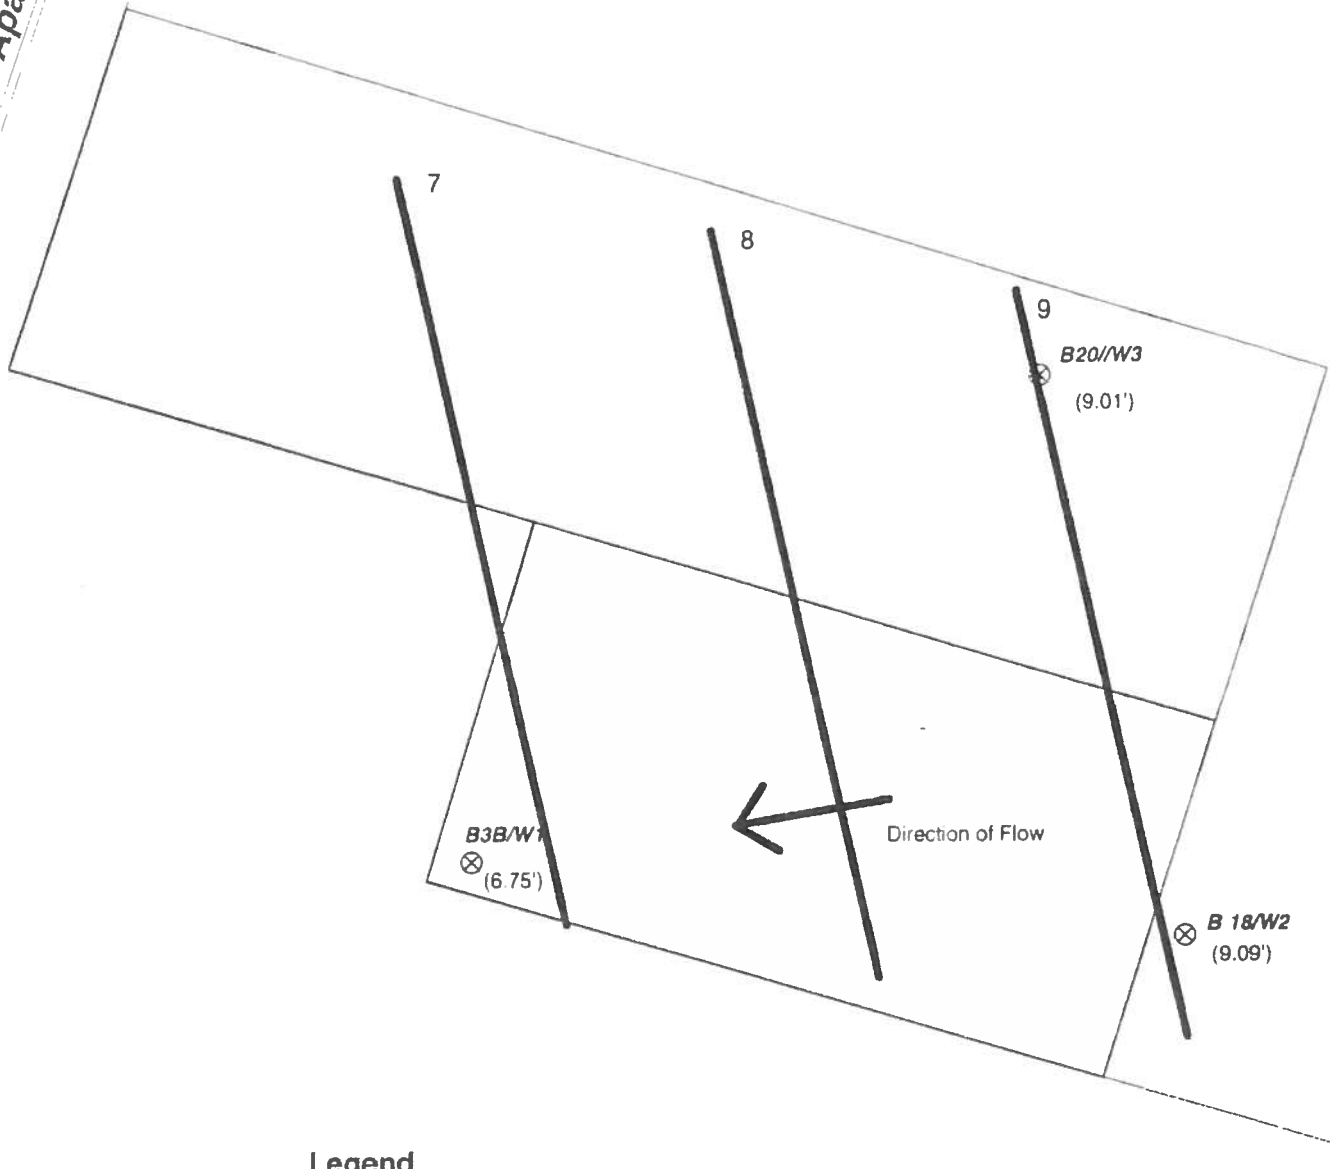
Figure 3: Water Table Contours
Project No. 03-0527.30

Three groundwater monitoring wells were installed on the Huggins Property as part of the subsurface investigation. The water table was found to range from 6 feet to 4 ½ feet below ground surface. The monitoring wells were surveyed and the water table aquifer flow direction was found to be to the southwest as shown in Figure 3. This is consistent with the proximity of the marshes and Forest River which are approximately 800 feet and ½ mile, respectively to the southwest. The water table was reported to be approximately 4 ½ feet below ground surface in previous environmental reports on the Huggins Property which is consistent with what was found during this investigation. The water table beneath the Hoover Creek Villas is expected to be at approximately at the same depth and also flow to the southwest.

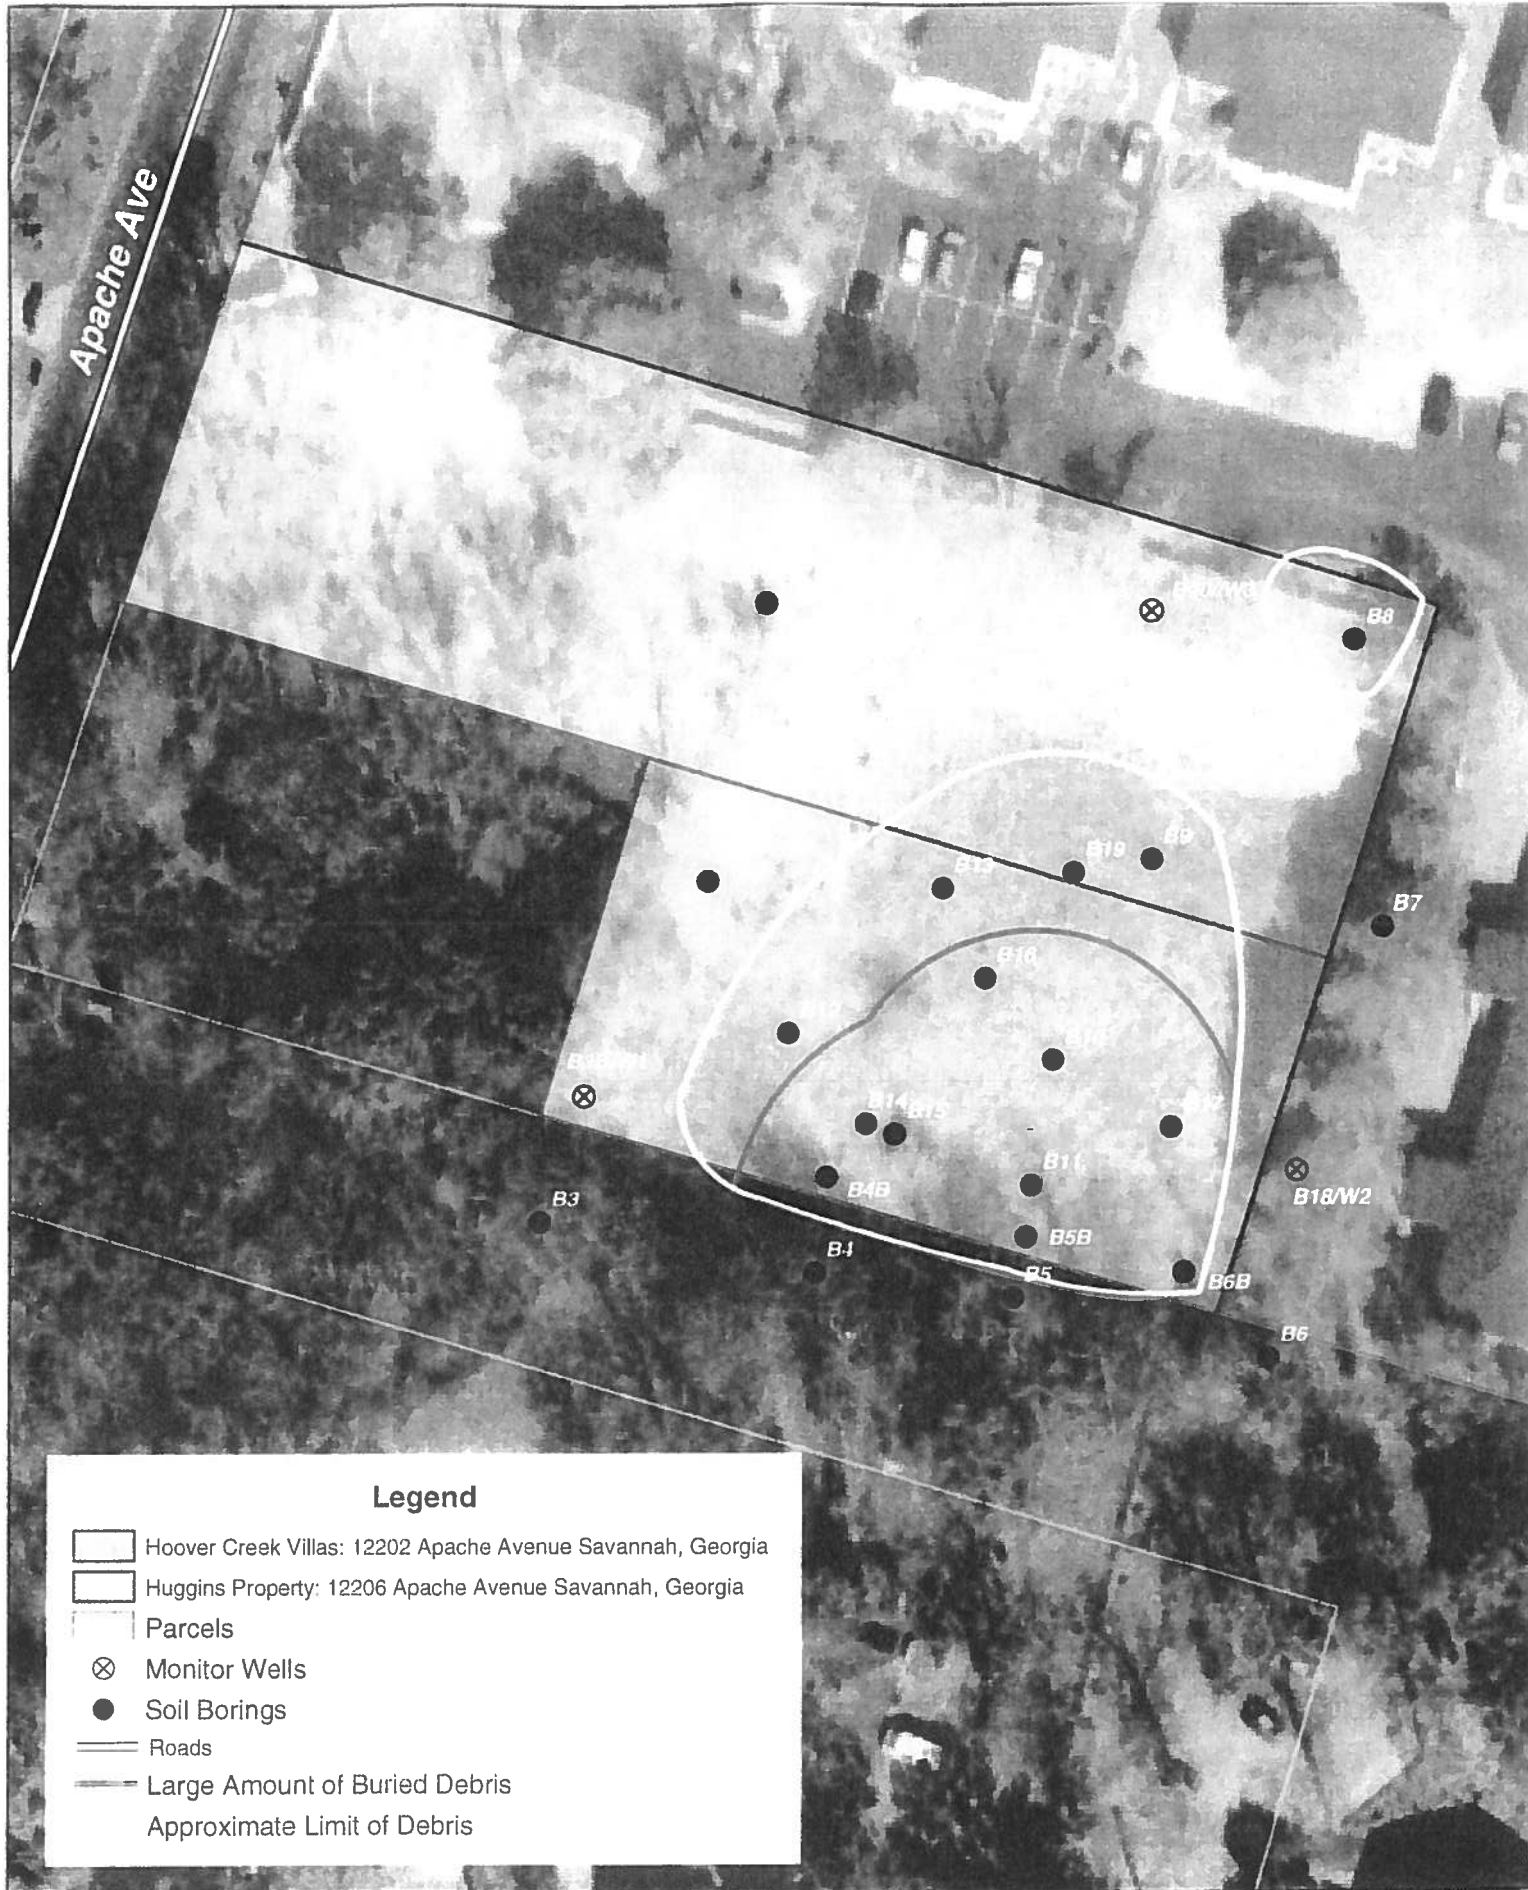
A yellow ring is drawn on Figure 4 to indicate the extent of the buried debris in the center and the northeast corner of the subject property. Very little woody and concrete debris was found in the trenches dug between the yellow and red rings. The minor amount of debris between the yellow and red rings ranged from ground surface to 8 feet deep. A relatively larger amount of buried debris was found at the subject property inside the area where the red ring is drawn in Figure 4. The debris graded out to nothing on the north and west sides of the red ring but stopped abruptly on the south and southwest sides of the subject property.

The materials in the center buried debris, shown inside the red ring drawn in Figure 4 consisted of logs, roots, concrete pipe, sofas, and tires. In the southeast corner of the subject property a buried above ground fuel storage tank was unearthed. The tank contained a little water but the water did not have a petroleum odor. Gases bubbled up through groundwater in the bottom of the trench dug at boring locations B14 and B15 as was described in the previous environmental report entitled "Site Inspection" dated October 8, 1998. We observed that the buried debris was less than 8 feet deep in contrast to the reported 12 feet in the previous environmental report. We observed less debris and fewer materials than were reported in the previous environmental report even though we are sure we trenched in the same locations. Finding of the trenching observations are summarized in Table 1.

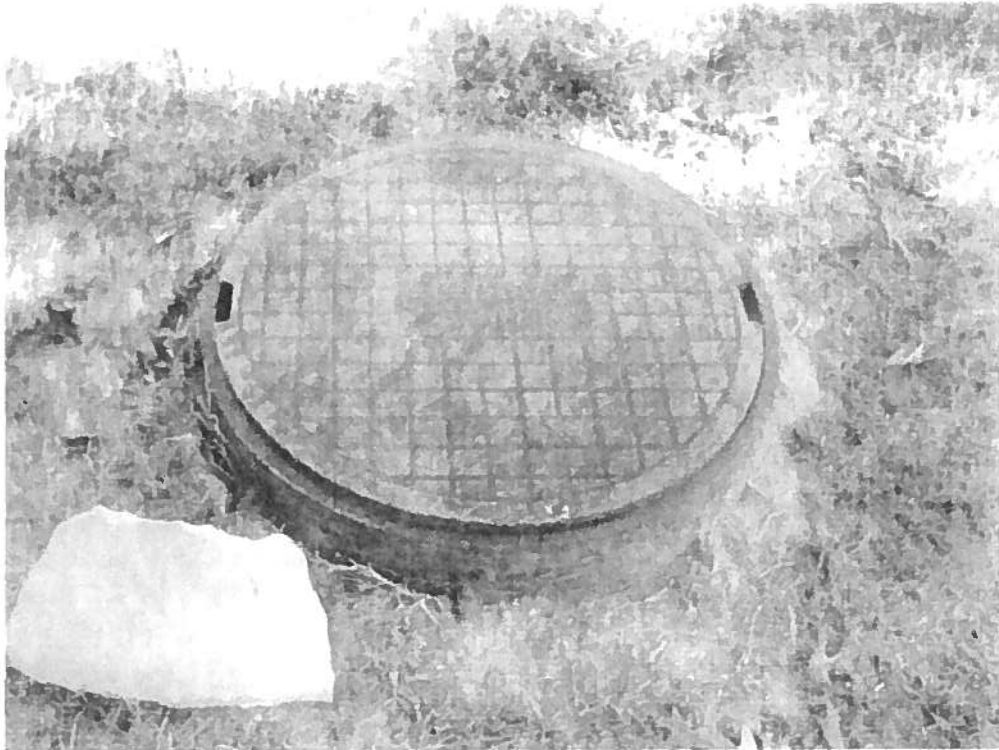
EMC PROJECT NO. 03-0527.30	DESCRIPTION	Sanitary sewer manhole at the site	11
	SITE NAME	Hoover Creek Villas, 12202 Apache Avenue, Savannah, GA	DATE 10/23/03
	CLIENT	HUNTER MACLEAN EXLEY & DUNN, PC

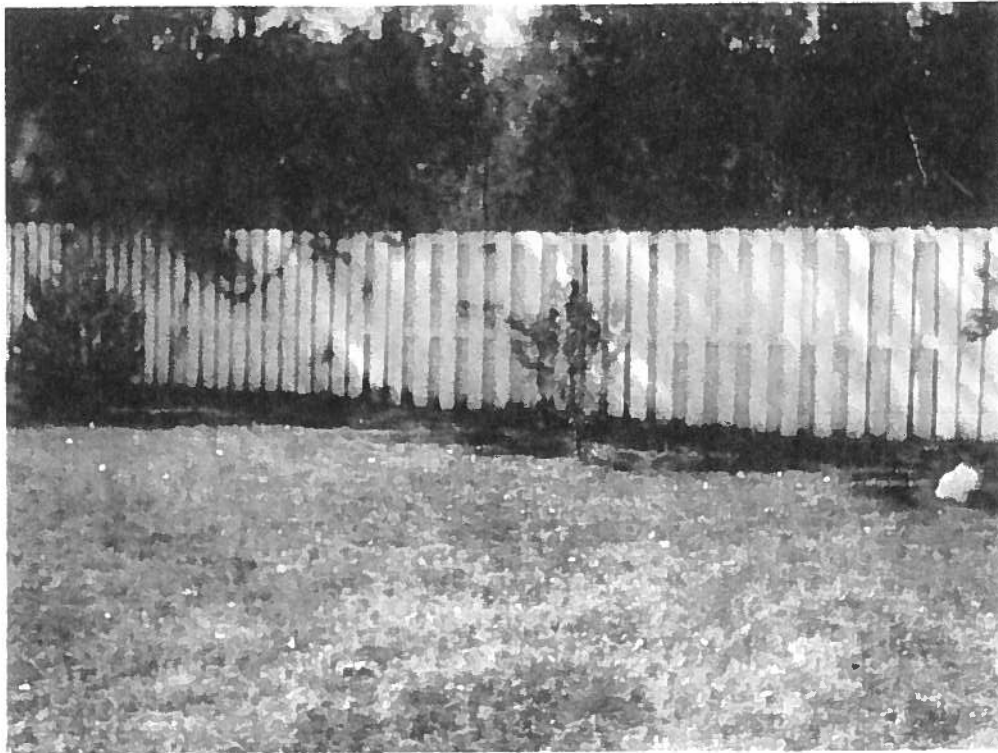
EMC PROJECT NO. 03-0527.30	DESCRIPTION	View of the Huggins property on the south side of the Hoover Creek Villas	15
	SITE NAME	Hoover Creek Villas, 12202 Apache Avenue, Savannah, GA	DATE 10/23/03
	CLIENT	HUNTER MACLEAN EXLEY & DUNN, PC

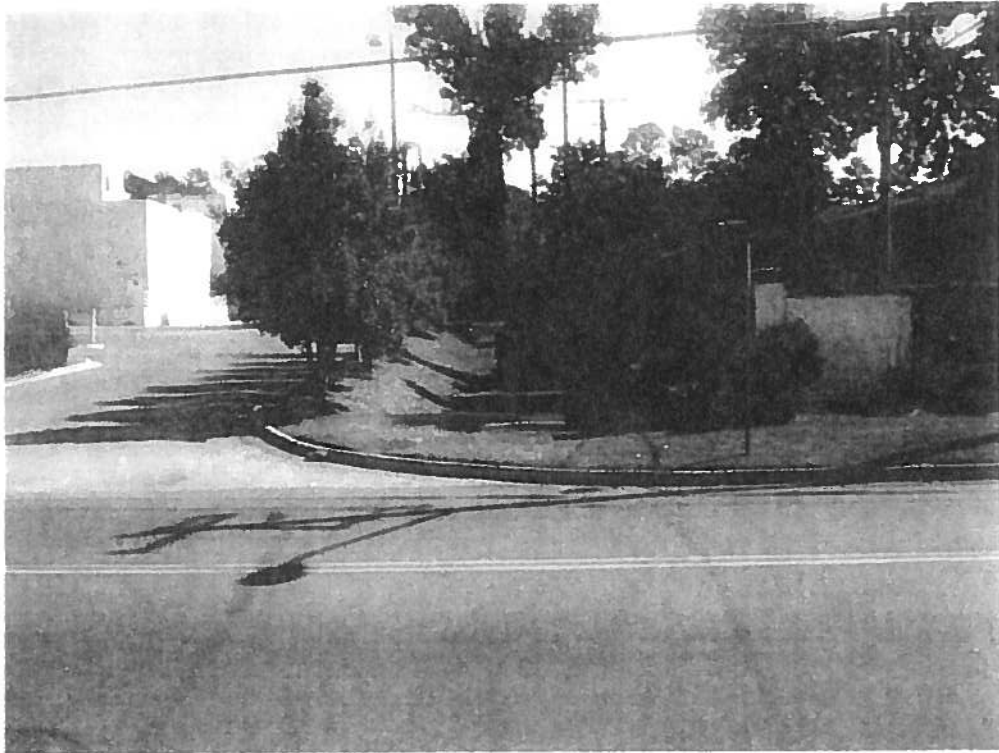
EMC PROJECT NO. 03-0527.30	DESCRIPTION	Drainage ditch between Publix Super Market and the north side of the site	19
	SITE NAME	Hoover Creek Villas, 12202 Apache Avenue, Savannah, GA	DATE 10/23/03
	CLIENT	HUNTER MACLEAN EXLEY & DUNN, PC

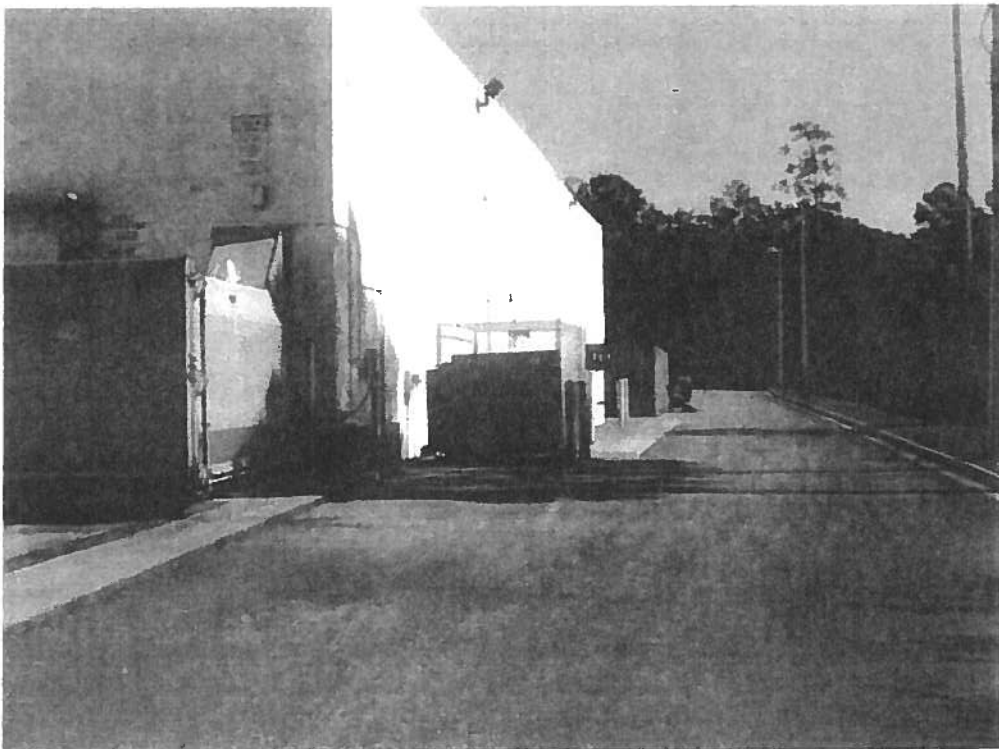
EMC PROJECT NO. 03-052730	DESCRIPTION	South side of Publix Super Market next to the Hoover Creek Villas, box compactor on the left and electrical transformer in the center of the photo	20
	SITE NAME	Hoover Creek Villas, 12202 Apache Avenue, Savannah, GA	DATE 10/23/03
	CLIENT	HUNTER MACLEAN EXLEY & DUNN, PC

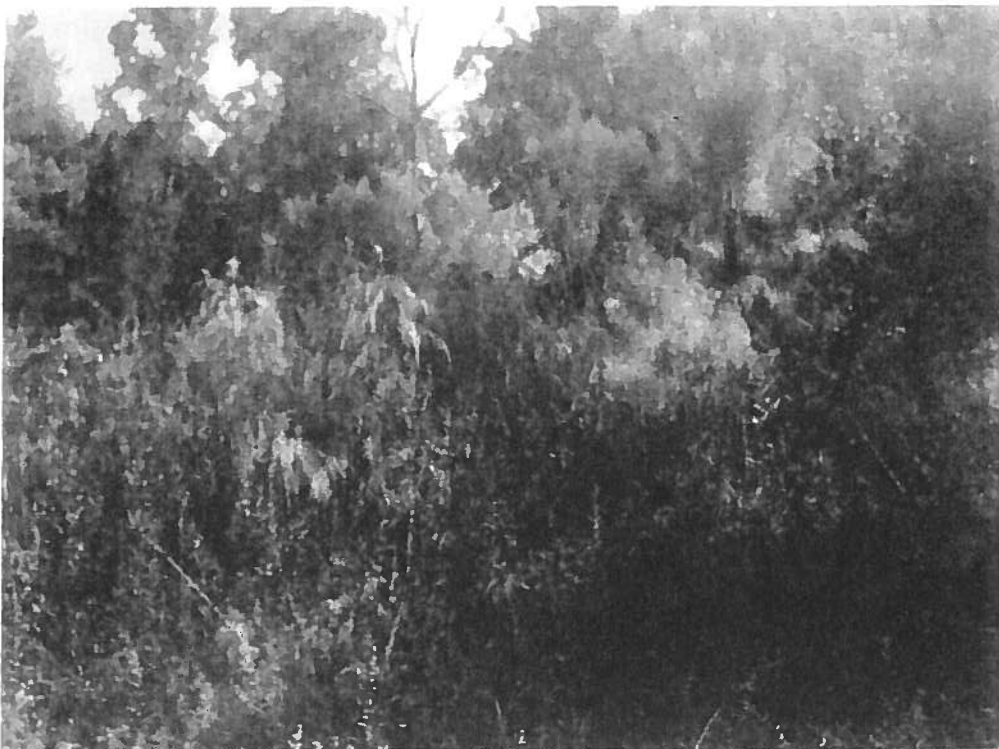
EMC PROJECT NO. 03-0527.30	DESCRIPTION	Site before excavating	2
	SITE NAME	Huggins Property, 12206 Apache Avenue, Savannah, GA	DATE 10/21/03
	CLIENT	HUNTER MACLEAN EXLEY & DUNN, PC

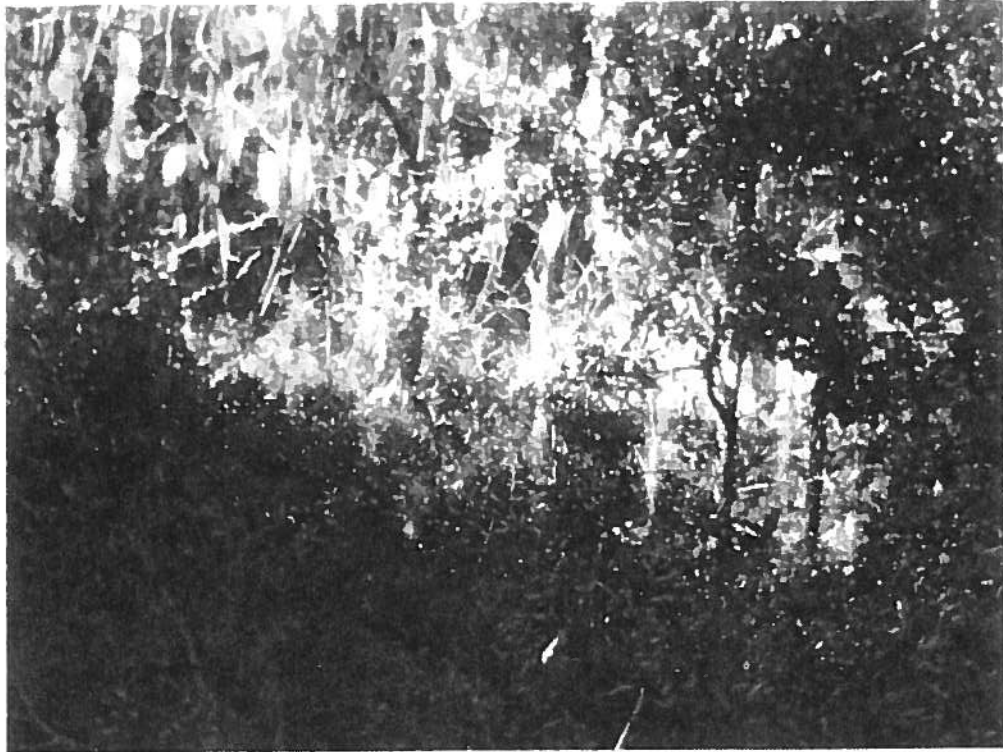
EMC PROJECT NO. 03-0527.30	DESCRIPTION	Site before excavating	3
	SITE NAME	Huggins Property, 12206 Apache Avenue, Savannah, GA	DATE 10/21/03
	CLIENT	HUNTER MACLEAN EXLEY & DUNN, PC

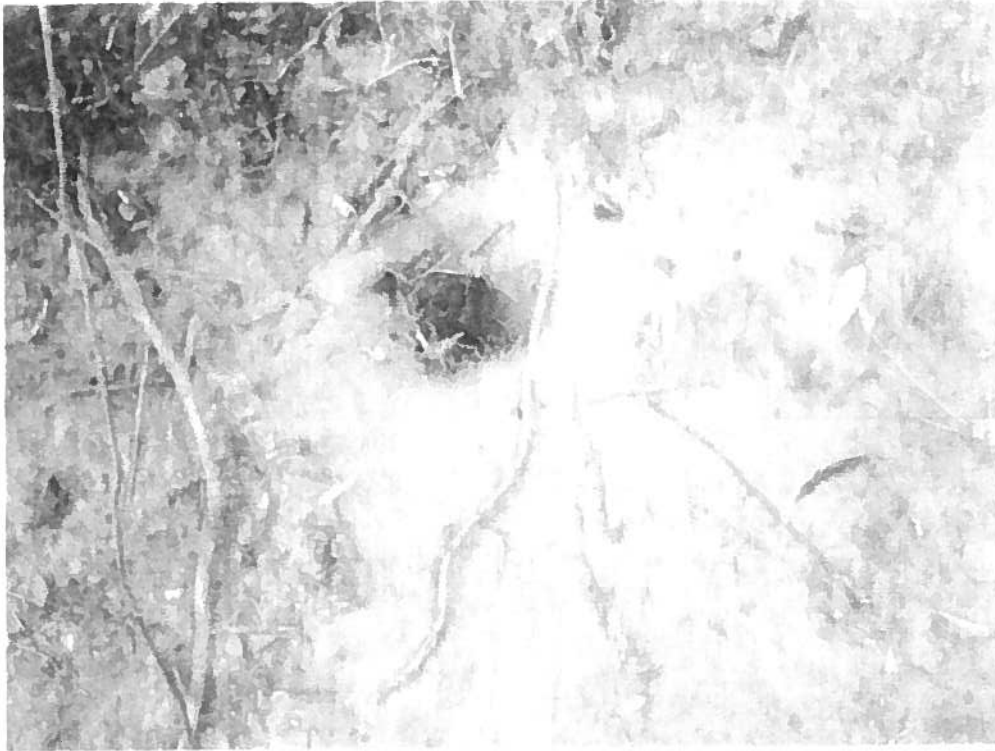
Soil borings B1 and B2 were drilled to 6 feet along the west side of the subject property. No buried debris was found in either of the two borings. We conclude that buried debris does not extend to the western property line of the subject property. The findings of the soil borings are summarized in Table 1.

EMC PROJECT NO. 03-0527.30	DESCRIPTION	Hand auger hole (B-1)	9
	SITE NAME	Huggins Property, 12206 Apache Avenue, Savannah, GA	DATE 10/21/03
	CLIENT	HUNTER MACLEAN EXLEY & DUNN, PC

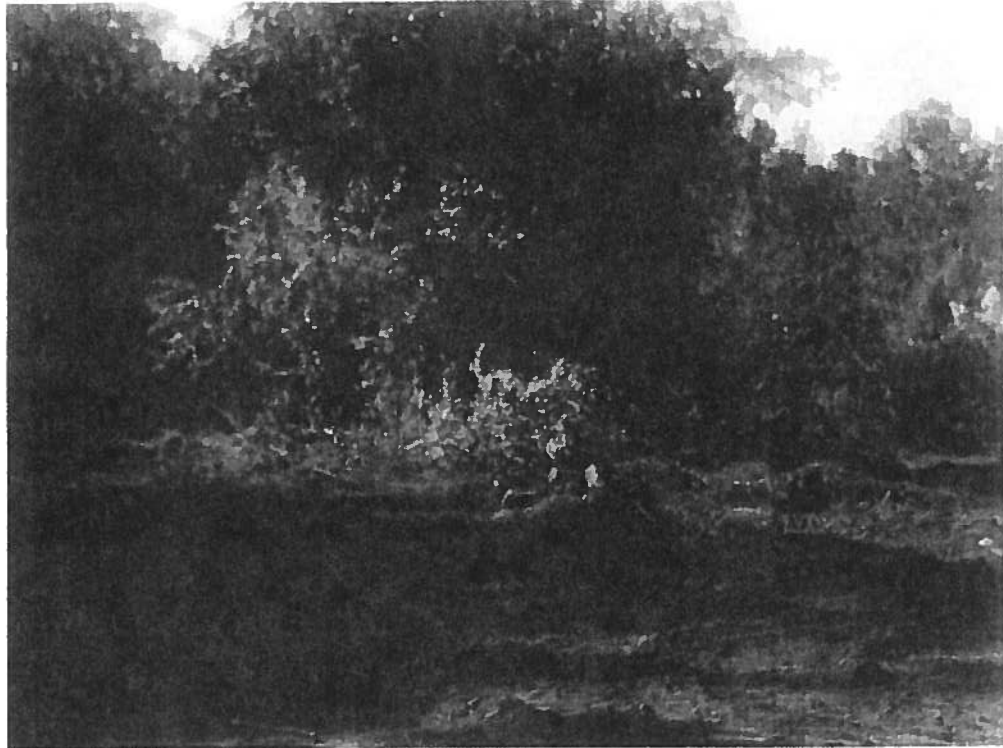
The trenches were filled back in. We tried to put the debris on the top of the dirt fill. The site is now rutted and it is difficult to drive between the groundwater monitoring wells. This is in contrast to the way we found the site and indicates the site was graded and leveled after it was trenched by Whitaker Laboratory in 1998.

EMC PROJECT NO. 03-0527.30	DESCRIPTION	Site after excavations were filled back in	15
	SITE NAME	Huggins Property, 12206 Apache Avenue, Savannah, GA	DATE 10/21/03
	CLIENT	HUNTER MACLEAN EXLEY & DUNN, PC

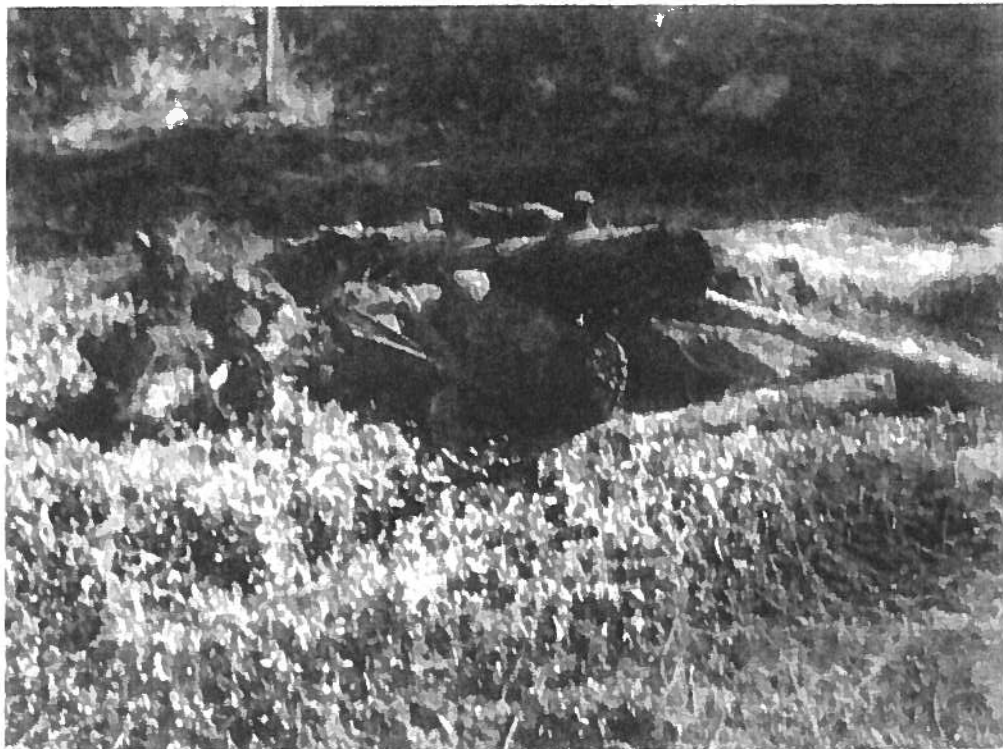
EMC PROJECT NO. 03-052730	DESCRIPTION	Site after excavations were filled back in	16
	SITE NAME	Huggins Property, 12206 Apache Avenue, Savannah, GA	DATE 10/21/03
	CLIENT	HUNTER MACLEAN EXLEY & DUNN, PC

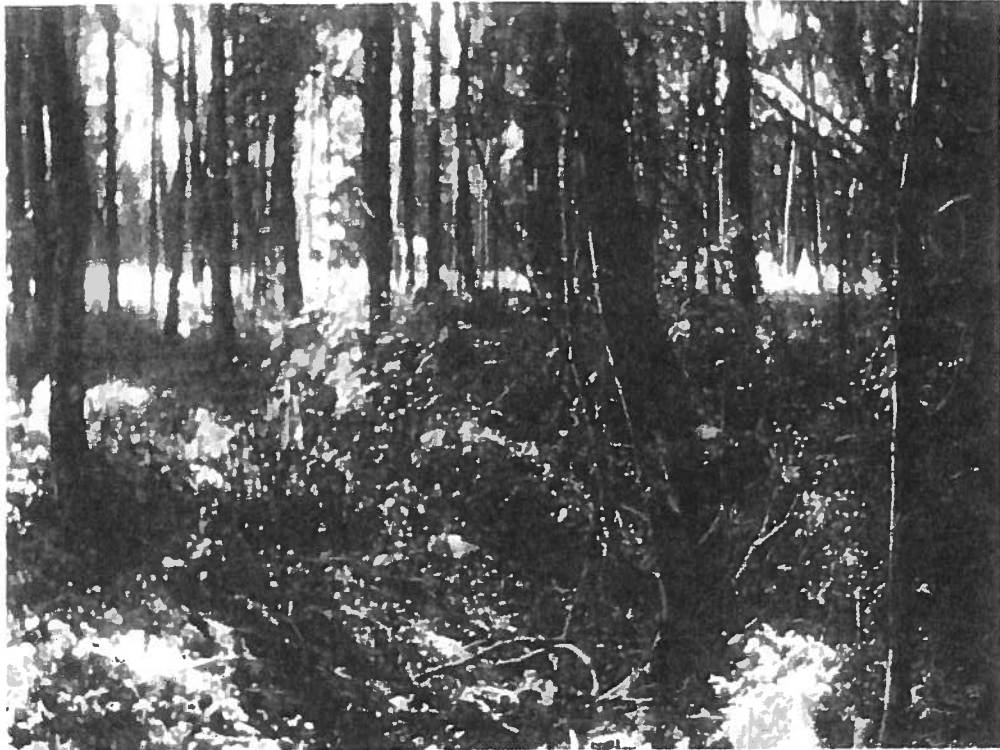
Barrel rings were observed on the ground south of the Huggins Property next to Armstrong Apartments property. Hazardous substances were not detected in the groundwater samples collected from groundwater monitoring wells installed on the Huggins Property. The property did not show any unusual vegetation patterns or staining related to spills of hazardous substances.

EMC PROJECT NO. 03-052730	DESCRIPTION	Old barrel rings on Armstrong Apartments property at the south side of Huggins property.	20
	SITE NAME	Huggins Property, 12206 Apache Avenue, Savannah, GA	DATE 10/21/03
	CLIENT	HUNTER MACLEAN EXLEY & DUNN, PC

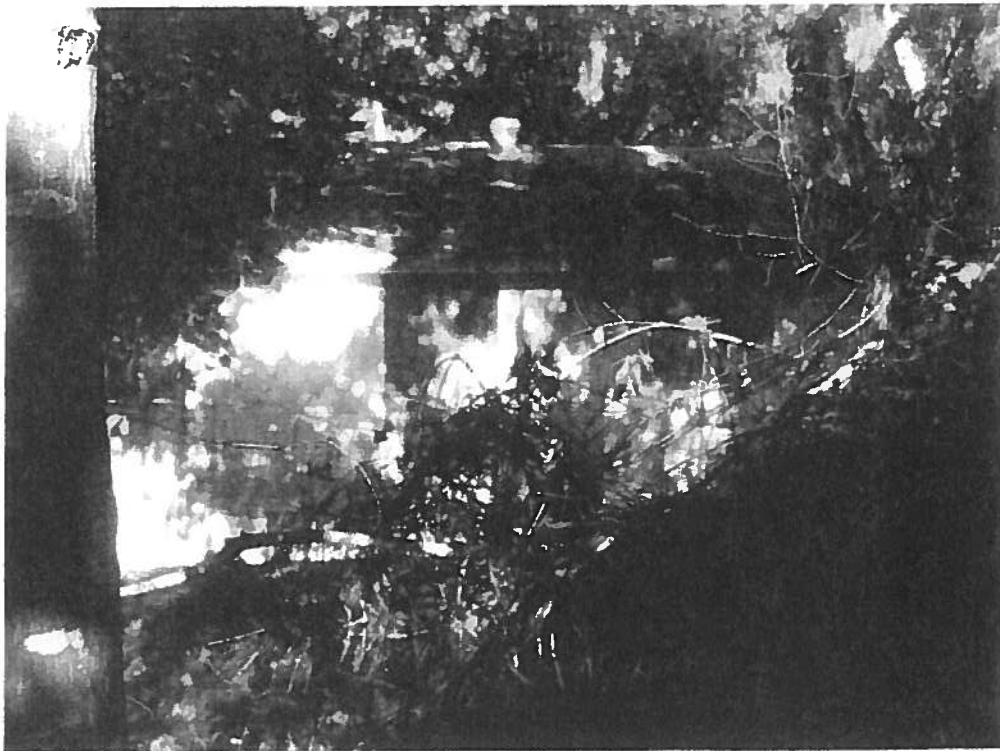
EMC PROJECT NO. 03-0527.30	DESCRIPTION	Wooded Armstrong Apartments property at the southwest corner of the Huggins property	21
	SITE NAME	Huggins Property, 12206 Apache Avenue, Savannah, GA	DATE 10/21/03
	CLIENT	HUNTER MACLEAN EXLEY & DUNN, PC

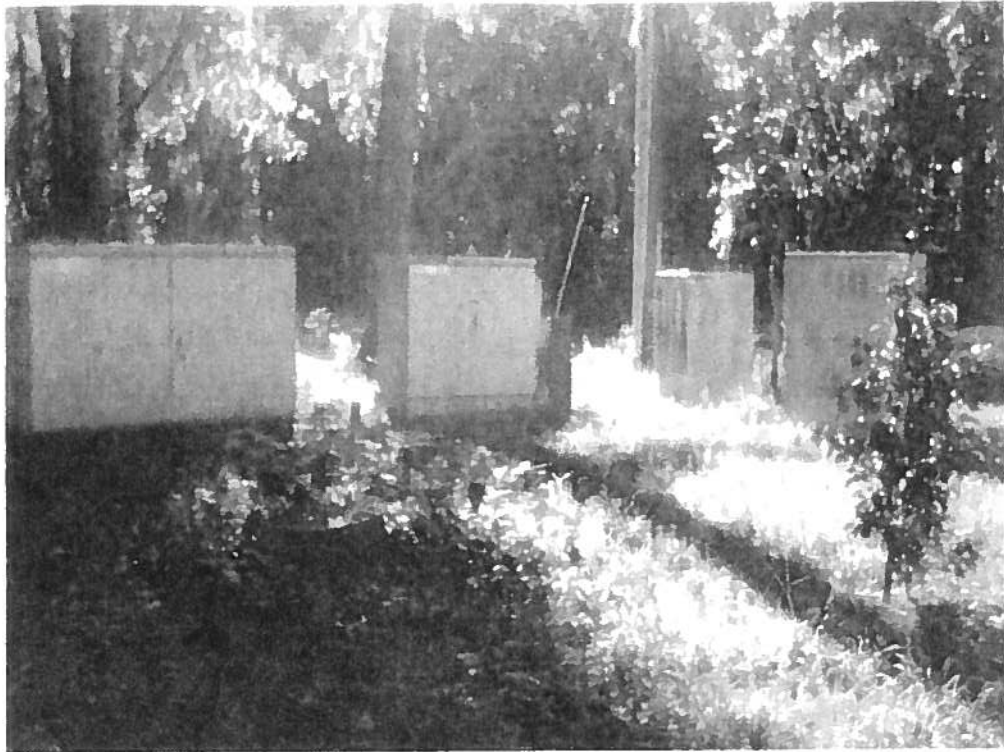
EMC PROJECT NO. 03-052730	DESCRIPTION	Waters property viewed from the southwest side of the Huggins property	22
	SITE NAME	Huggins Property, 12206 Apache Avenue, Savannah, GA	DATE 10/21/03
	CLIENT	HUNTER MACLEAN EXLEY & DUNN, PC

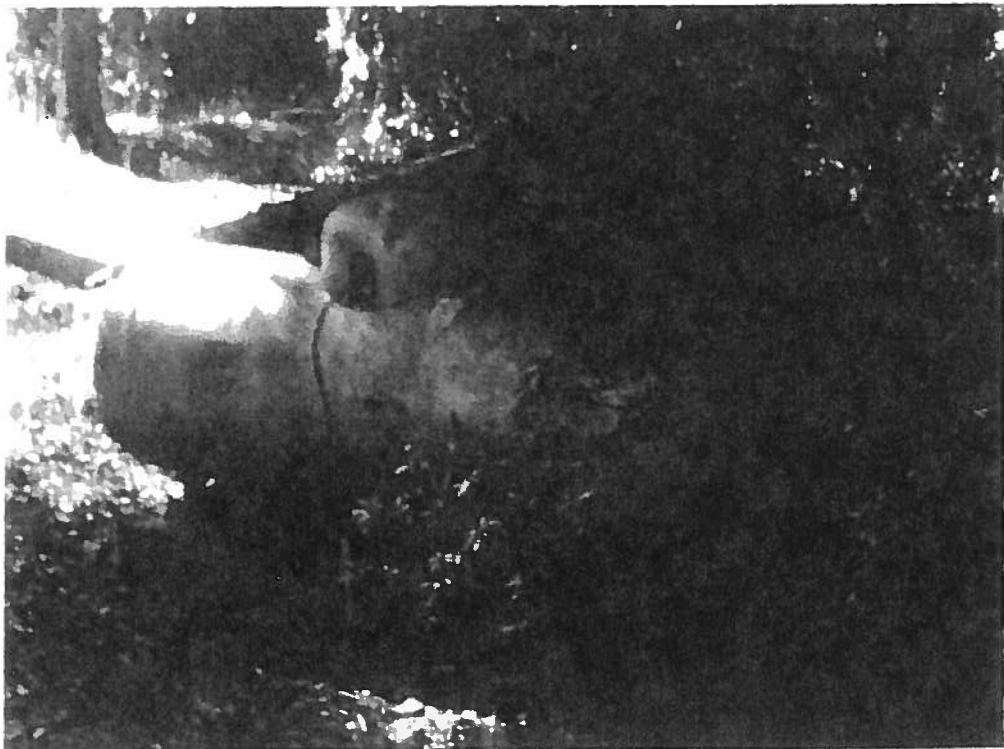
No transformers were observed on the Huggins Property. Four BellSouth Telephone and Comcast Cable relay boxes were observed on the property at 12210 Apache Avenue between Huggins Property and Apache Avenue. The boxes were reported by SEPCO personnel to be non-PCB containing. No evidence of dielectric fluid spills was observed on the ground around the boxes.

EMC PROJECT NO. 03-0527.30	DESCRIPTION	BellSouth telephone and Comcast cable junction and relay boxes in front yard of the Waters property, 12210 Apache Avenue	23
	SITE NAME	Huggins Property, 12206 Apache Avenue, Savannah, GA	DATE 10/21/03
	CLIENT	HUNTER MACLEAN EXLEY & DUNN, PC

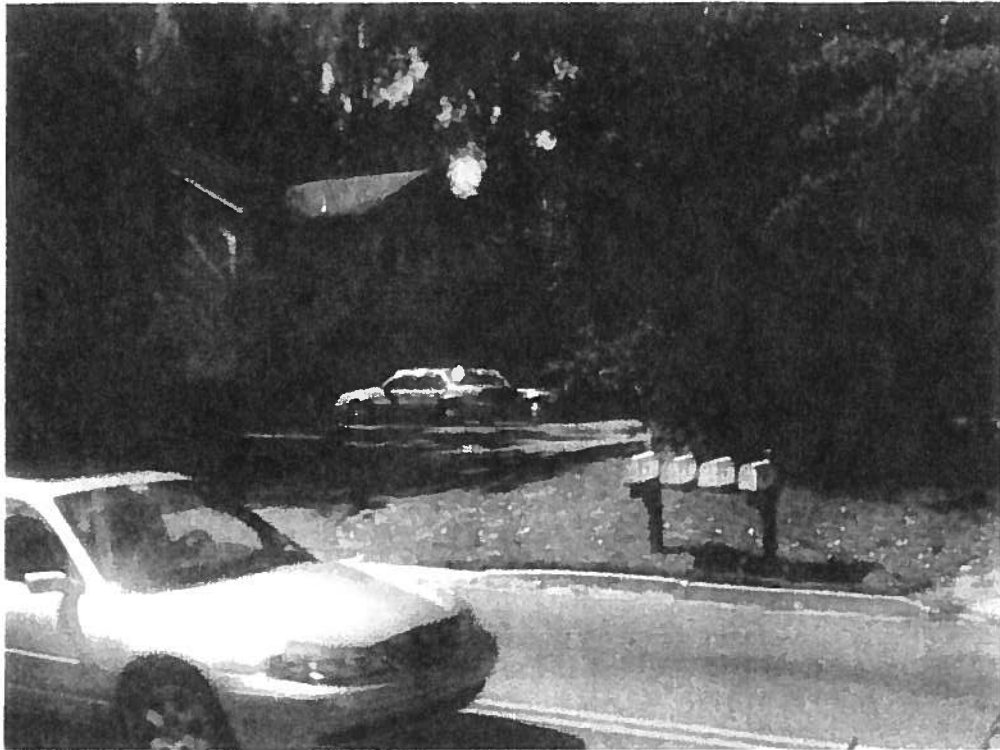
No evidence of wells (supply, monitoring, or dry well) was observed at the subject property during the site reconnaissance except 1 water supply well observed on the adjoining property located at 12210 Apache Avenue. Three shallow groundwater monitoring wells were installed on the subject property for the purpose of conducting the subsurface investigation.

EMC PROJECT NO. 03-052730	DESCRIPTION	Propane tank and private water well house, in background, at Waters property, 12210 Apache Avenue	24
	SITE NAME	Huggins Property, 12206 Apache Avenue, Savannah, GA	DATE 10/21/03
	CLIENT	HUNTER MACLEAN EXLEY & DUNN, PC

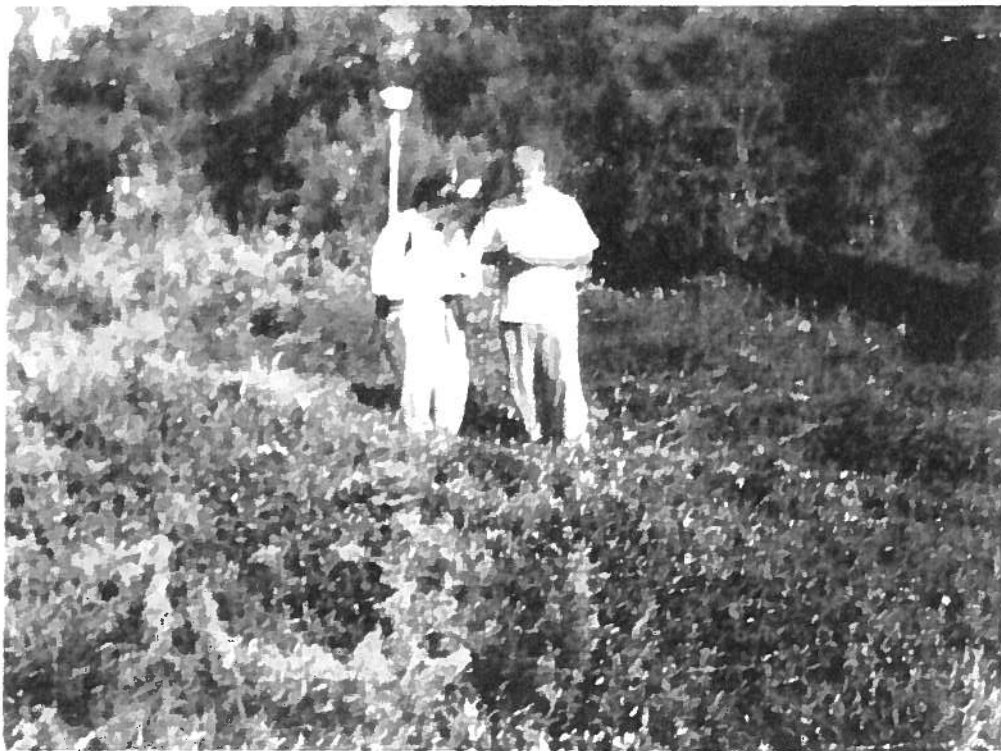
EMC PROJECT NO. 03-0527.30	DESCRIPTION	Glisson property across Apache Avenue from Huggins property	25 DATE 10/21/03
	SITE NAME	Huggins Property, 12206 Apache Avenue, Savannah, GA	
	CLIENT	HUNTER MACLEAN EXLEY & DUNN, PC

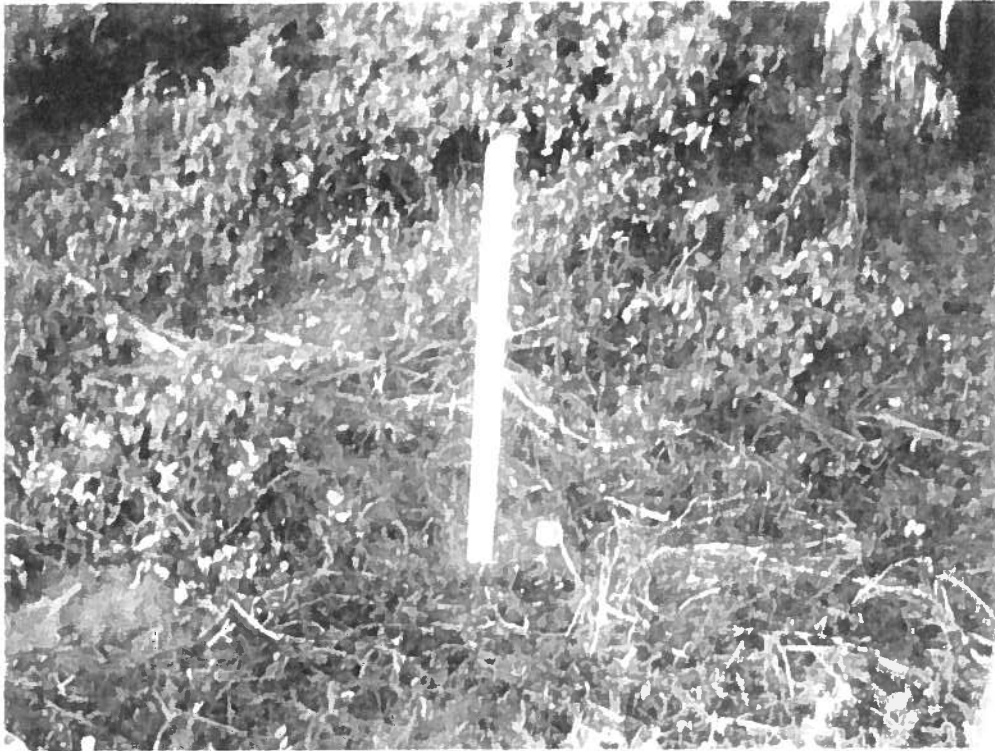
EMC PROJECT NO. 03-052730	DESCRIPTION	Mapping soil boring and monitoring well locations at the site with the GPS	26 DATE 10/21/03
	SITE NAME	Huggins Property, 12206 Apache Avenue, Savannah, GA	
	CLIENT	HUNTER MACLEAN EXLEY & DUNN, PC
