FACILITY CONDITON ASSESSMENT SERVICES REPORT

Windward Commons

ARMSTRONG ATLANTIC STATE UNIVERSITY

November 18, 2013

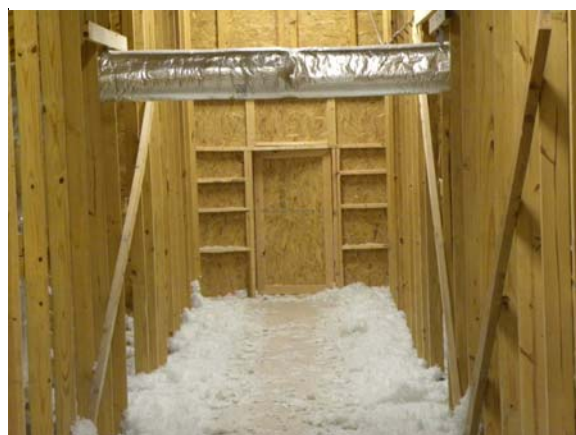
Figure 52 Typical Attic Insulation

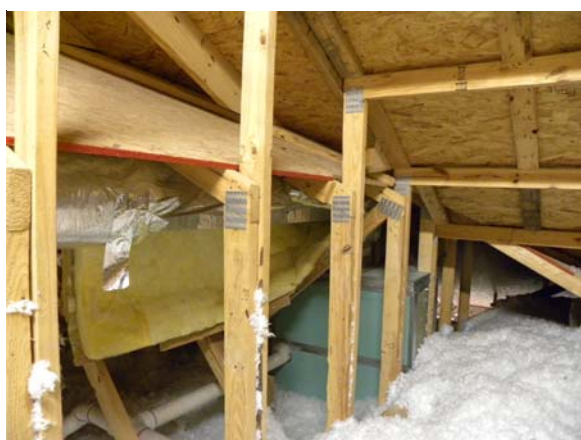
Figure 50 Depiction of Typical Attic Insulation
