Subject: Facility Condition Assessment
FCA - College of Coastal Georgia
1 College Drive
Brunswick, Georgia
Cardno ATC Project No.: 070.19150.3071

FACILITY CONDITION ASSESSMENT REPORT

**FCA - College of Coastal Georgia
Lakeside Village Student Housing
1 College Drive
Brunswick, Georgia 31520**

CARDNO ATC PROJECT NO. 070.19150.3071

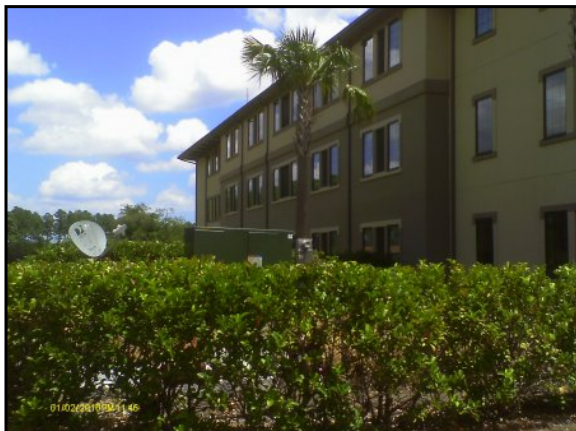
5 : The north side of Wing 1, facing east.

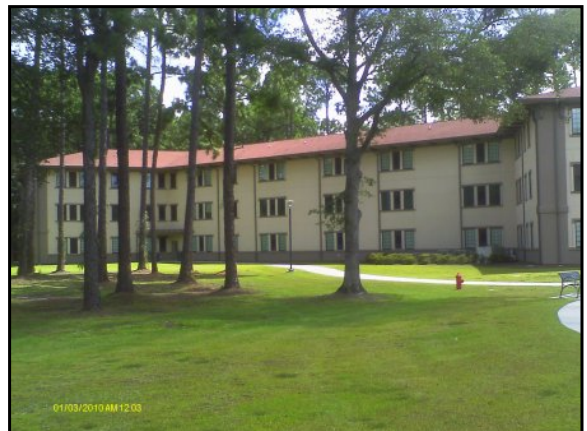
6 : The north side of Wing 3, facing southeast.

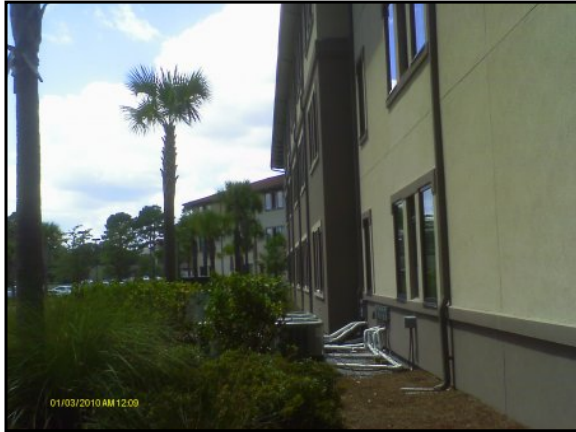
7 : South side of Wing 3, facing west.

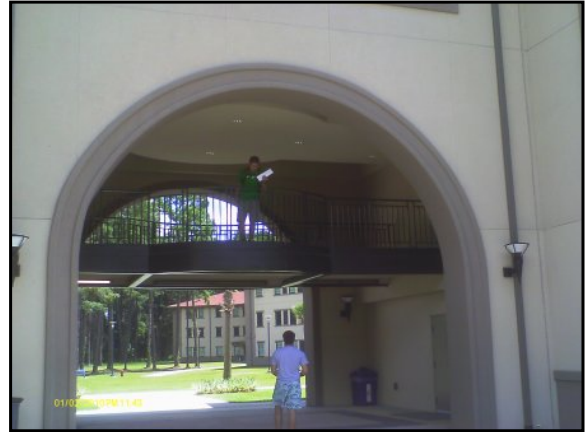
8 : Breezeway between Wing 1 and Wing 2.

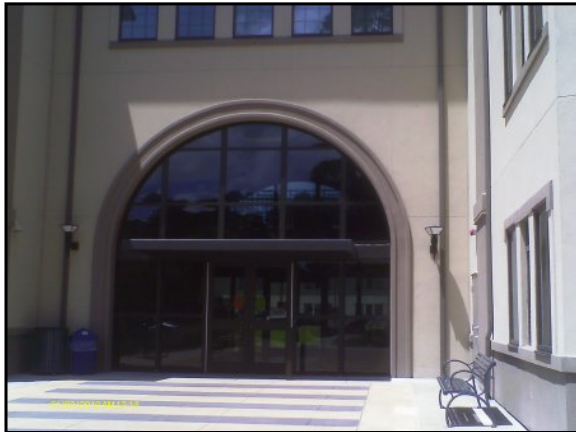
9 : Main entrance to the building in the west side via Wing 2.

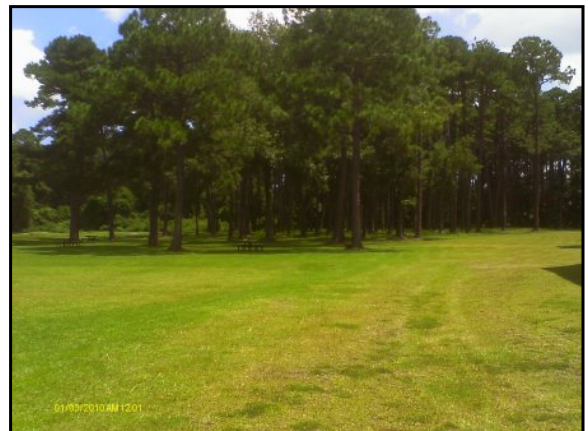
12 : Wooded and grassed area east of the building.

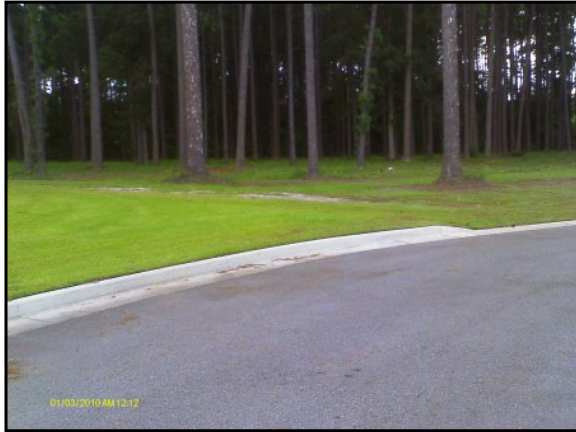
13 : South adjoining wooded area, facing south.

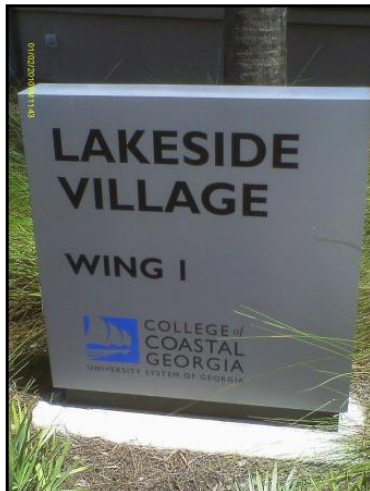
15 : Signage outside Wing 1.

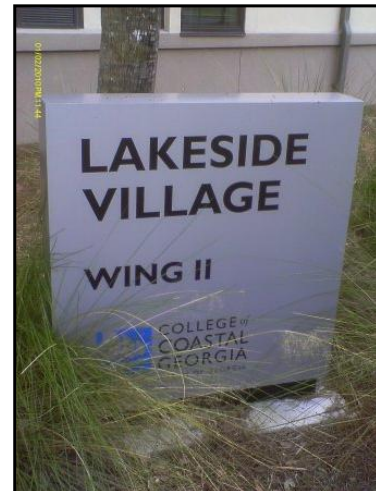
16 : Signage outside Wing 2.

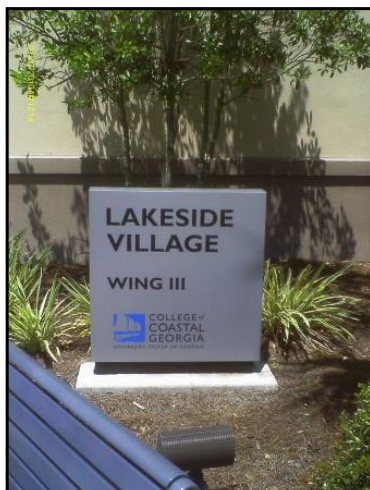
17 : Signage for Wing 3.

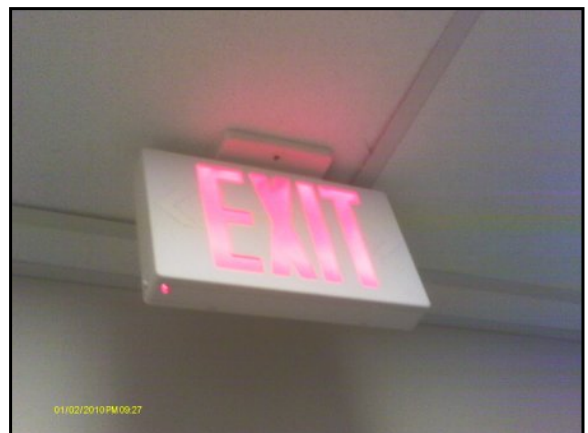
18 : Typical exits signs in hallways.

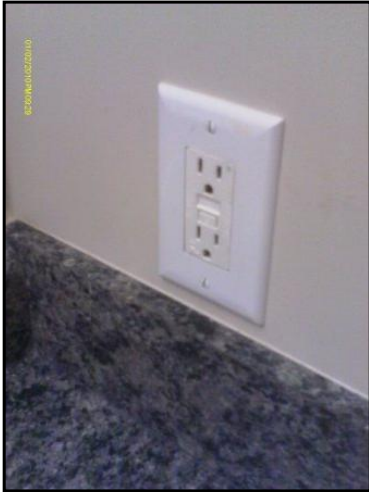
19 : GFIC receptacles in dormitory rooms.

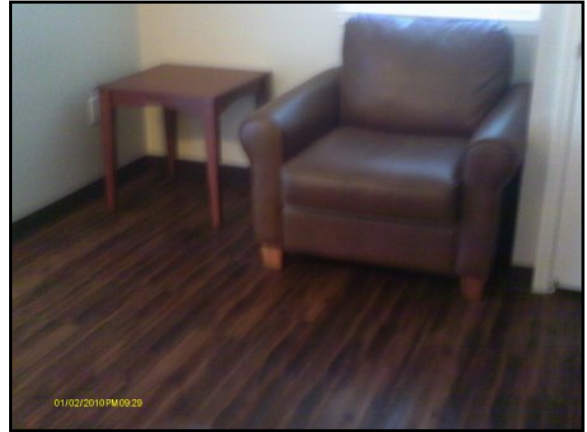
20 : Typical dormitory room furniture.

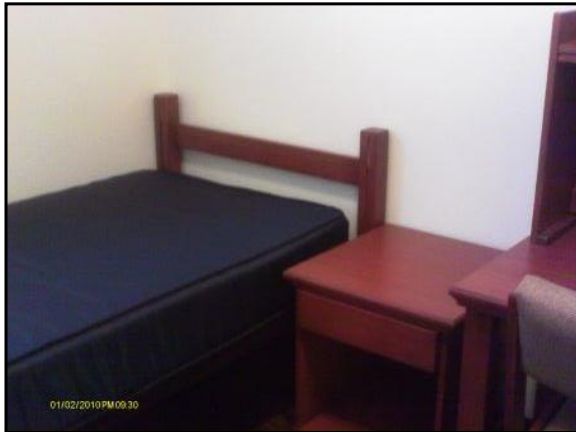
21 : Typical dormitory bedroom furniture.

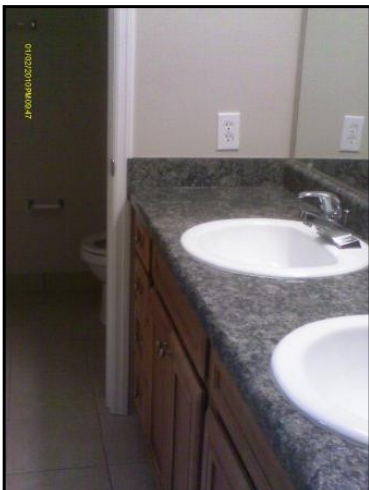
23 : Typical bathroom sinks in the dorm rooms.

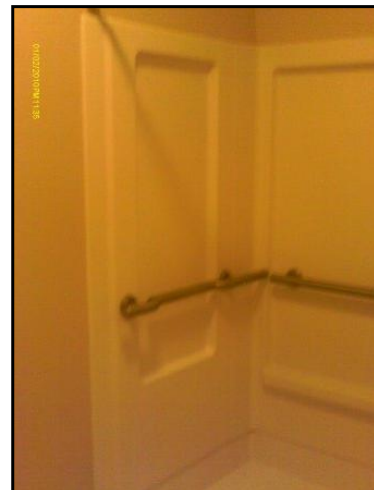
24 : Handicap access for showers in the dorm rooms.

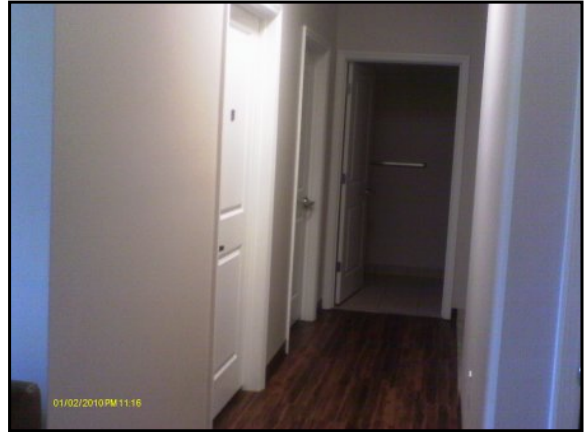
26 : Typical interior of dorm room.

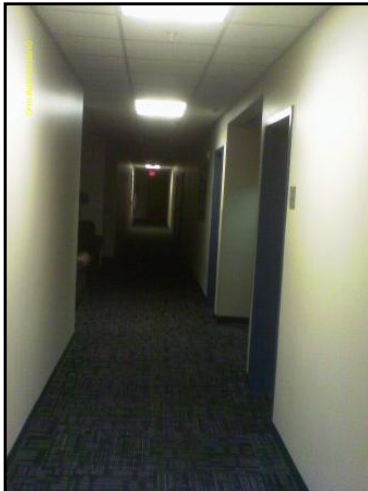
27 : Hallway of the building.

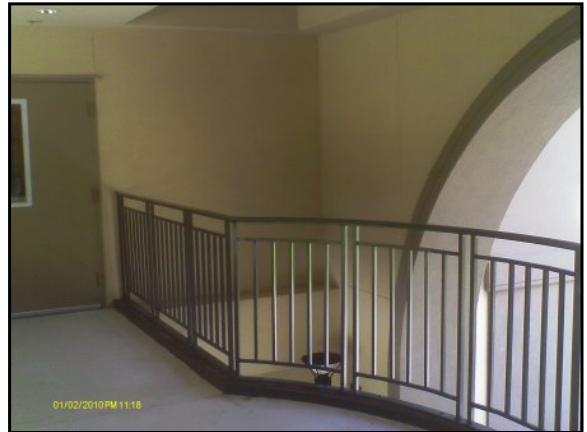
28 : Exterior second floor breezeway between Wing 2 and Wing 1.

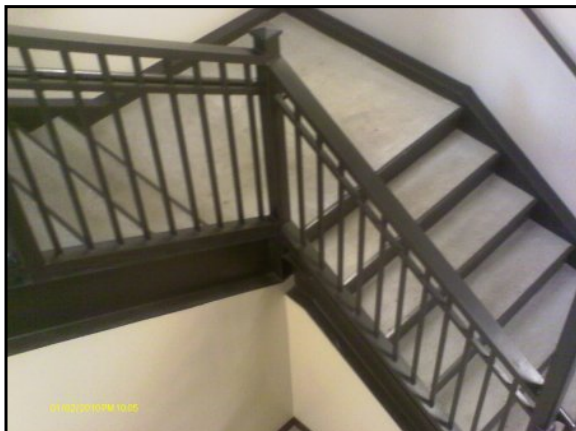
29 : Typical stairwell in the buildings.

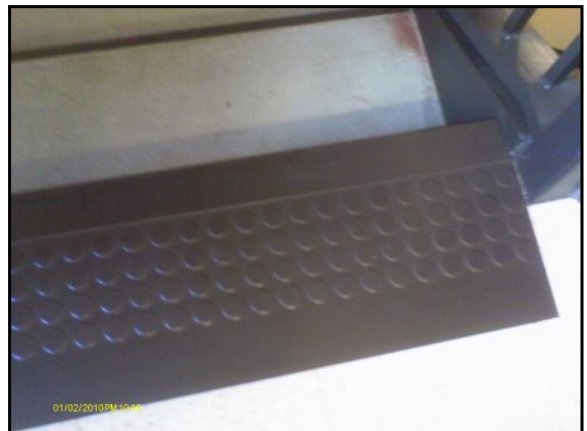
30 : Non-skid treads for the stairwell's.

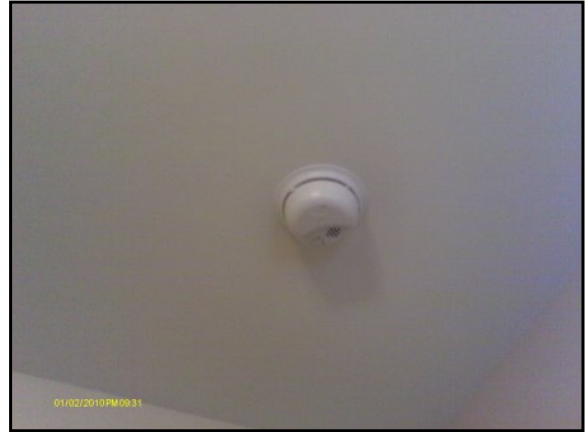
32 : Smoke detectors in hallways.

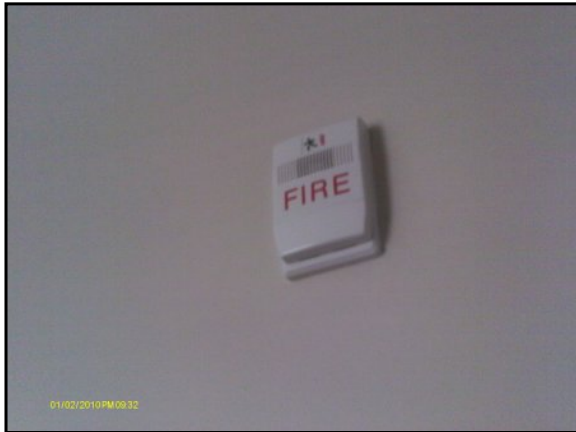
33 : Fire alarms in hallways.

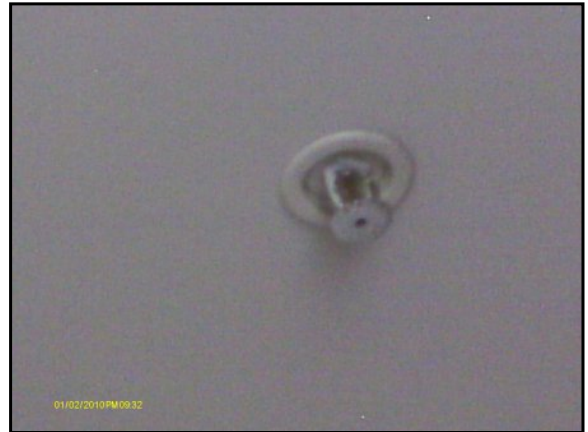
34 : Sprinkler heads in hallways of building.

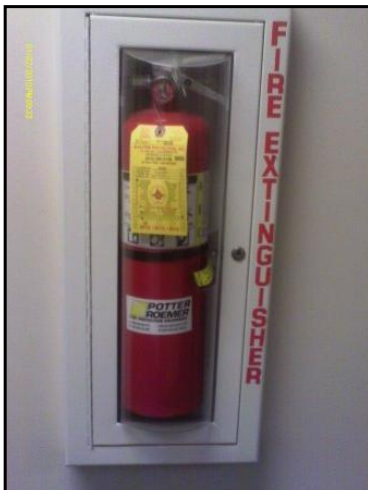
35 : Typical fire extinguisher in building hallways.

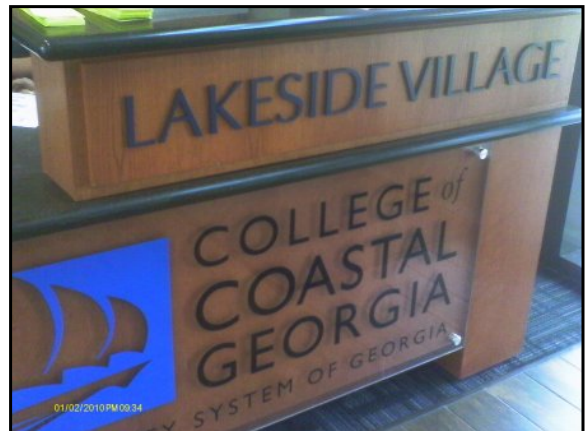
36 : Signage at the property.

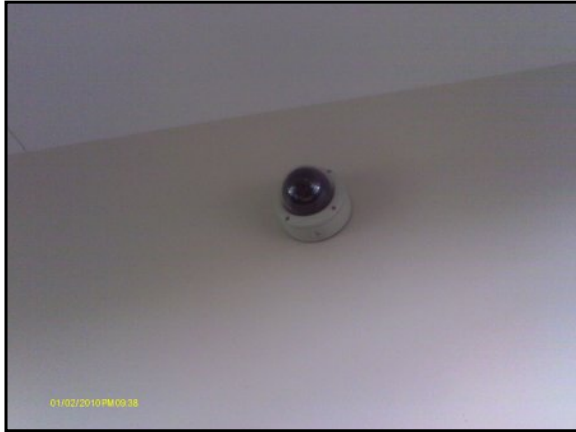
37 : Security cameras in the building.

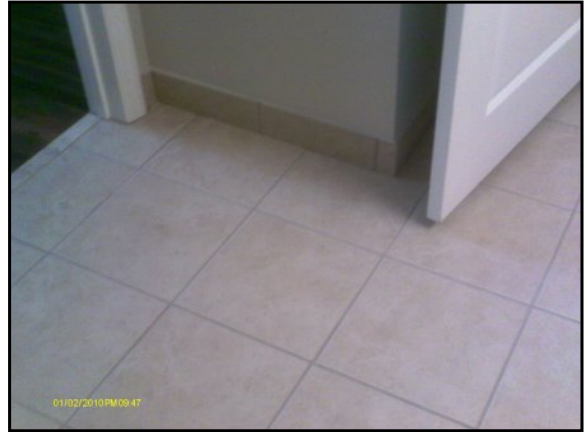
38 : Typical ceramic tile floor covering in the building.

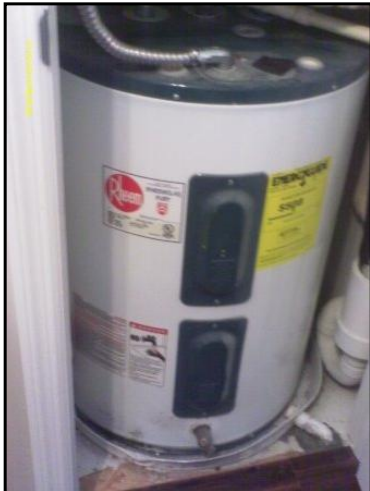
39 : Typical hot water heater at the Property.

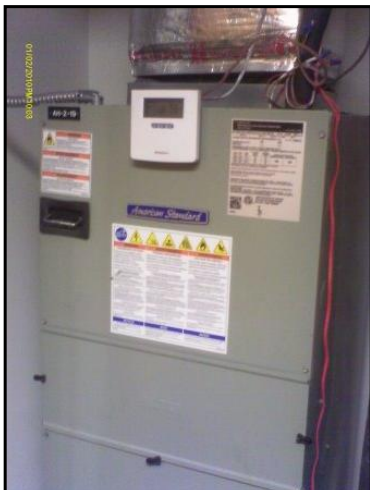
41 : Typical HVAC unit in hallway mechanical closets.

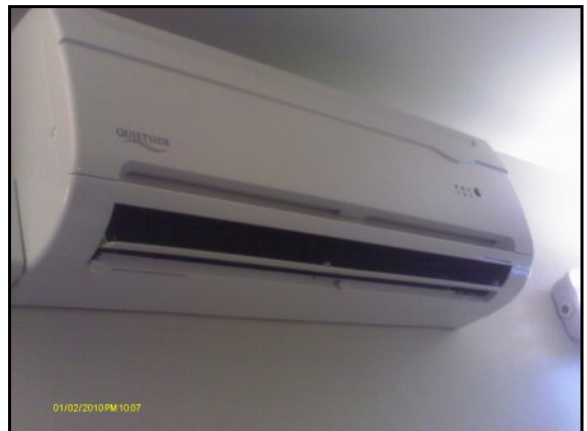
42 : Air recirculator in stairwells.

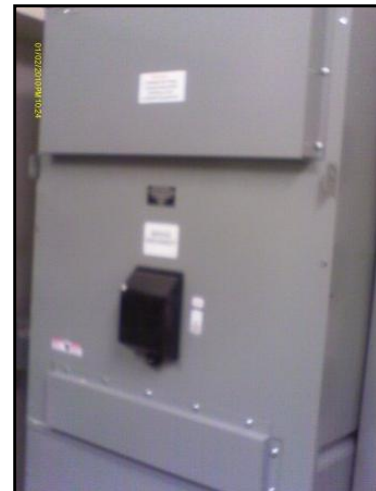
46 : Main electrical power equipment in Wing 3 of the Property.

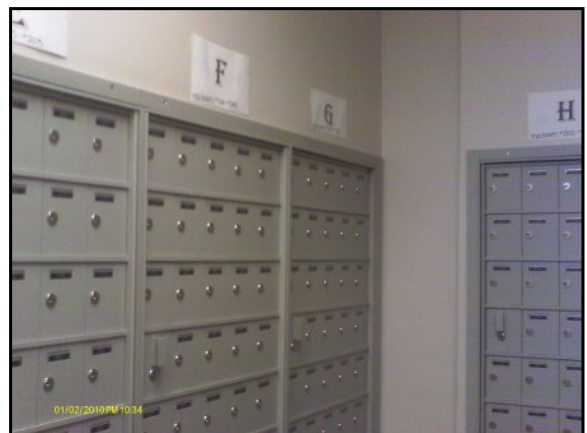
48 : Main room for the building.

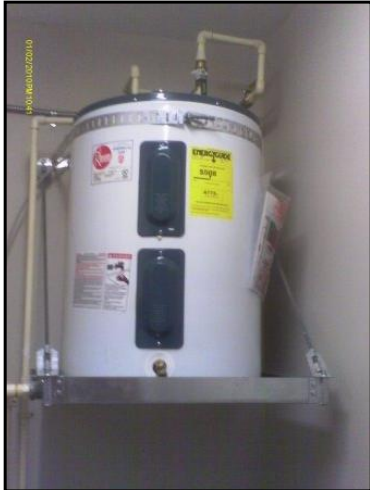
49 : Typical 38 gallon hot water heater in hallway janitorial closets.

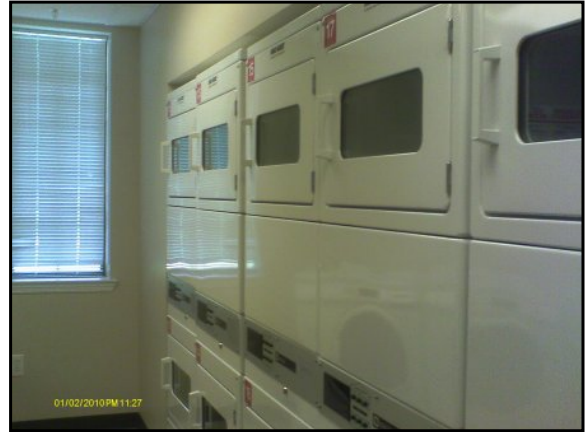
50 : Laundry facilities (dryers) for the building.

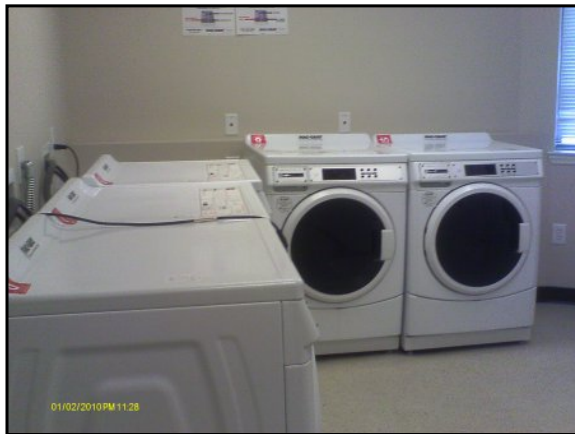
51 : Laundry facilities (washers) for the building.

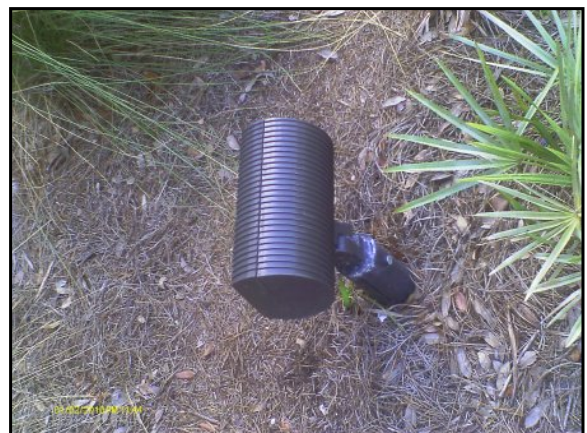
54 : Exterior ground lighting.

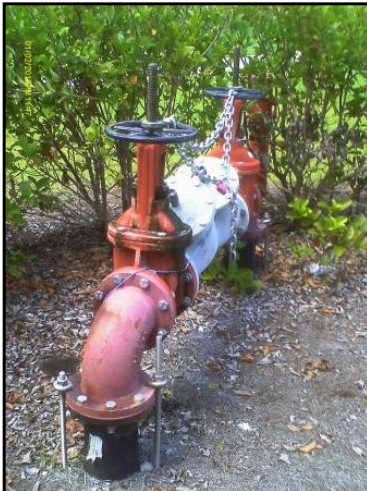
57 : Exterior fire suppression supply line.

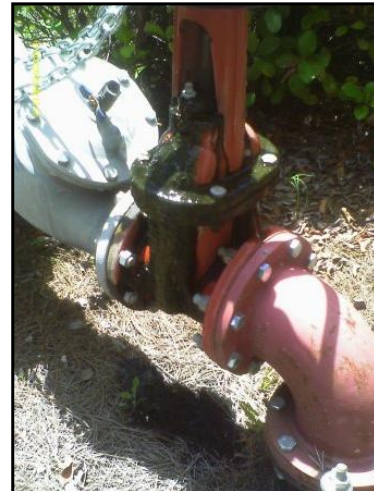
58 : Water supply outside Wing 2/3.

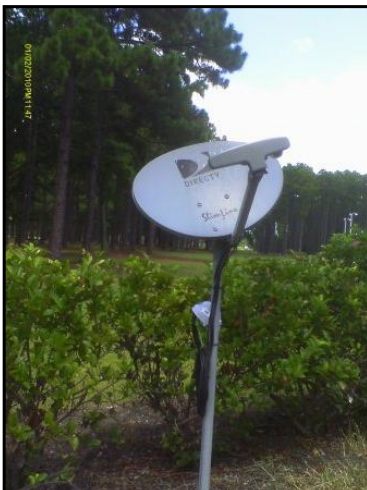
59 : Satellite TV at the property.

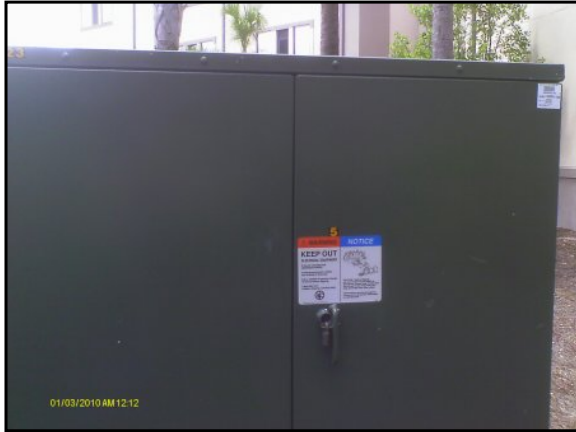
61 : Pad mounted transformer outside Wing 2/3.

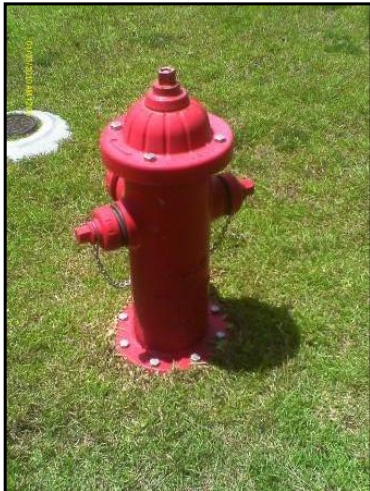
63 : Fire hydrant on the southeast side of the property.

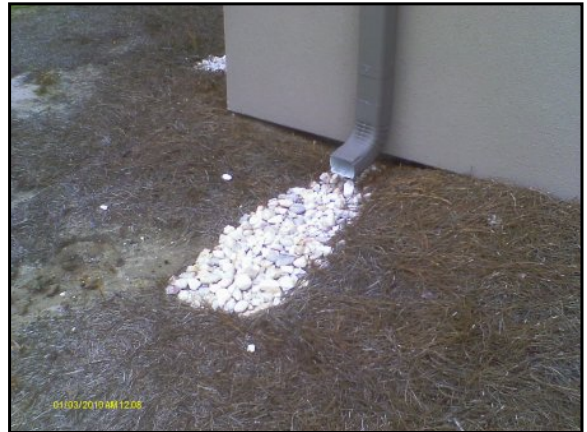
64 : Gravel at the downspouts.

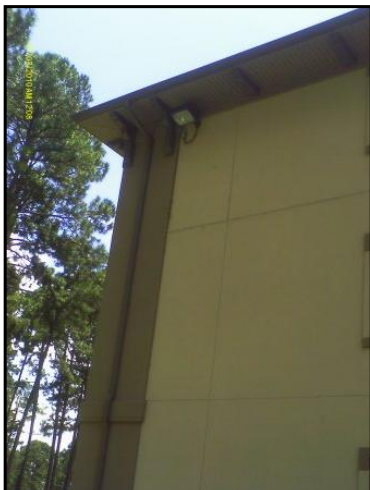
65 : Exterior security lighting.

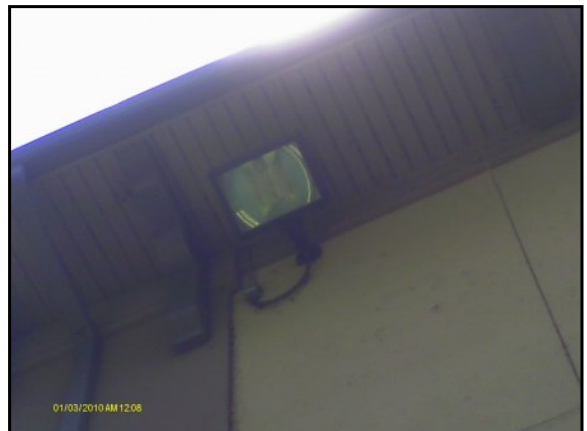
66 : Exterior security lighting (close-up).

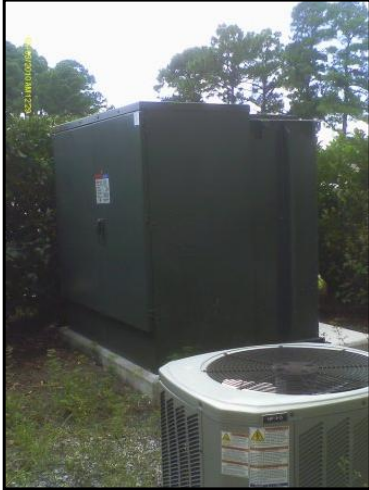
67 : Pad mounted transformer outside Wing 2.

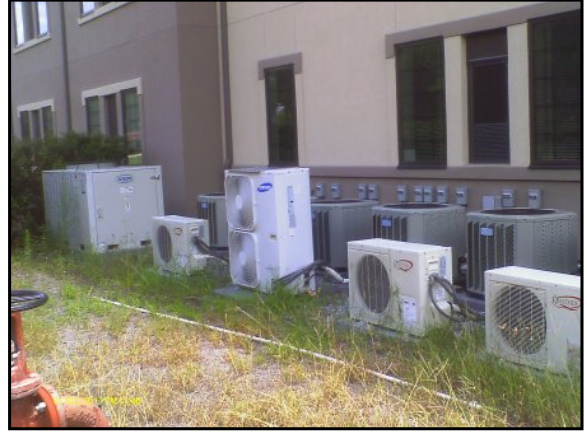
68 : Exterior HVAC compressors on the north end of Wing 1.

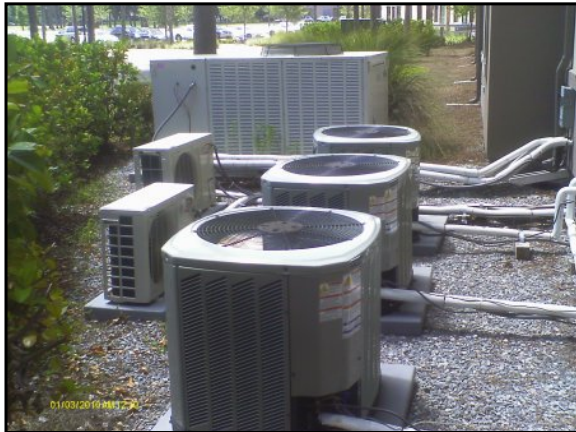
69 : Additional HVAC compressors outside the west side of Wing 3.

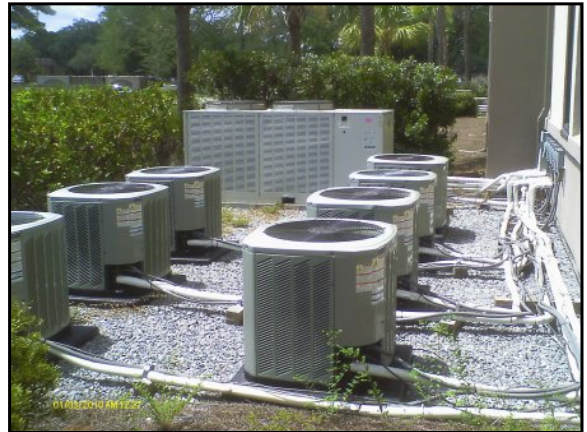
70 : HVAC compressors outside Wing 2.

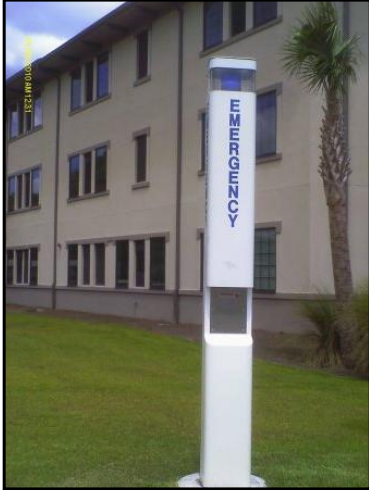
73 : Emergency call box outside Wing 1/2.

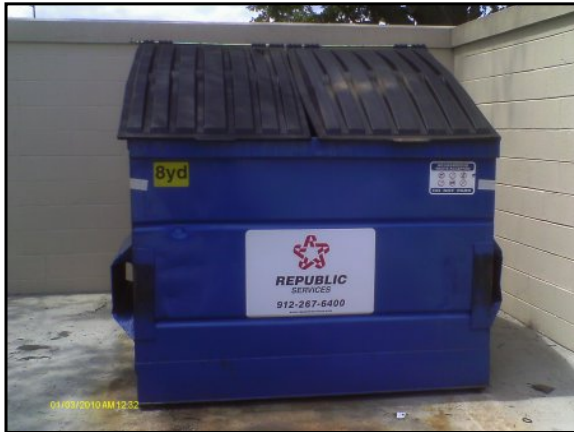
75 : Trash dumpster.

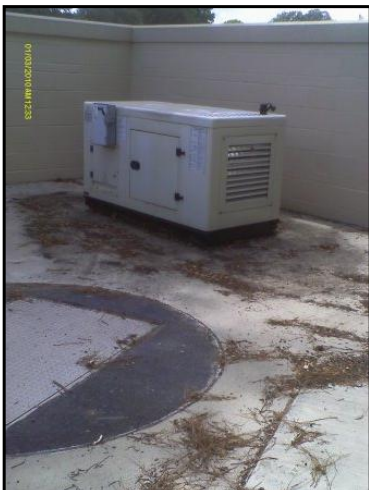
77 : Sewer lift station (foreground) adjacent to the diesel emergency generator in the dumpster compound.
